July 7, 2020
File No. 04.0029644.02

Re: Observations and Opinions of Probable Cost - Gas Holder House
Concord Manufactured Gas Plant – 1 Gas Street (Site)
Concord, New Hampshire
DES Site # 198904063, Project RSN # 1479

**Re: Concord Gasholder Building Evaluation
Concord, NH**

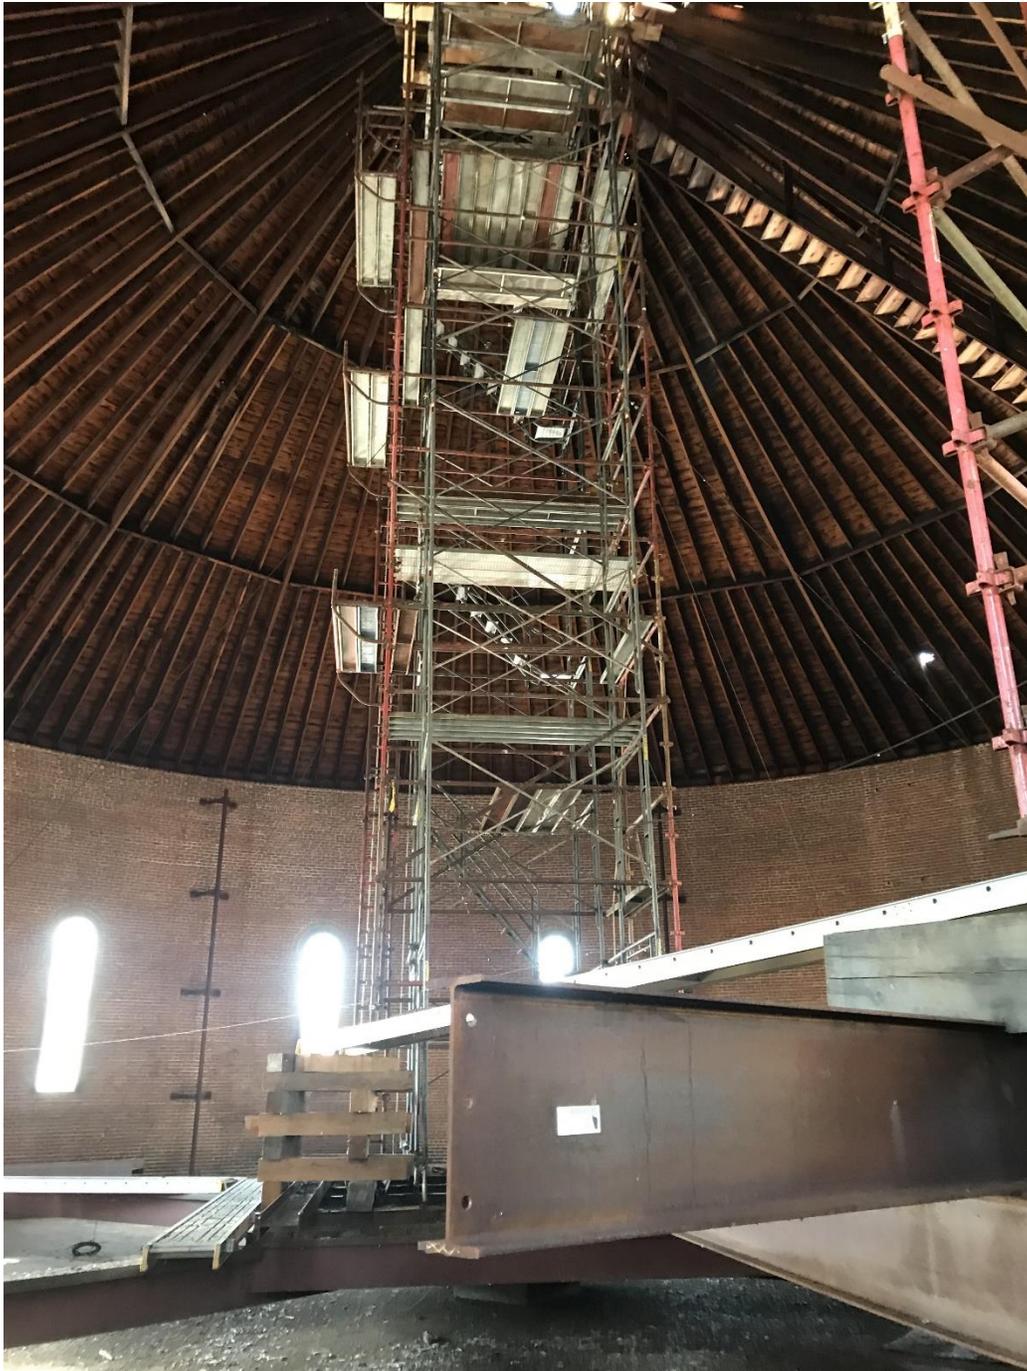
Photo #1-Center Shoring Systems

1. Based on our memorandum dated February 10, 2020, new C12 channels have been added to the top of the W16 main support girders. This was done as the W16's initially had limited capacity due to their unbraced lengths. The addition of the channel has increased their load carrying capacity.
2. An entirely new shoring structure has been constructed at the center of the building. The shoring system which was in place in 2010 is still present, the new shoring was simply constructed through and around the existing shoring. See photo #1. The new shoring system has a different geometry and style than that of the existing. We looked for and did not find any markings to indicate a model number or find any other information which would allow us to determine its capacity from a catalog or manufacturer's product data sheet.

Overall, the structural steel framing and shoring is in good condition.

While all of the shoring is performing its intended purpose of supporting the cupola or portions of the roof, we reiterate our statement of 2010 that at some point it all should be removed and replaced by a structural steel support system. Conceptually this could be sets of steel columns (with some horizontal beams and bracing), supported on new steel beams which would clear span the space. The columns would, at a minimum, extend up to the compression ring around the base of the cupola. As stated in our report of 2010, the large wood beams which run from the cupola down to the eave have a significant sag in them and are likely undersized for the snow loads. Installing columns which supported these at midspan would greatly increase the capacity and overall stability of the roof system.

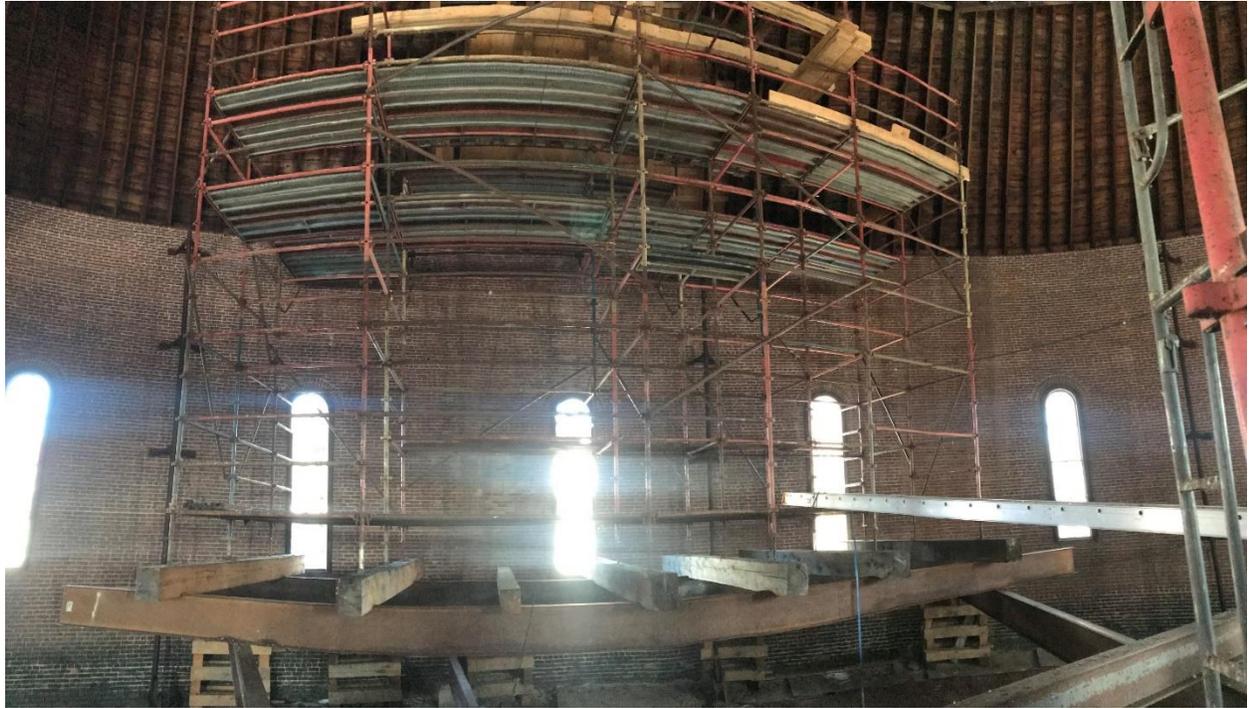
Photo #2-Shoring System at North Side

3. A completely new shoring structure has been erected on the north quadrant of the building. See photos 2 and 3. We understand this was erected some time ago when a large tree fell and impacted the roof. The shoring system is constructed both inside and outside of the building. The shoring system is supported on a grid of what looks to be 8x8 wood timbers supported on structural steel beams spanning East-West. The structural steel beams are supported by two W16 structural steel beams which span from the center support pier to the perimeter ledge of the building. At the perimeter ledge the two W16 beams rest on timber cribbing. We did not observe a positive attachment method, such as lag bolts, to anchor the steel beams to the wood cribbing, nor did we see much of a positive attachment/anchorage system for the wood cribbing itself.

The new shoring system at the north side appears to be functioning as intended to support the damaged roof area.

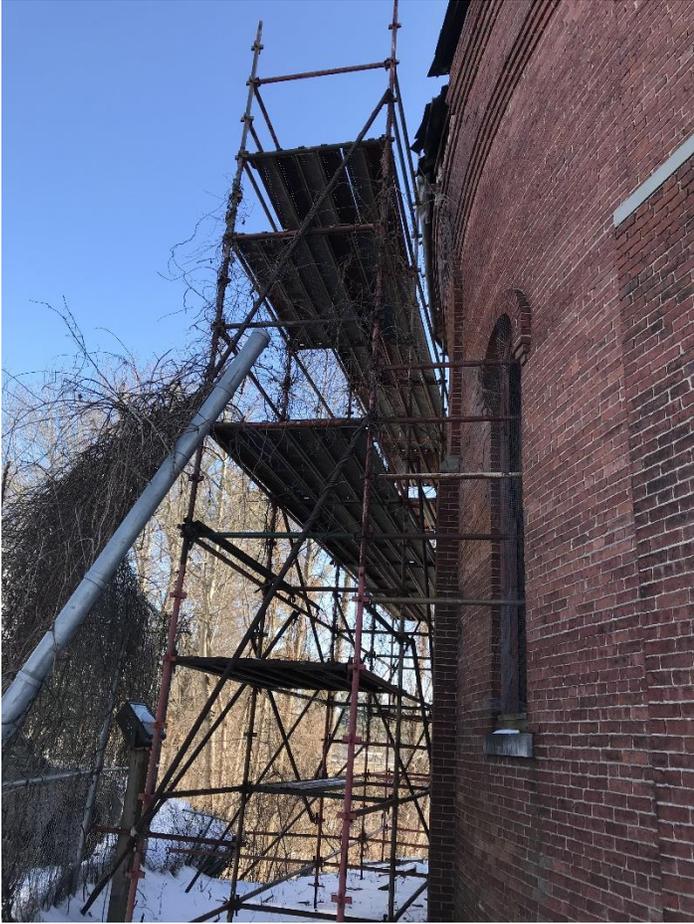
Photo #3-Exterior Shoring

This shoring system on the interior of the structure is connected to a similar height and size shoring system on the exterior of the building. Horizontal struts are extended through the window openings connecting the two systems.

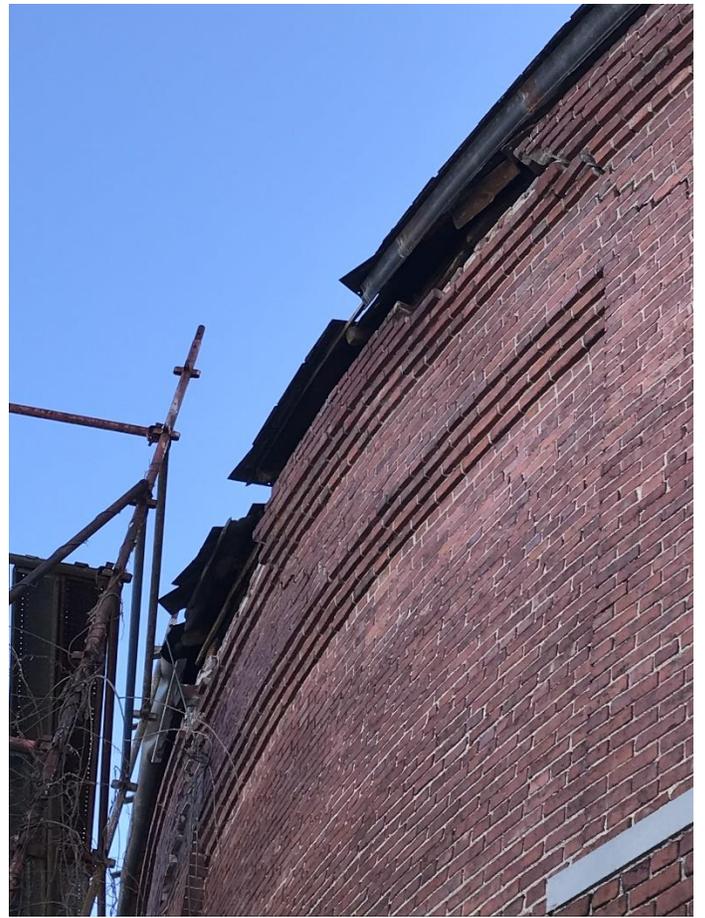
Photo #4 – Roof Edge North Side

There were several places where we could see daylight through the roof. Where the tree hit the roof, it looks as though there may be a large gap in the roof edge, see photo #4. Keeping the wood roof members dry and free of rot is critical to the longevity of the structure. As previously documented, we believe the overall capacity of the roof framing is marginal. A reduction of the framing capacity due to rot will put the structural stability of the entire roof system in jeopardy. Also, we observed a significant amount of bird droppings throughout. Combined with moisture, bird droppings can accelerate steel corrosion. In the long term, the droppings could potentially cause a reduction in the capacity of both the structural steel beams as well as the shoring. Therefore, we strongly recommend a roofing project be completed in the near future to make the structure watertight. The penetrations for the shoring system through the windows should be sealed tightly such that no birds can enter the building in that manner.

In summary, the overall condition of the building has not changed substantially in 10 years. We do believe there is some urgency in the need to make it watertight and to keep birds out. Longer term planning should see the temporary shoring replaced with new permanent structural steel framing.
