City of Concord, NH

Storm Water Master Plan

April 2007

Final Report

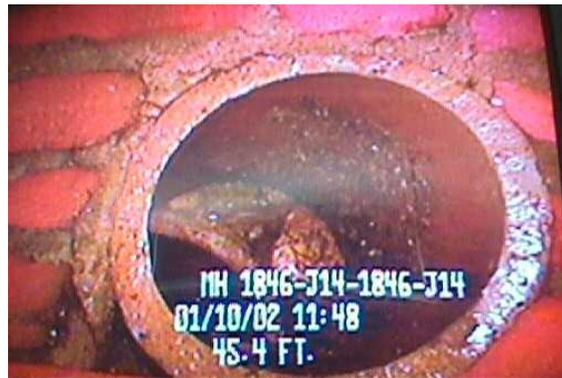
- Two pipes cross through the drain.
- There are heavy roots and light roots at several locations
- There was debris in the pipe at three locations.
- There were two sections of the drain, about 150 feet and 285 feet long, respectively, that were in poor condition (collapsed and crushed sections, major cracks, misalignments, etc.)
- There is one possible illicit connection, 151 from Manhole 2181.1-J14 in the easement.
- There are 12 other locations where water from service connections was entering. Since it was raining, this is probably clean water, but a follow-up inspection should be conducted during dry weather to ensure these are not illicit connections. In addition, there were 4 unplugged but dry service connections.

Several sections of drain were identified as being in poor condition

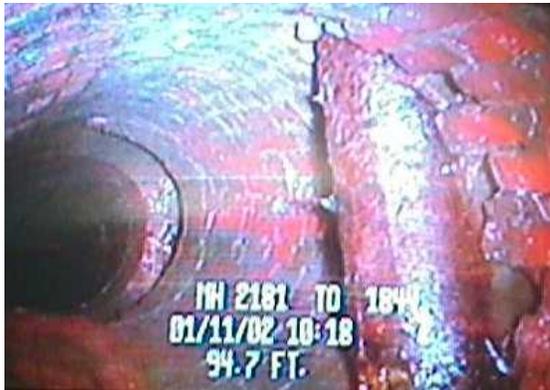
Blockages identified in the Spruce Street drain included several locations with pipes crossing the drain. This occurred on South Street between manholes 2181-J14 and 2074-J14 where two small pipes separately cross the top of the drain. They block less than 15 percent of the drain's effective area. Although not ideal, these blockages are not considered significant enough to warrant re-routing these pipes, which because of their gravity flow, would be very expensive. A pipe also crosses the drain on Thompson Street between manholes 1846-J14 and 1844-J14. An eight-inch pipe crosses the drain at this location. Pipes with debris and protruding taps were also identified.

Pipes crossing the drain impede flow directly and tend to accumulate debris increasing the effective impediment. Redirecting the offending pipes can be quite expensive.

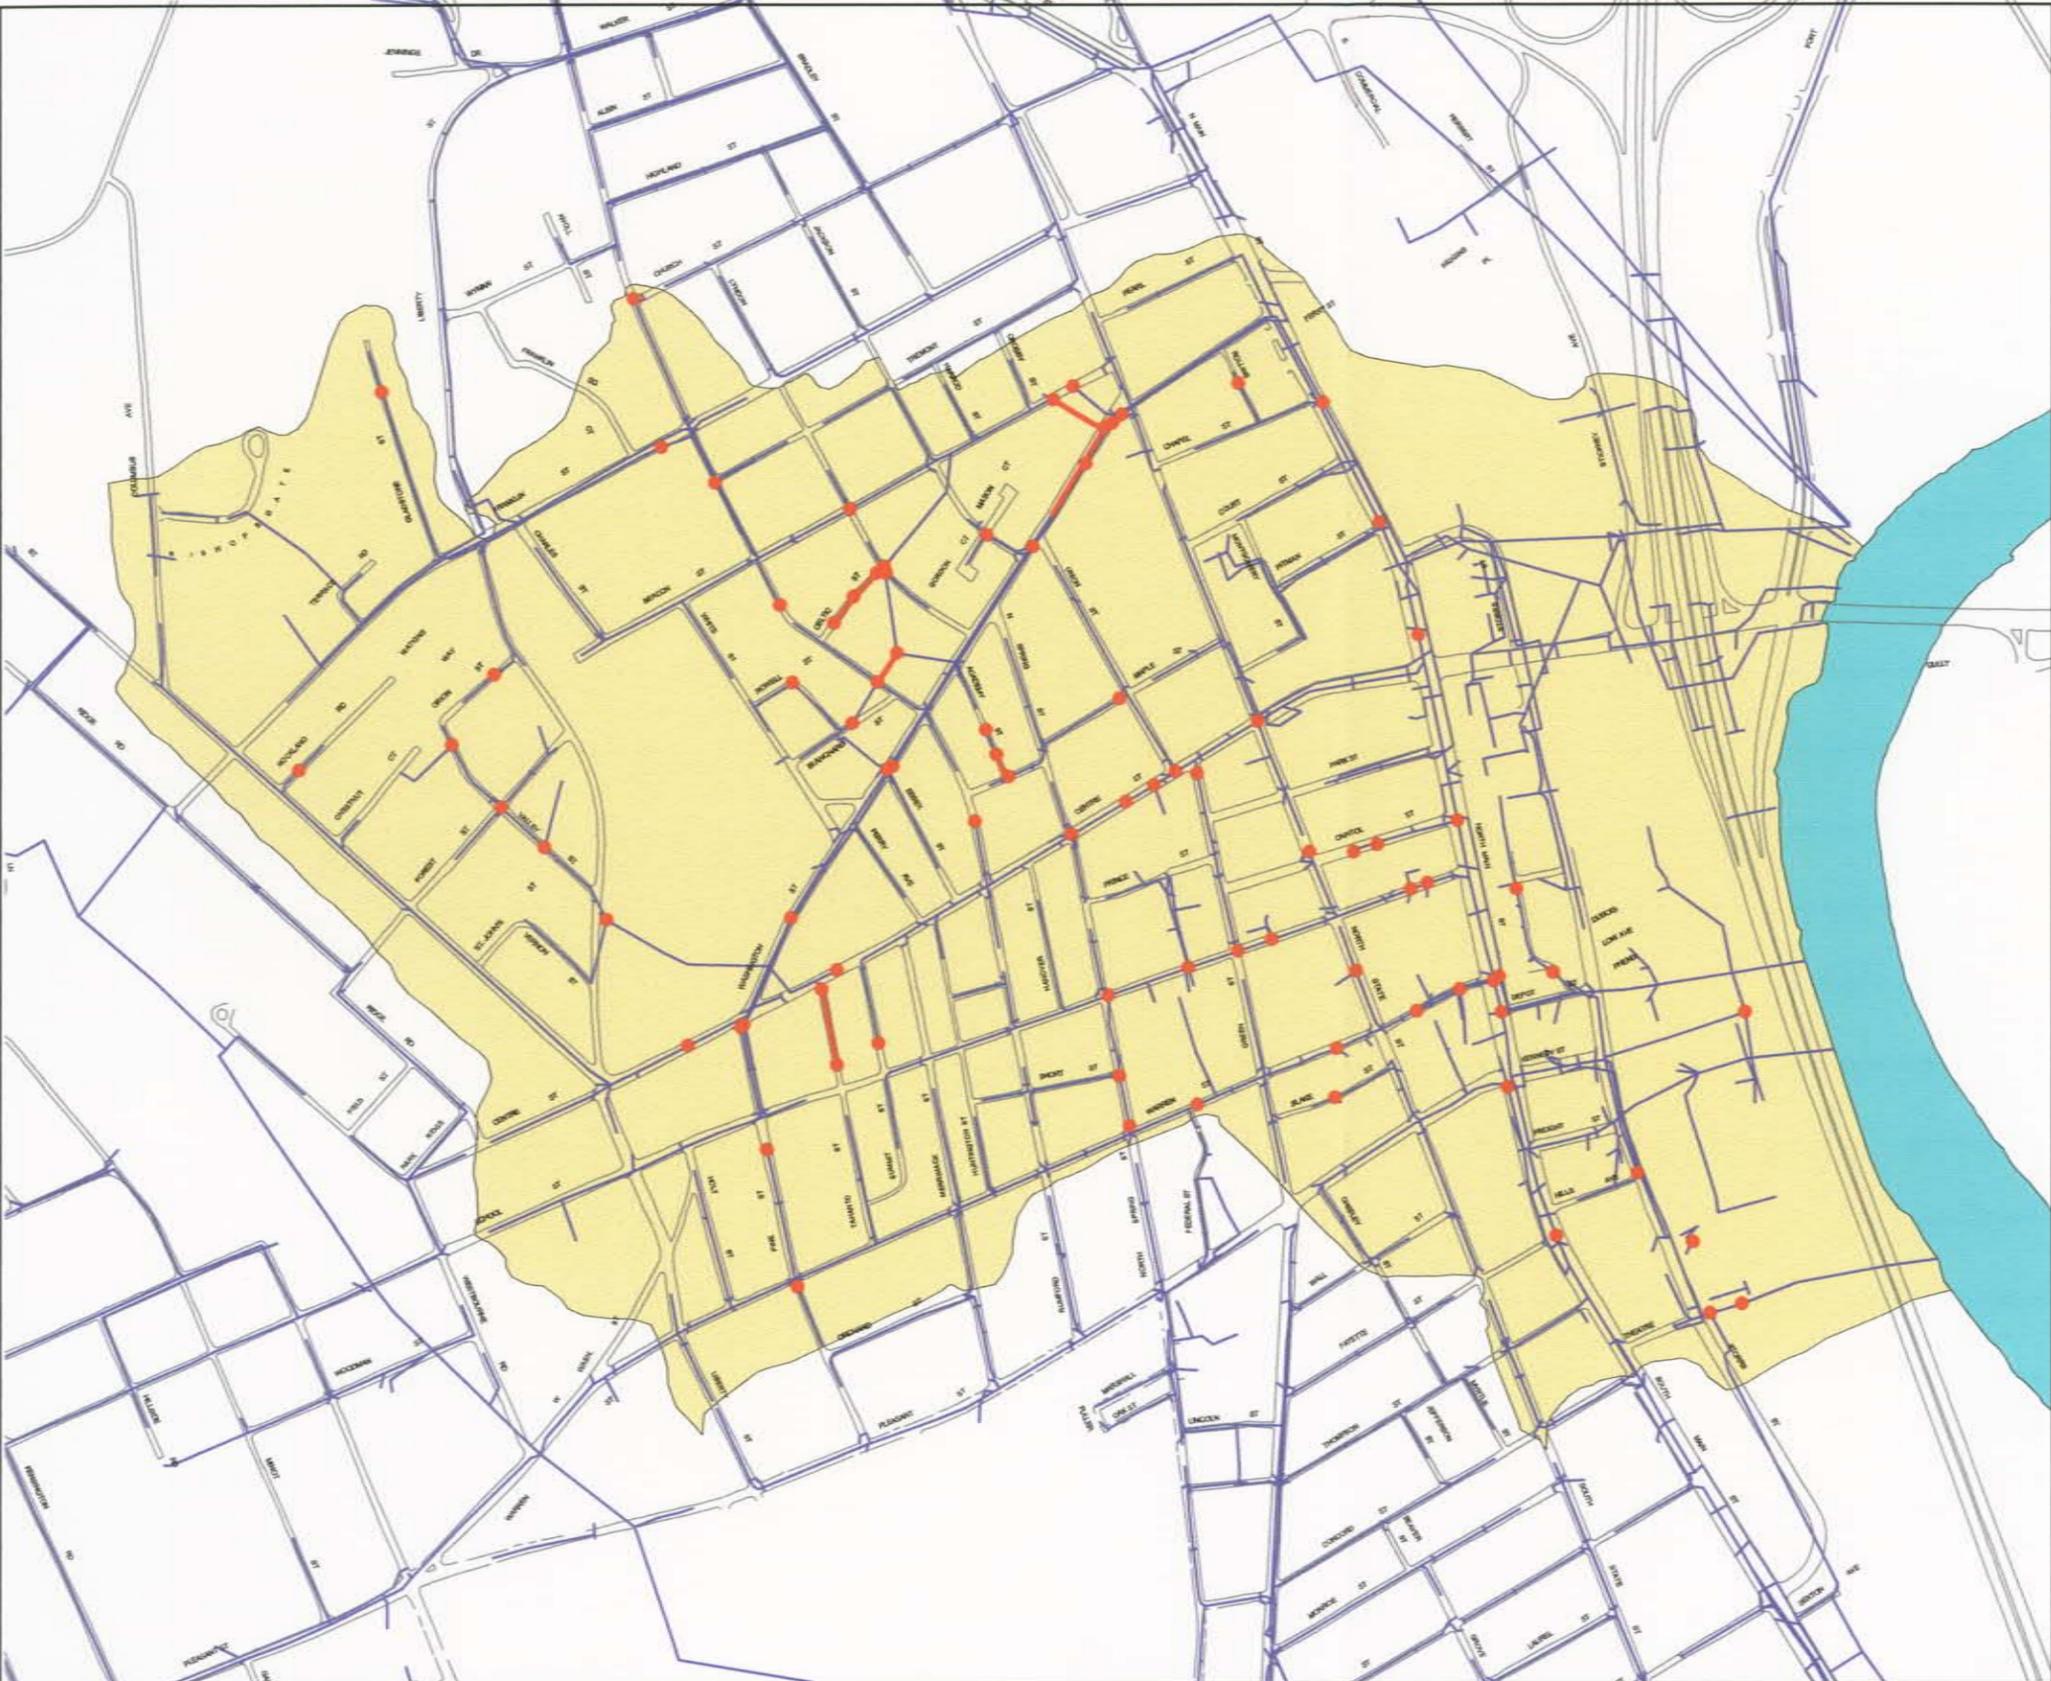
Figure 5-6: Pipes and Inverts/Shelves in Fair to Poor Condition

- Manholes with shelf and/or invert in Fair/Poor condition
- Fair/Poor Condition Pipes
- Roads
- Drain Pipes
- Merrimack River
- Washington Street Drainage Area

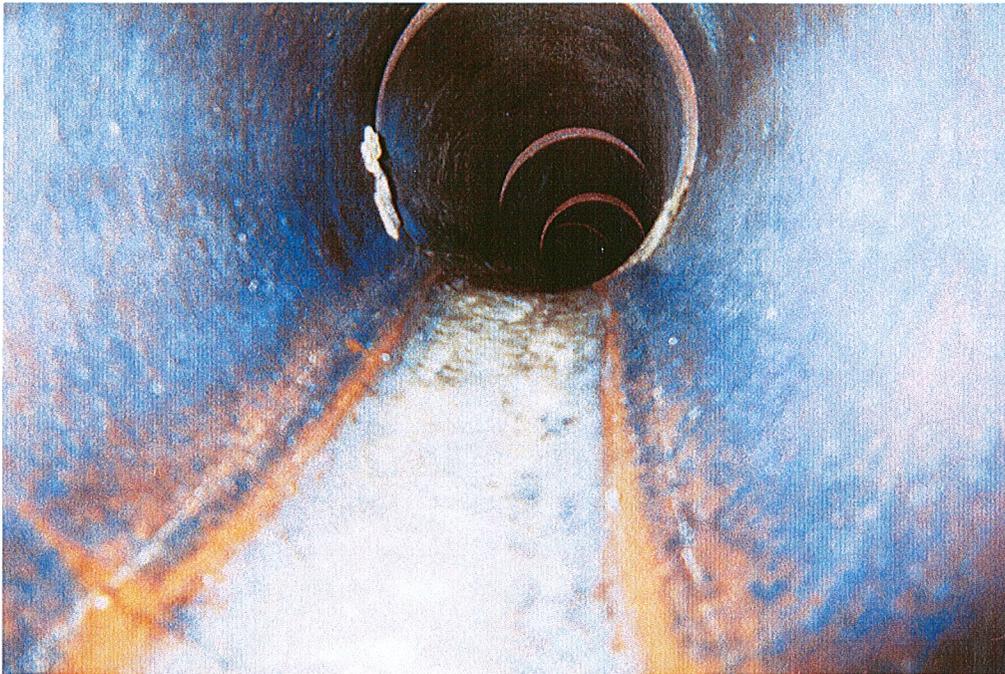
Evidence of “dripping sewage” was found in the 8” line (above, upstream of manhole number 3116-I13) running from the end of Chestnut Street to just south of the corner of Valley Street and Orion Street, near the north end of White Park.

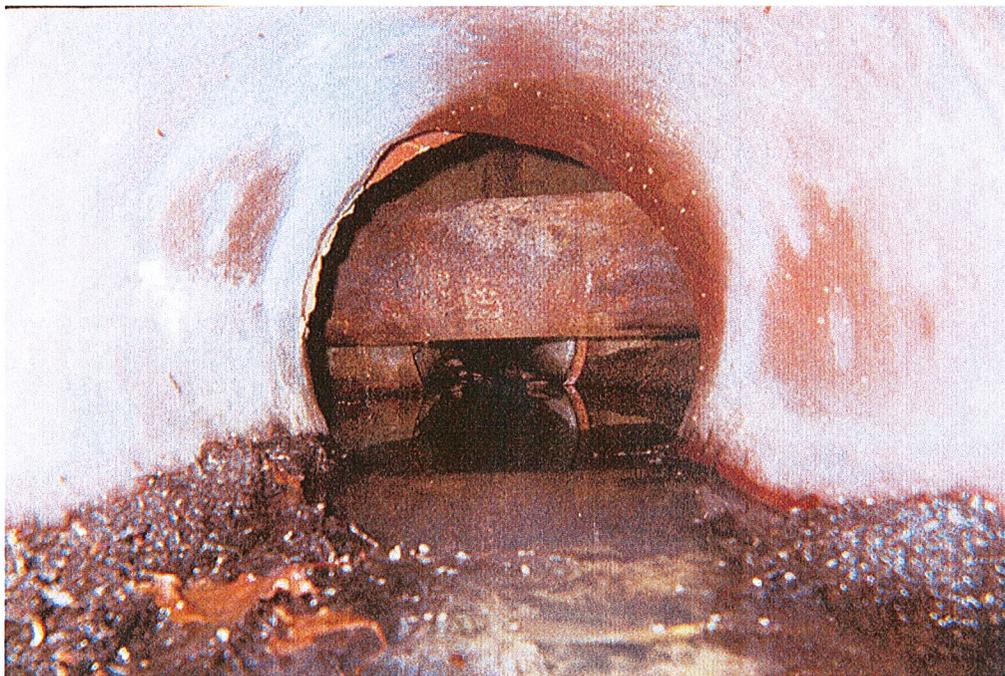
Sewer line runs through storm drain about 6’ upstream from manhole 179-I13, on Valley Street between Forest Street and Liberty Street. Small amount of grey-colored flow with a slight septic smell noticed here (manhole numbers 179-I13 to 808-I13). This is also downstream of the above-mentioned “dripping sewage”.

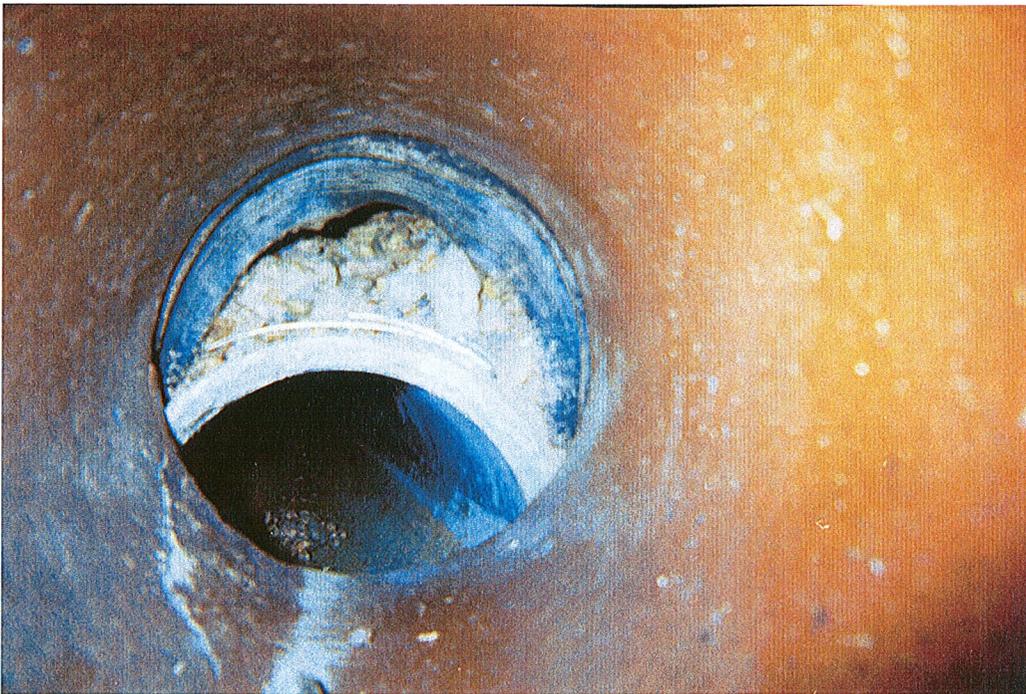
Joint failure and possible cross connection on Liberty St, north of Vernon St (manhole 213-I13). A section of 8" pipe about 4' upstream (south) of the manhole settled 4" to 5", giving way at the joint. The source of any flow in the settled pipe was not located, but mapping indicates it may be connected to the sewer system.

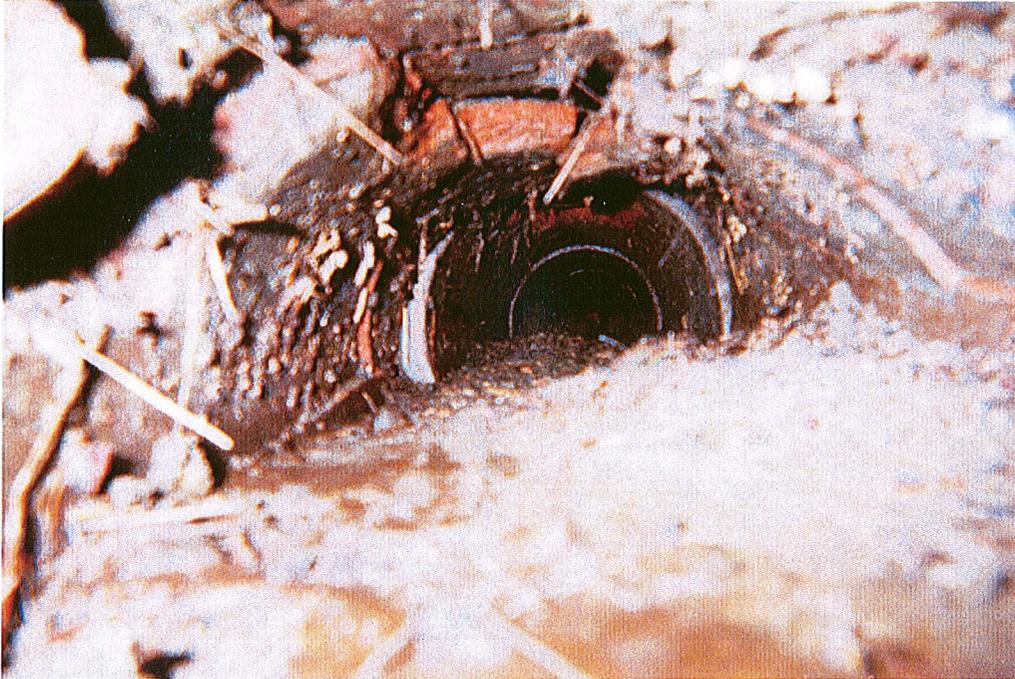
8" vcp on Celtic Street is 50% full of debris flowing into manhole 3440-I13.
The 8" vcp flowing out of this manhole is collapsed to 3".
No picture was available of the collapsed pipe.

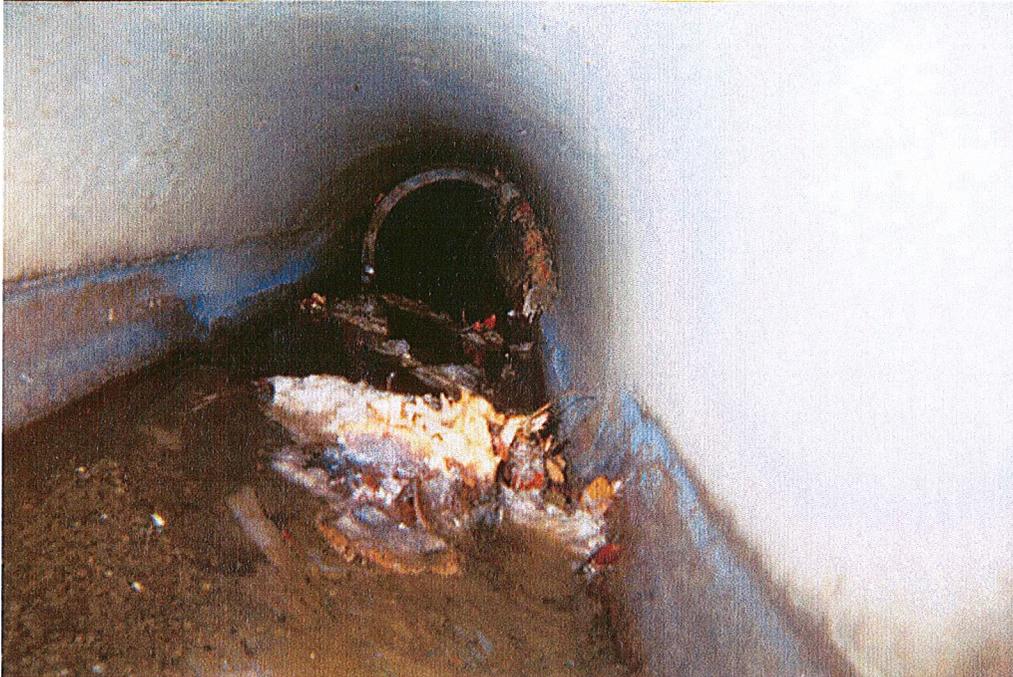
Possible cross connection near North Main Street at Pearl Street (manhole 3898-J13).
Flow containing floatables, including toilet paper, were found in the manhole.

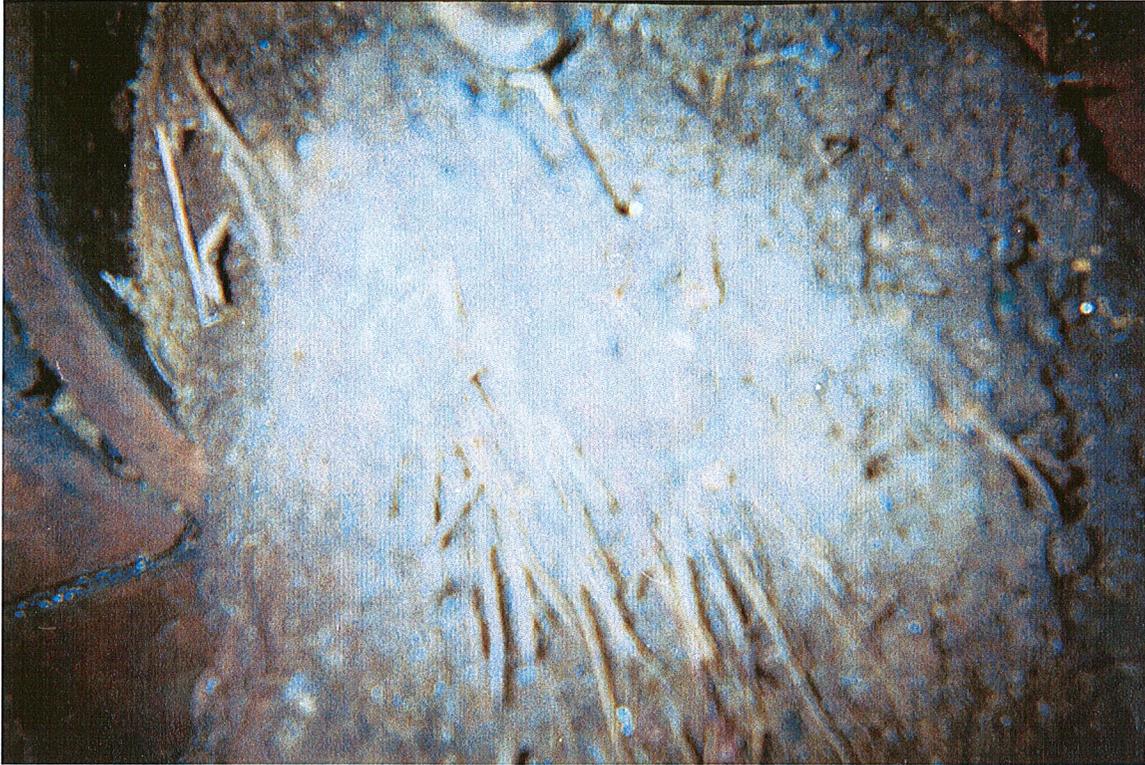
Manhole 213-I13 (Liberty Street, west of White Park), 10" pipe 100% full of debris.
