# DOWNTOWN CONCORD PARKING SYSTEM STRATEGIC PLANNING FINAL REPORT

FINAL • January 2016

## 3.6 PUBLIC GARAGES CONDITION SURVEY

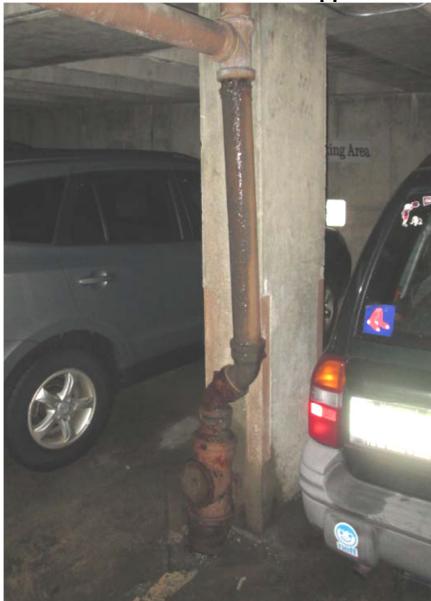
- The Firehouse Block Garage is 36 years old and now requires maintenance to address the current structural and waterproofing deterioration, rusted sanitary piping and some relatively minor electrical issues;

**Figure 71 Firehouse Block Garage: 6”  
Sanitary Line Leaking at  
Connection at Upper Tee.**

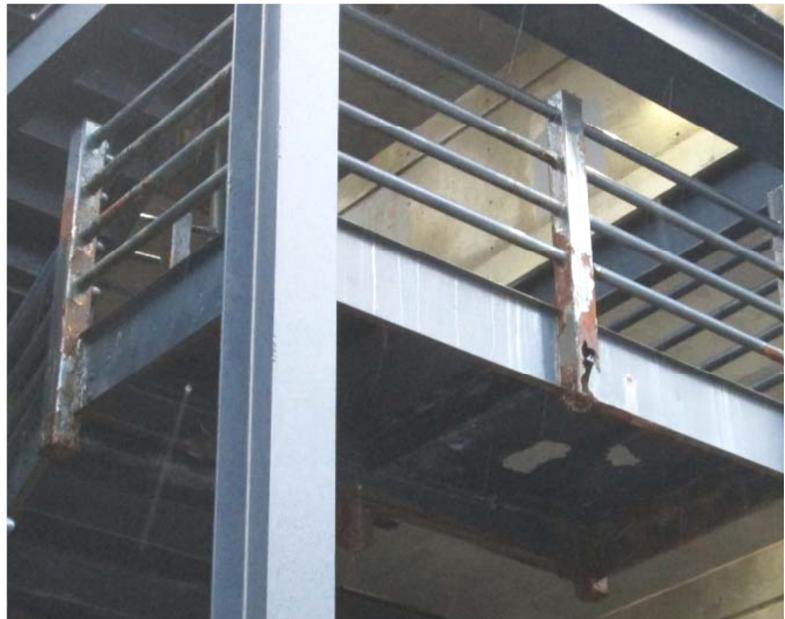
**Figure 72 Durgin Garage: Rust and Decay in Metal Posts on Northeast  
Stair Tower**

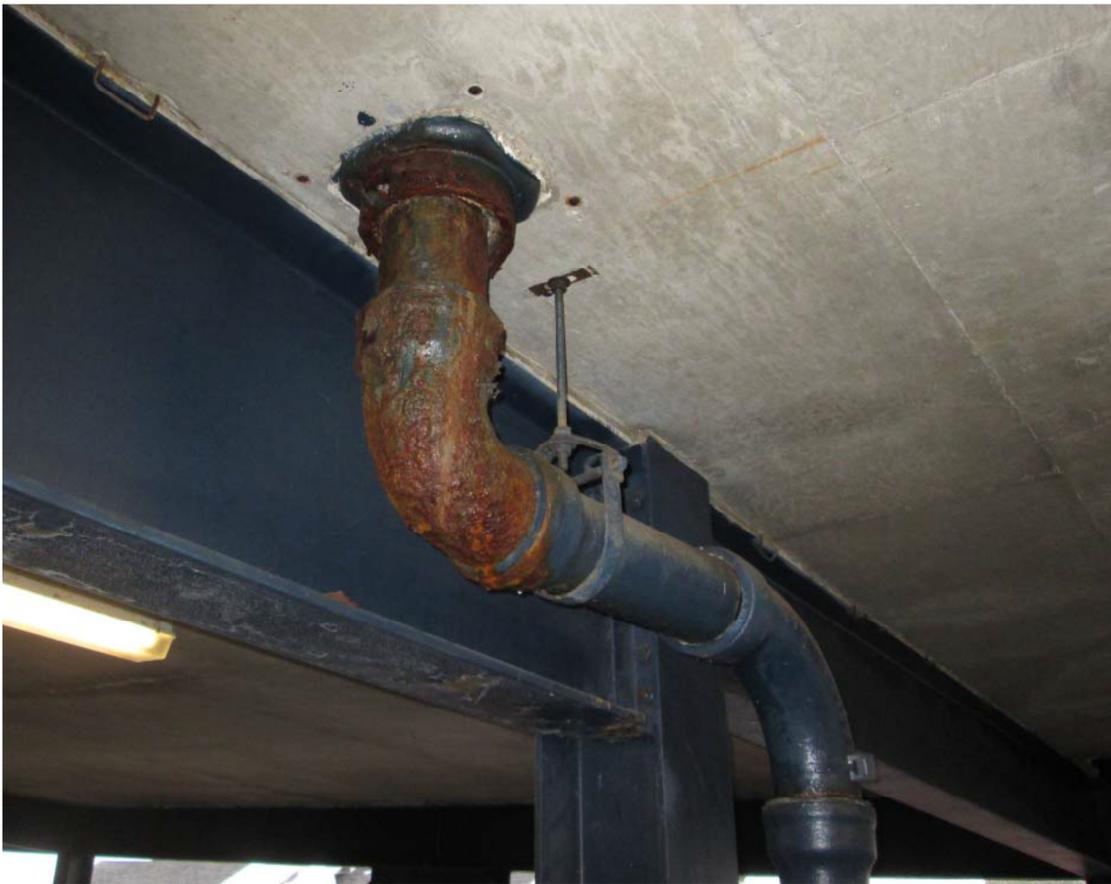
- The Durgin Garage is 32 years old and is currently scheduled to undergo a significant repair and rehabilitation project that will address the existing structural and waterproofing deterioration, poor elevator conditions, leaking issues, and severely rusted stair towers.

**Figure 73 Durgin Garage: Negative Pitch and Corrosion of 6" Sanitary Riser at Column Line F4 Level 4**

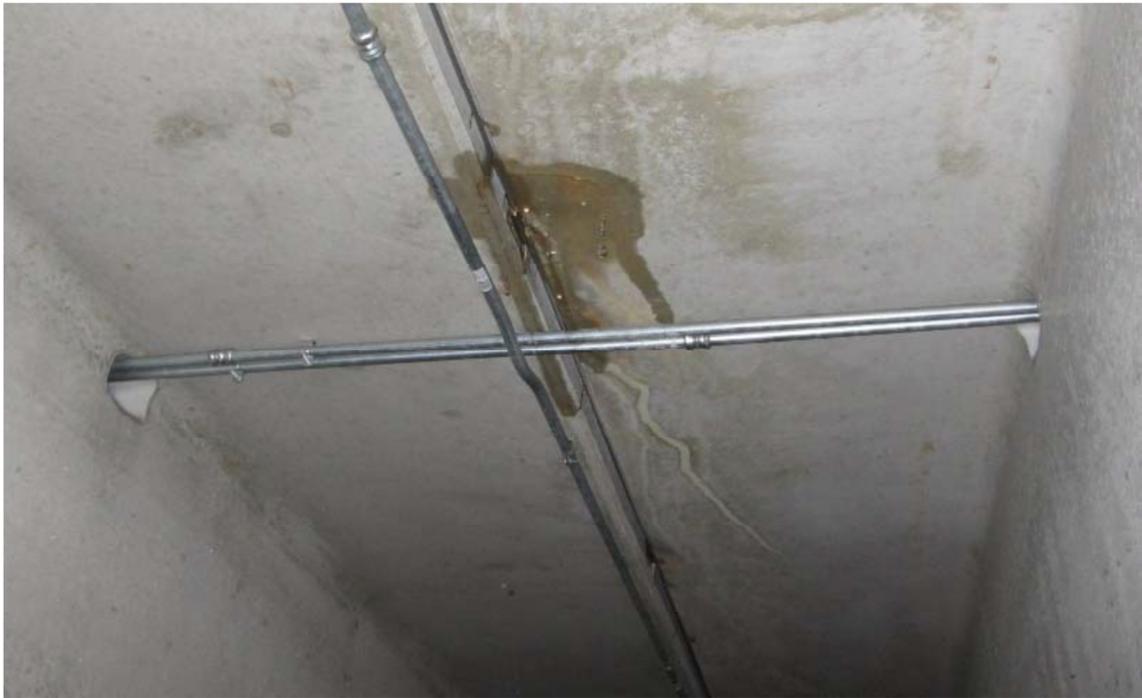
**Figure 74 Capital commons Garage: Roof Leak Southwest Area**

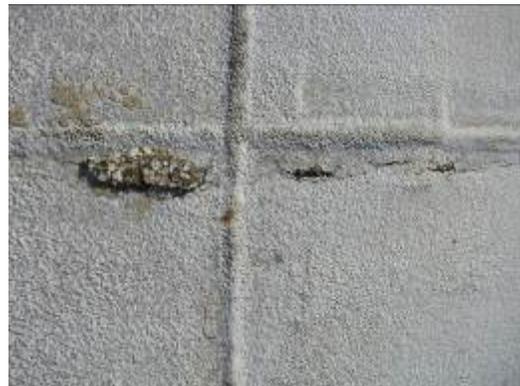
- The precast, pre-topped concrete decks of the garage were typically observed to be in a 'like new' condition. Concrete floor deterioration was only observed at a few sections of the pour strips.

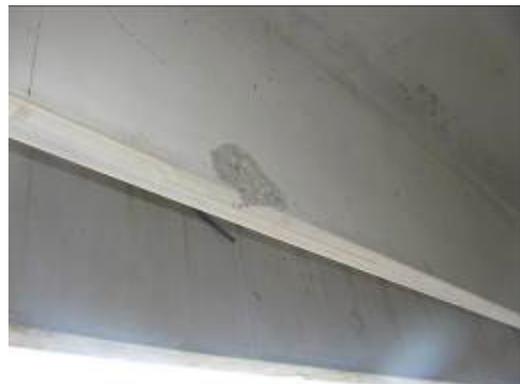
- While the tee flanges were also observed to be in 'like new' condition, a few areas of chipped concrete were observed at the underside of some of the tee stems.

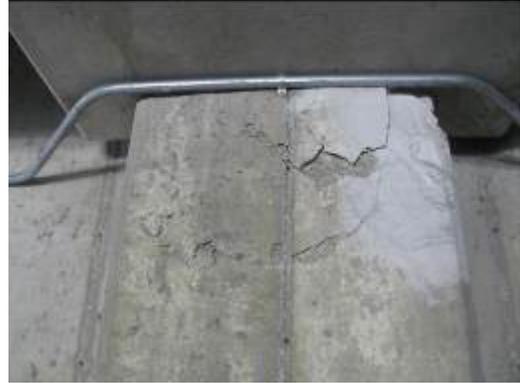
- Vertical and overhead spalling at the precast concrete columns and walls were observed in a few locations in the garage.

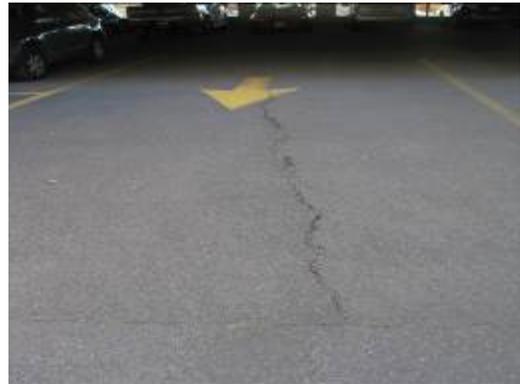
- A few areas of deteriorated asphalt were also observed at the slab-on-grade.

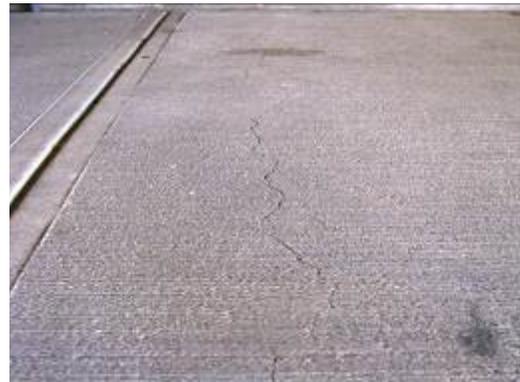
- Cracks in the precast, pre-topped tees and at the cast-in-place pour strips were observed on all supported levels of the parking garage.

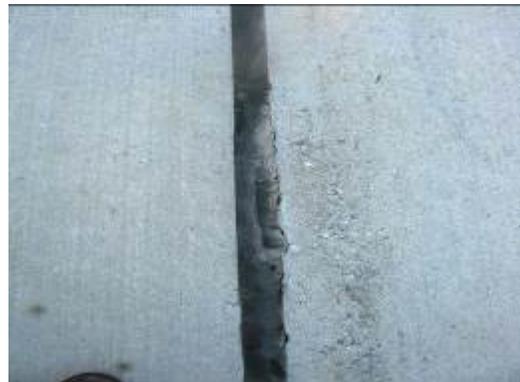
- The sealants between the precast concrete elements making up the supported floor slabs of the garage, appear to typically have either failed or are reaching the end of their useful service life. Failed precast sealants were observed throughout the parking garage.

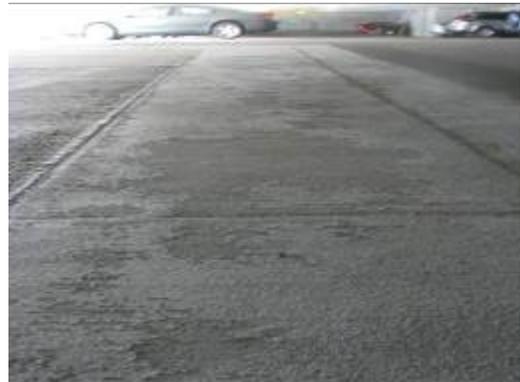
- The cast-in-place concrete pour strips at the crossover bays are protected with a traffic bearing waterproofing membrane. This membrane was observed to be wearing thin in some locations on the second floor of the garage.

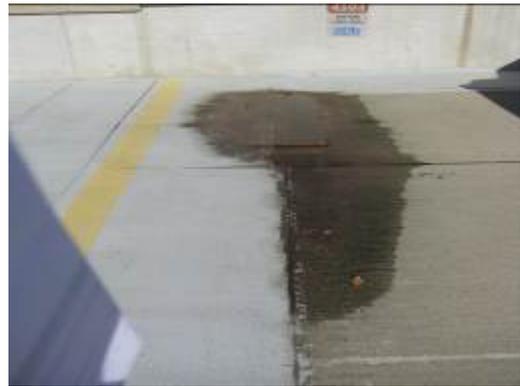
- An area of ponding water was observed at the northern end of the roof level deck.

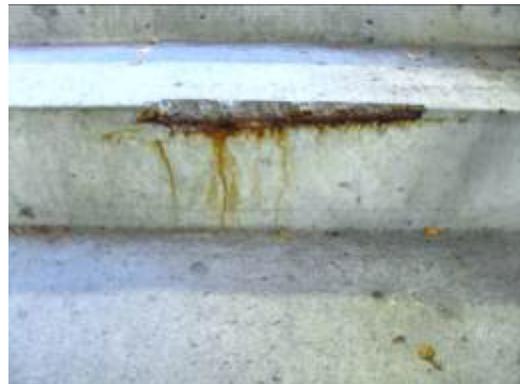
- While all of the stair towers appear to be in good condition, some of the sealant at the vertical joints within the stair towers was observed to be failed. Additionally, some spalling was observed at one of the stair treads at the second level of the main elevator/stair tower.

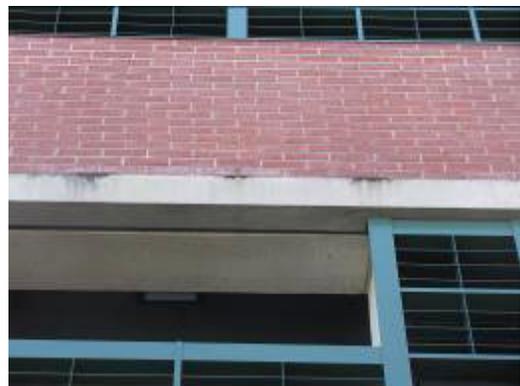
- Some of the mortar between the brick masonry and concrete lintels and at the north and south façades of the garage was observed to be failed and is washing out. The mortar between some of the masonry and concrete elements at the exterior of the stair tower head houses at the roof level exhibited similar failure.

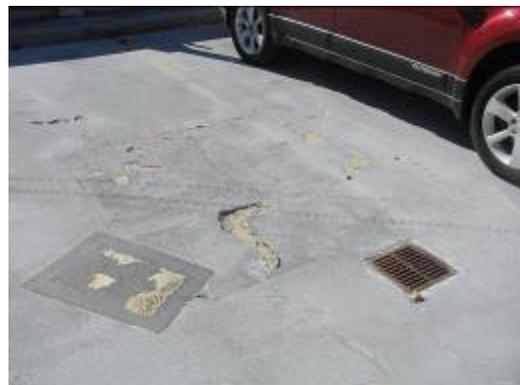
- Deterioration at the cast-in-place concrete slab was observed at all the supported levels of the parking garage. This was typically worse at the lower supported levels of the parking garage.

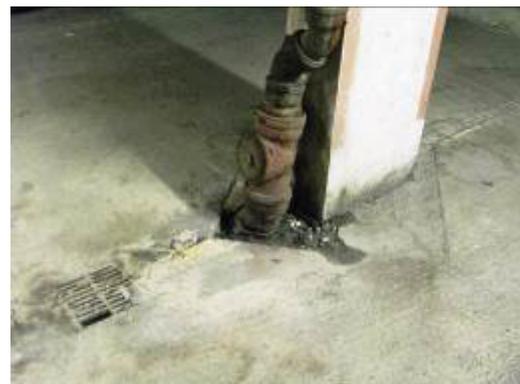
- A few areas of spalling were also observed at the slab-on-grade.

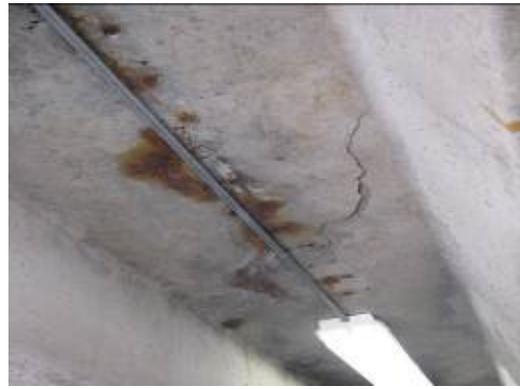
- Several areas of spalling and cracking were observed at the underside of the concrete pans. Some spalls were also apparent at the underside of the concrete joists.

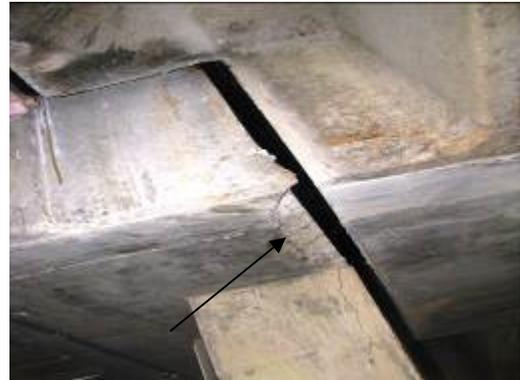
- Cracks and sections of spalled concrete were observed on some of the beams adjacent to the pan/joist sections of the slab.

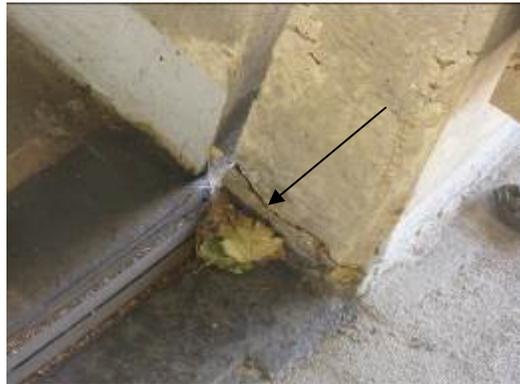
- Some of the cast-in-place concrete columns and walls in the garage were also observed to be suffering from corrosion related deterioration.

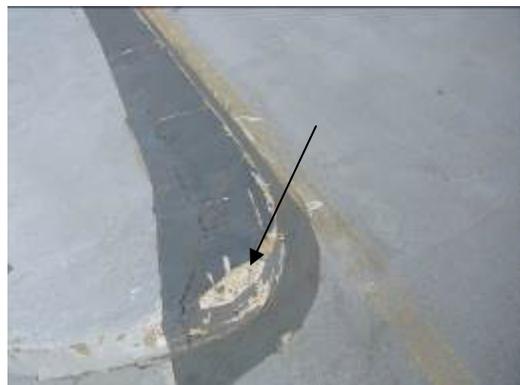
- Corrosion related deterioration and spalling was observed at some of the concrete curbs on all levels of the parking garage.

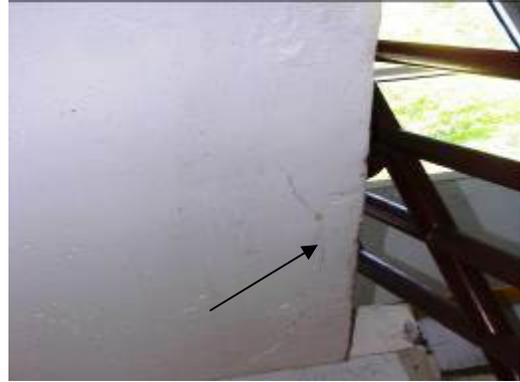
- Both stairwells exhibited some concrete deterioration at the underside of the stair runs and landings.

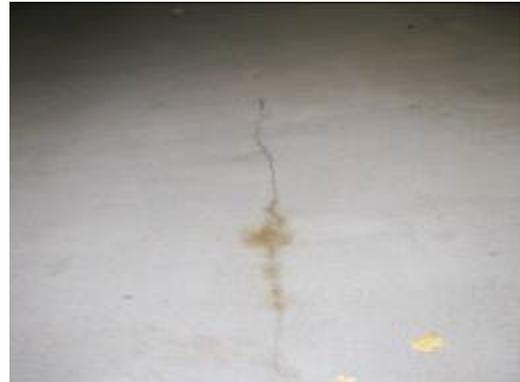
- Cracks at the cast-in-place concrete slab were observed on all levels of the parking garage. In addition, the sealant at previous crack repairs is failed in some areas throughout the garage, and as a result water is leaking through them.

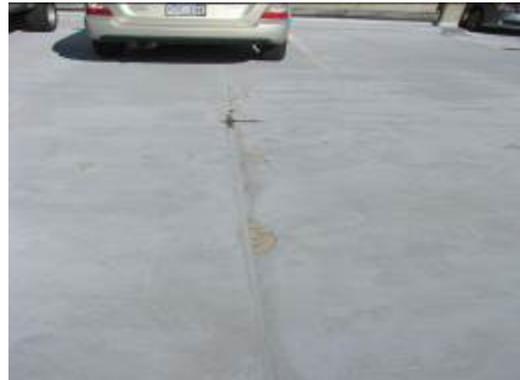
- All of the sealant at the supported level construction joints was observed to be failed.

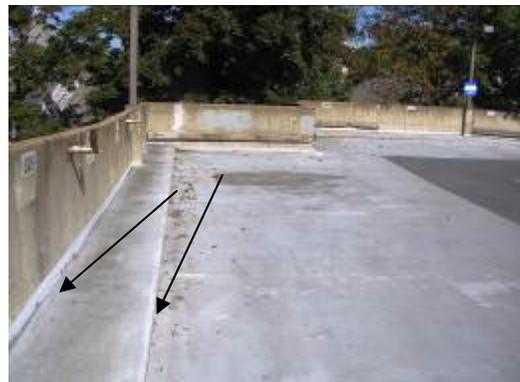
- The cove joints at the perimeter of each parking level, as well as between the curbs and floors, curbs and walls, floors and columns, are typically failed.

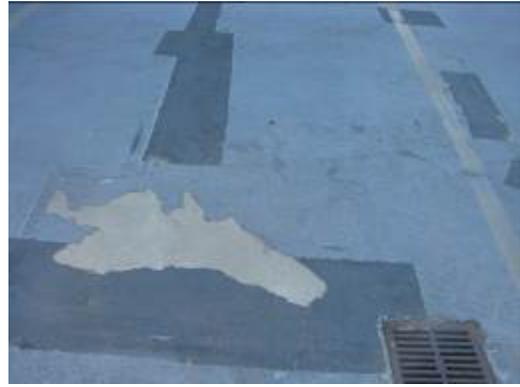
- A waterproofing membrane covers all of the supported levels of the garage. Worn out, as well as deteriorated areas of membrane exist at all supported levels.

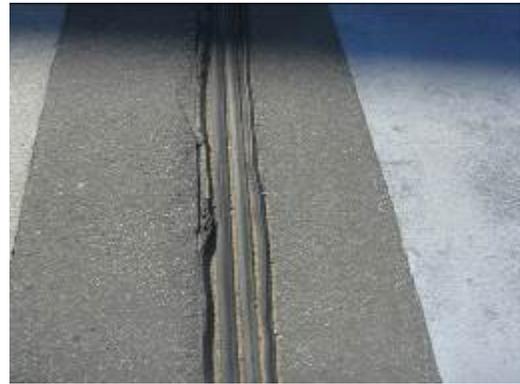
- The expansion joints on the entry and roof levels are failing and are allowing water to travel between levels. In addition there is typically a strip of deteriorated concrete on either side of these joints.

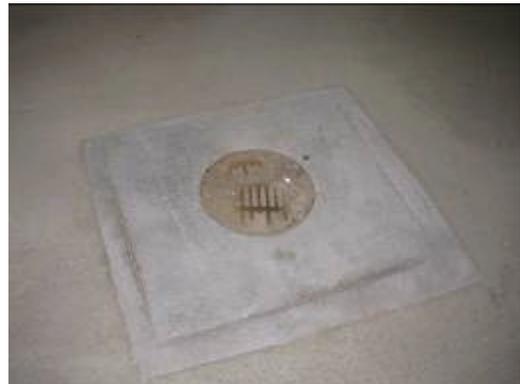
- Some of the floor drains on all levels of the parking garage were observed to be deteriorated. A few of these drains are located within deteriorated areas of the concrete slab. Some sections of drain pipe were also observed to be suffering from corrosion related deterioration.

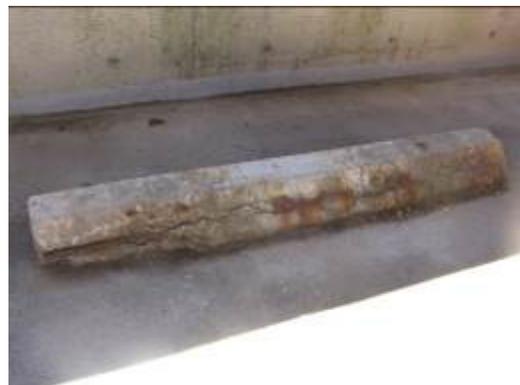
- Most of the wheel stops in the parking garage are severely deteriorated and create a potential trip hazard.
