## Playground Assessment Report

**Inspection Date:** 5/6/2015

**Location:** Concord, NH

**Playground Name:** Monkey Around Playground

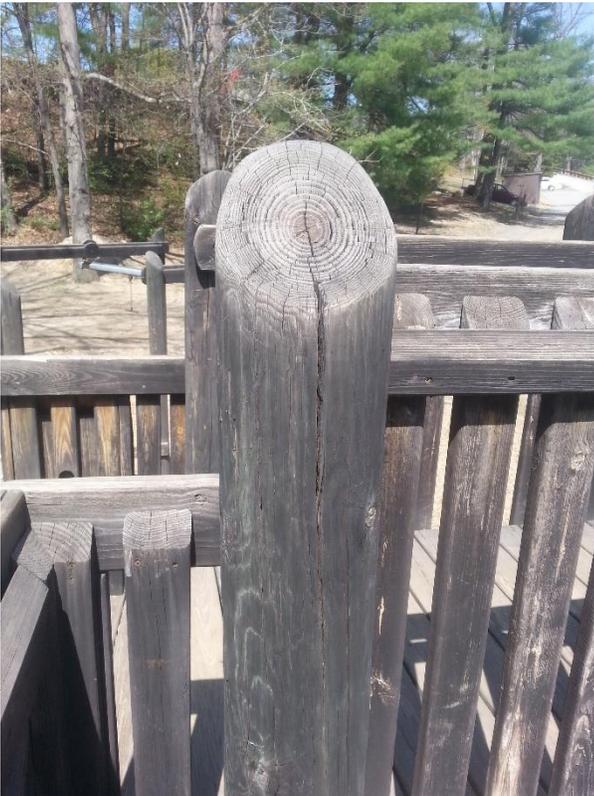
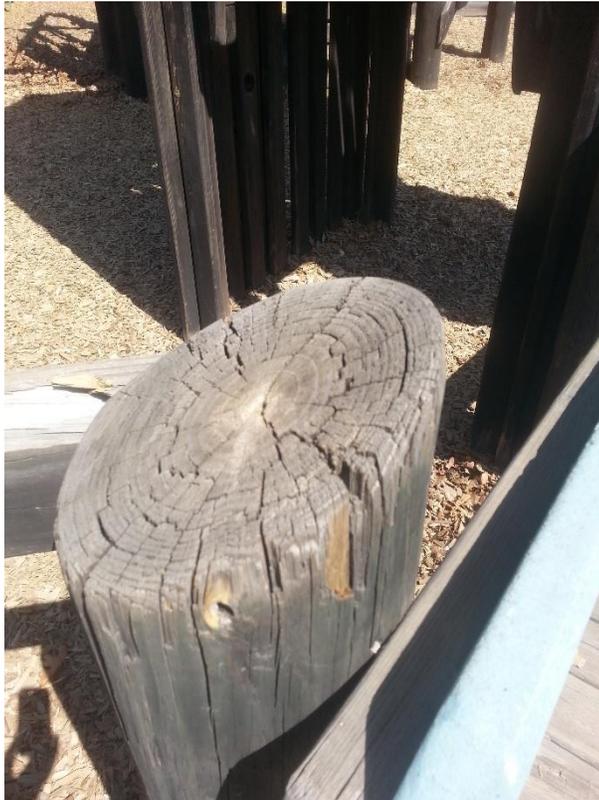
**Main support posts**

The post are in good shape

The post should be sanded smooth.

Stain/seal with solid body stain.

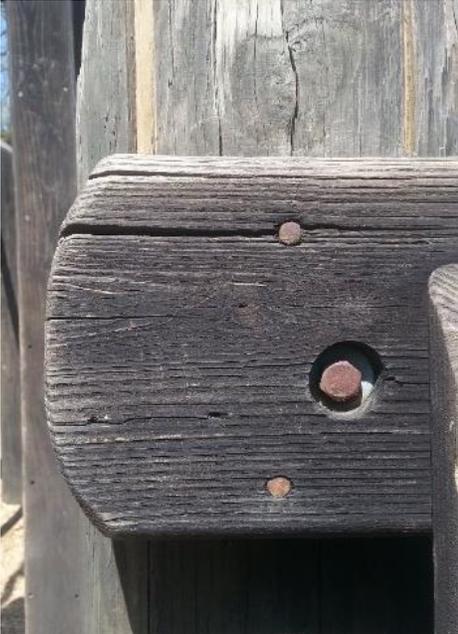
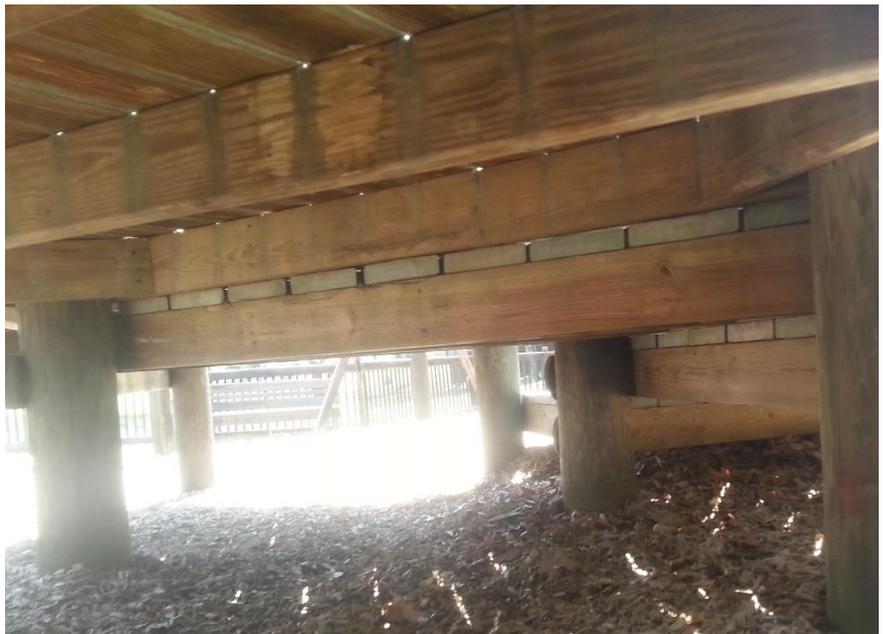
**Framing**

The framing is in good condition.

Stain/seal exposed surfaces with solid body stain.

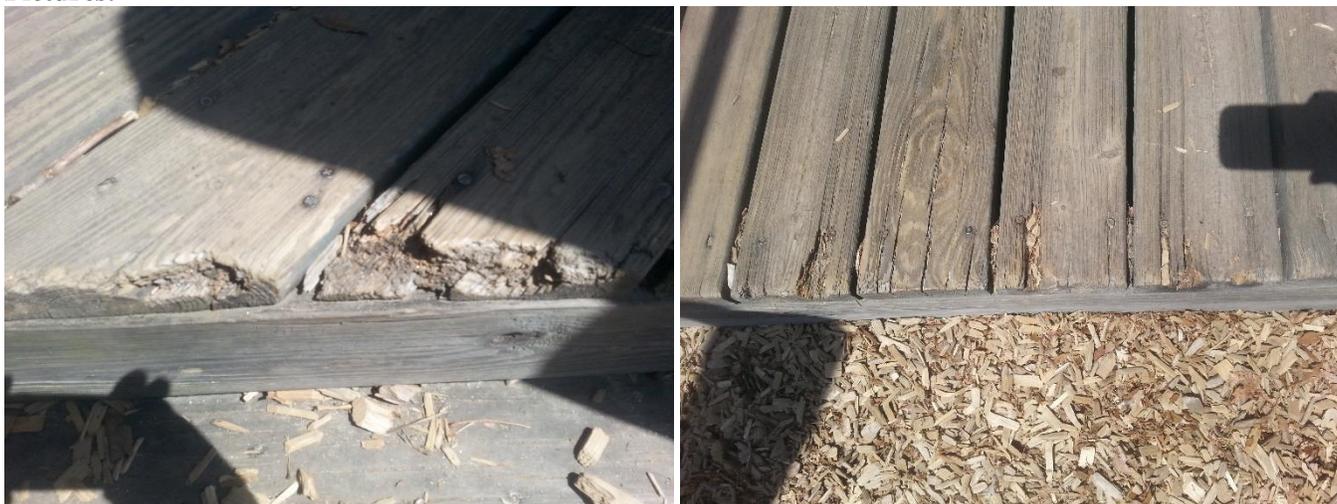
**Decking**

The decking is in poor condition and has severe splintering  
Some of the original decking was Timbrex.

Replace with recycled plastic  
Add joists where necessary

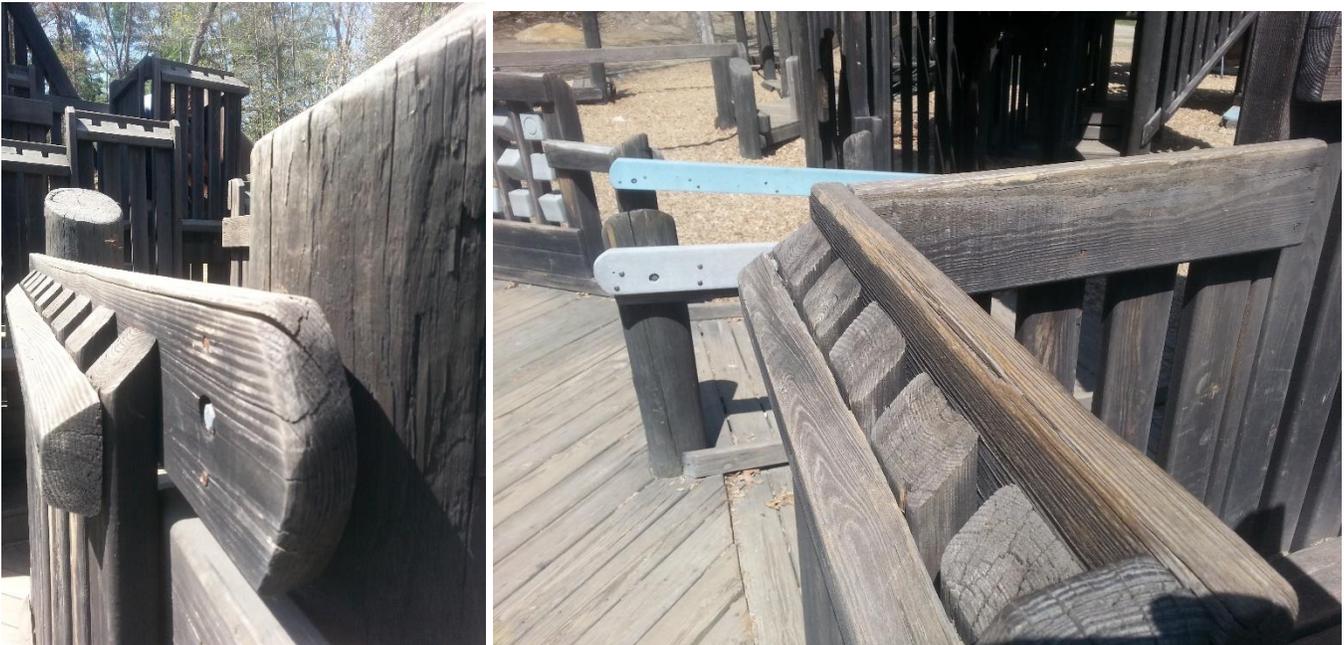
**Handrails**

The handrails are in medium condition. Some splintering but not structural.  
The handrails are treated with CCA and are a high contact area

Replace with recycled plastic

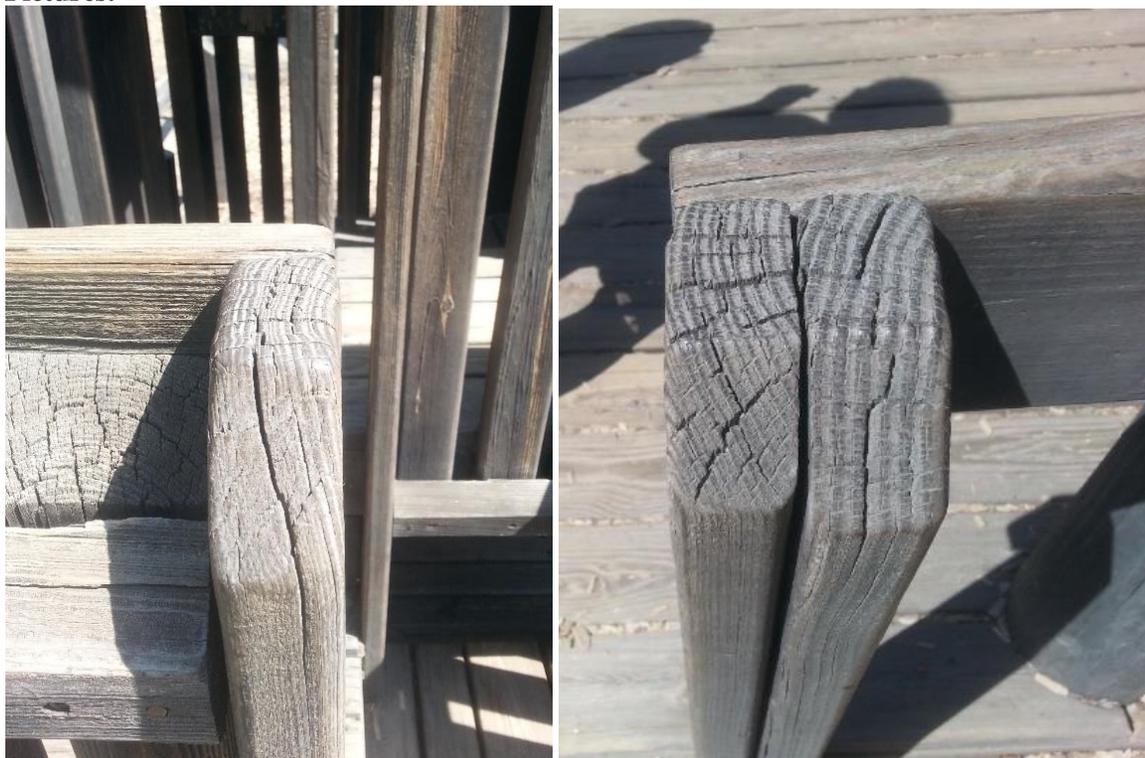
**Handrail Posts**

The handrail posts are in medium condition. Some minor splintering & wear.

Replace with recycled structural plastic.

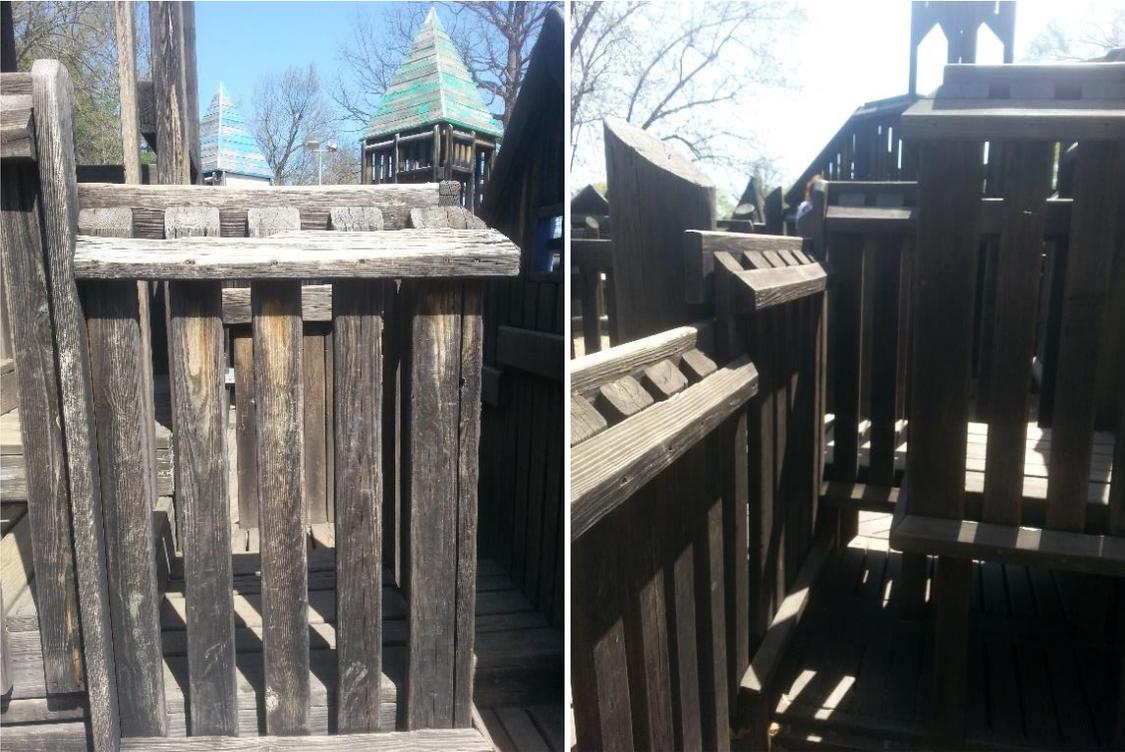
**Balusters**

The balusters are in medium condition (minor splintering & Wear).

Repalce with recyceld plastic balusters.

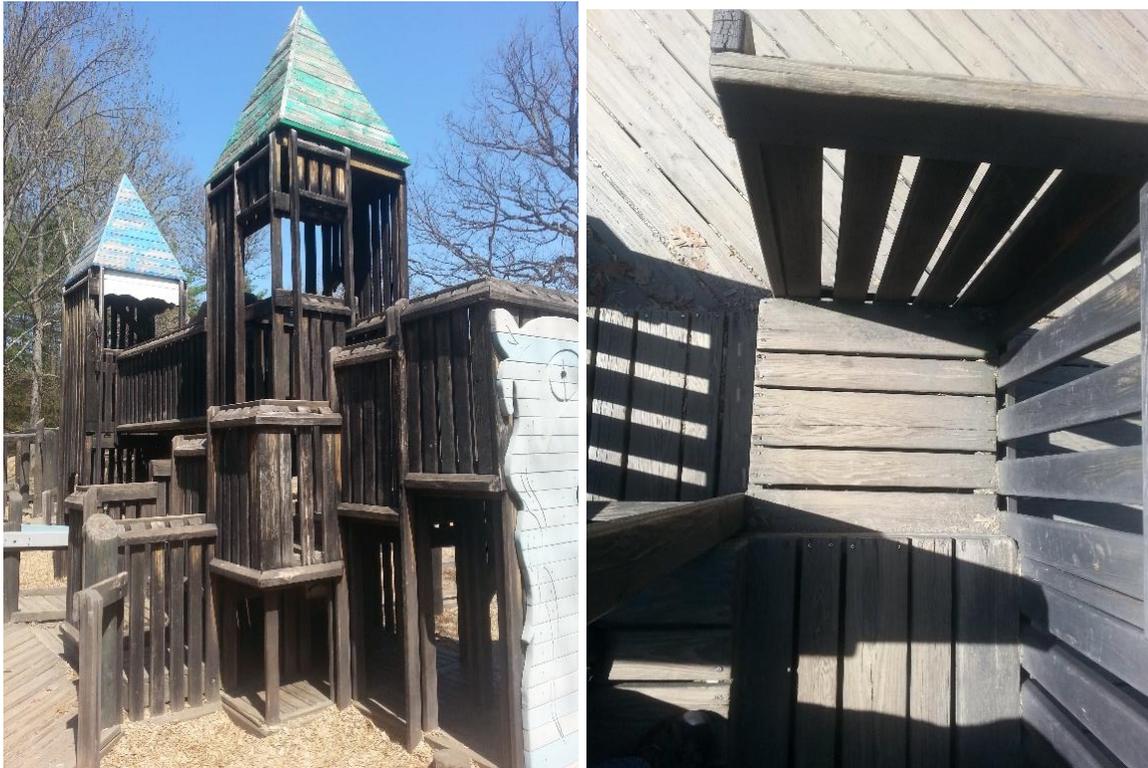
**Mazes cubes**

The maze cubes are in medium condition (minor splintering & Wear).

Replace the decking with recycled plastic

Add joists where necessary

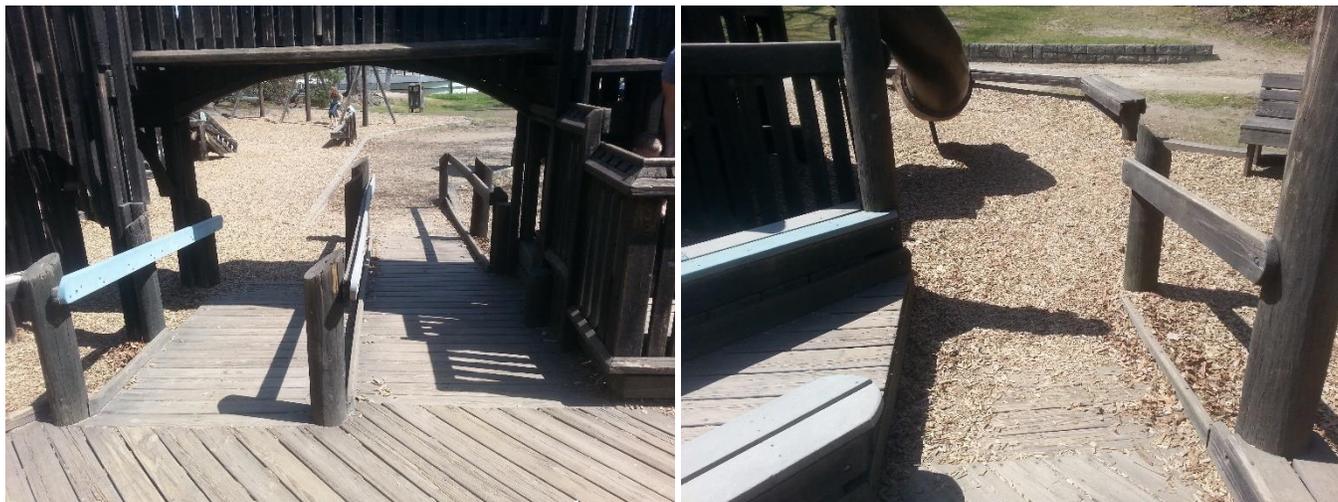
**Accessible ramps**

The entrance ramp is over 12' without a landing

The ramps have no lower handrail

Rebuild entrance ramp adding a landing

Add lower handrails

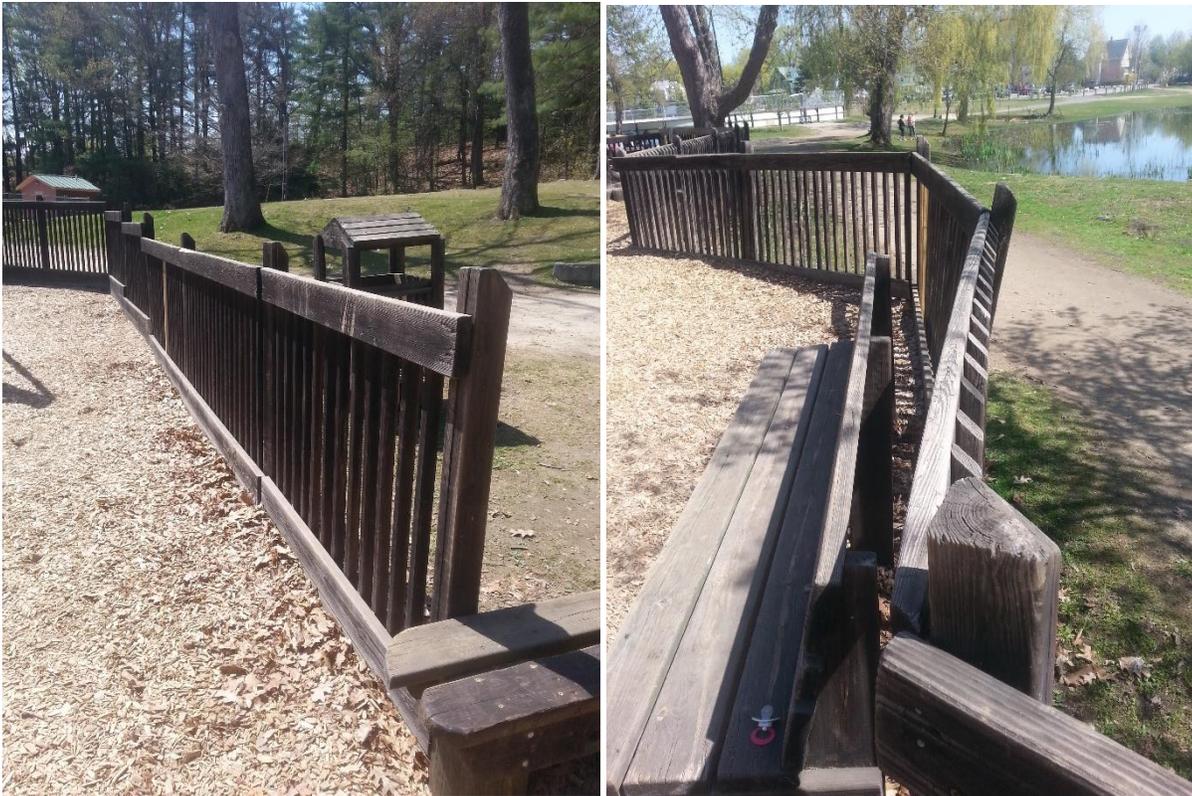
**Fence**

The fence is in bad condition (major splintering, missing pickets and wear).

The playground is within 200' of the lake

Replace with new all plastic fence.

Fence the entire playground due to proximity to water

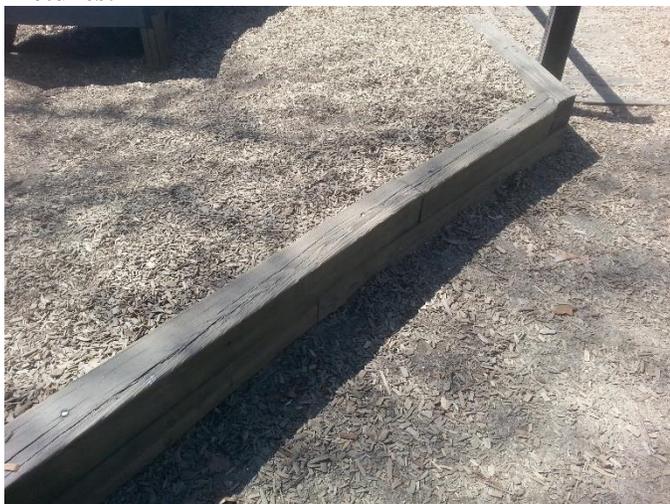
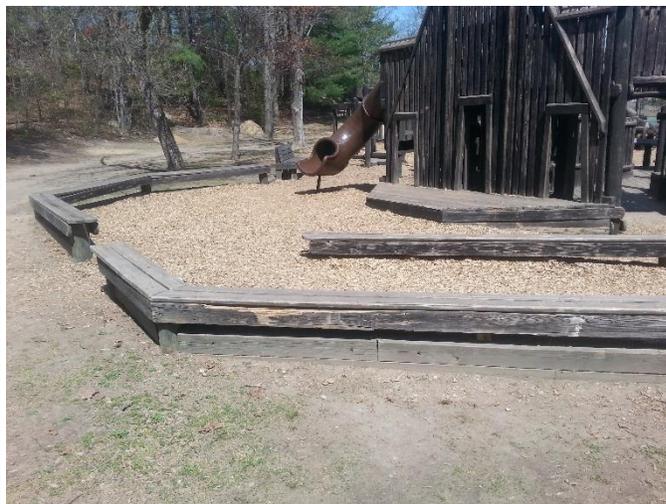
**Low perimeter**

Perimeter is in medium condition.

Replace perimeter with fence

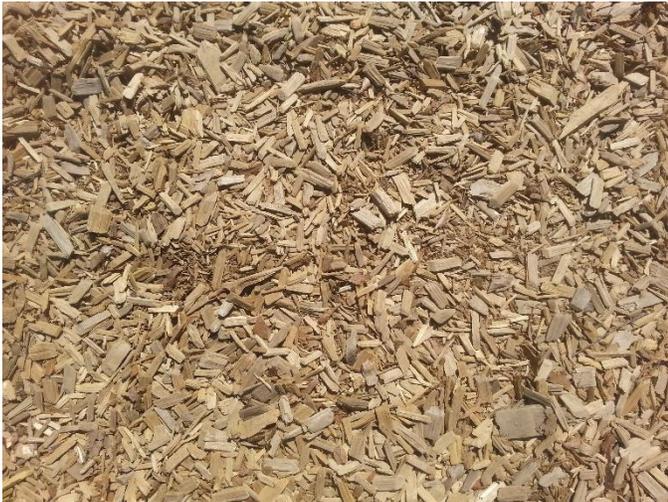
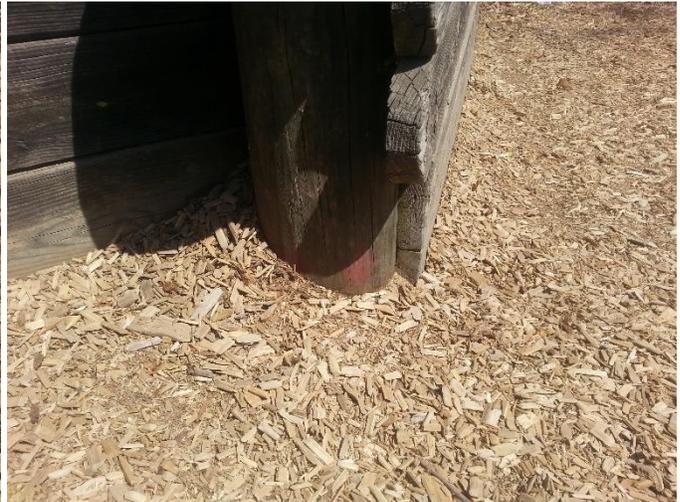
**Safety Surfacing**

Safety surfacing is in medium condition. Some areas are not at a sufficient depth.

Add additional engineered wood fiber to a total depth of 12" throughout.

Make sure the finished safety surfacing meets all safety requirements.

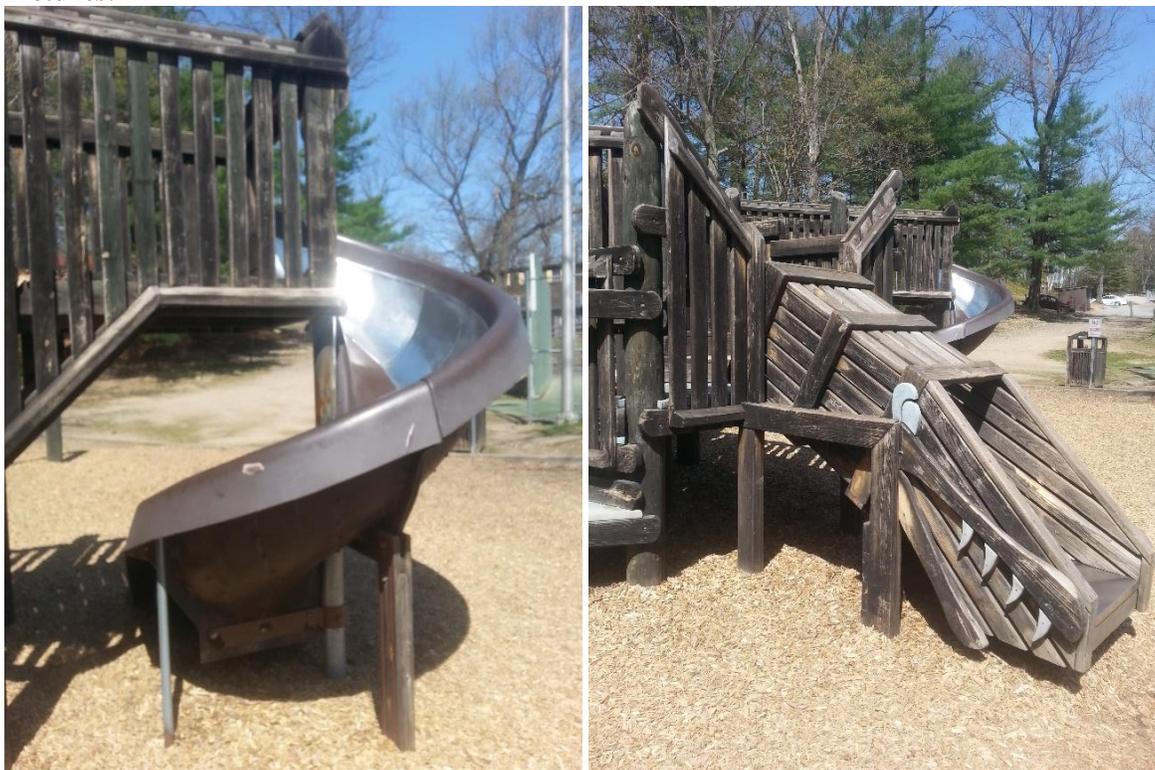
**Equipment type/name:** Slides

The Manufacture slides are worn and showing signs of corrosion.  
The site built slides have metal beds and some are in direct sunlight.  
The site built tunnel slide has wooden sides

Replace the majority of the slides with low maintenance manufactured slides  
Rebuild the site built tunnel slide with recycled plastic sides

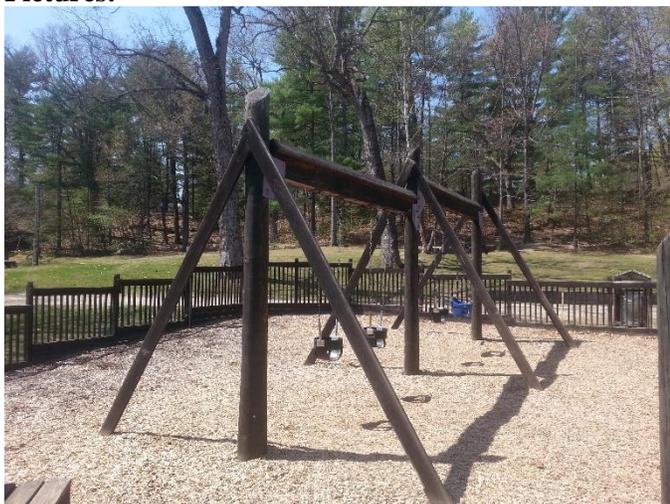
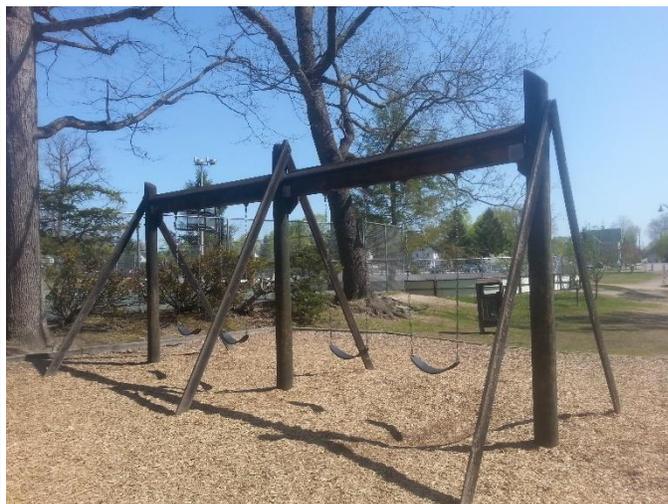
**Equipment type/name:** Swings

The swings are site built and are showing signs of wear. There are no therapeutic swings

Replace the swings with low maintenance manufactures ones.

Add therapeutics swings.

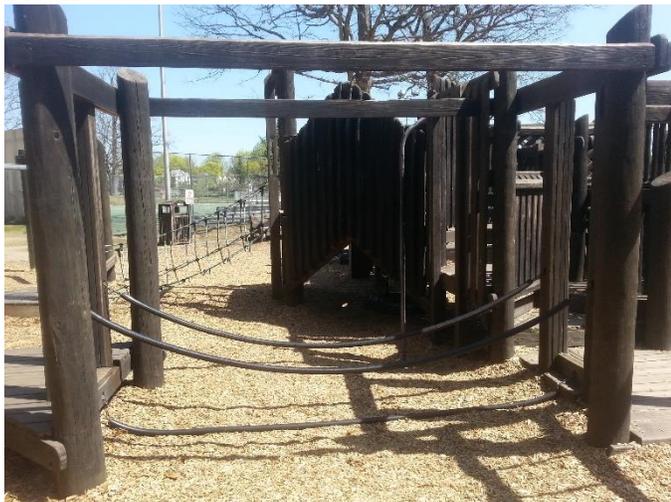
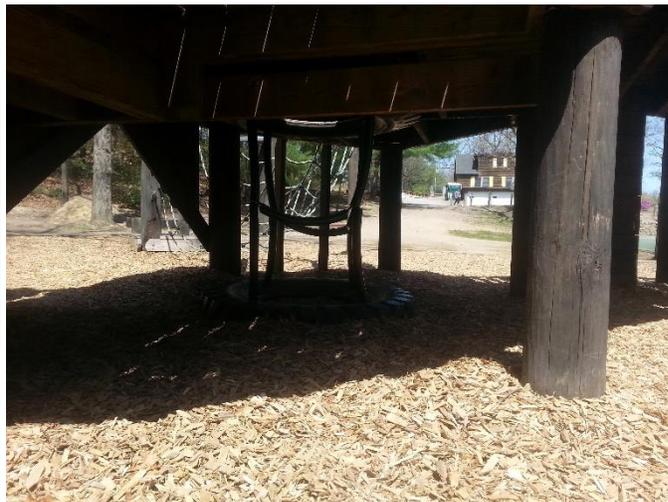
**Equipment type/name:** Hose and chain climbing equipment

Much of the hose and chain equipment has been rebuilt or replaced with low maintenance cables

Replace the remaining equipment with low maintenance cables.

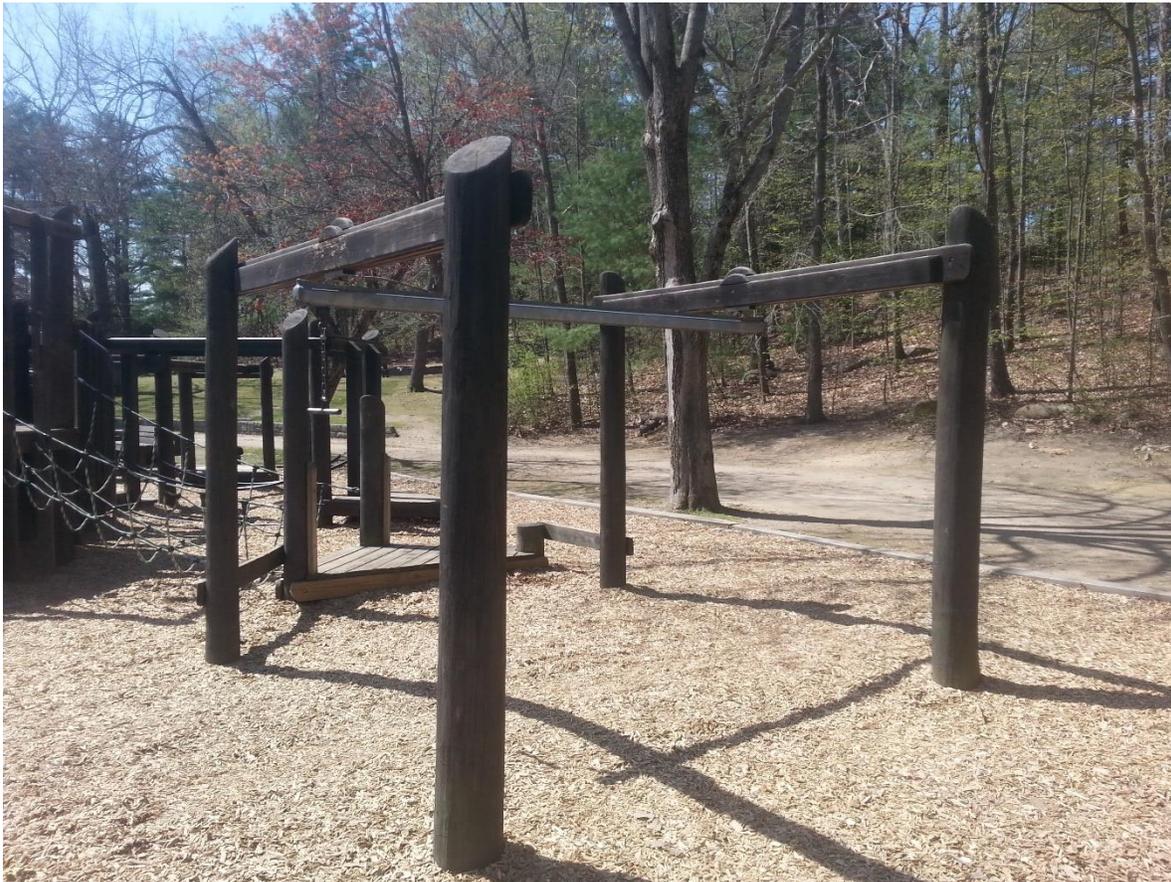
**Equipment type/name:** Trolley ride

The Trolley ride is no longer compliant.

Replace the Trolley ride with new custom designed equipment.

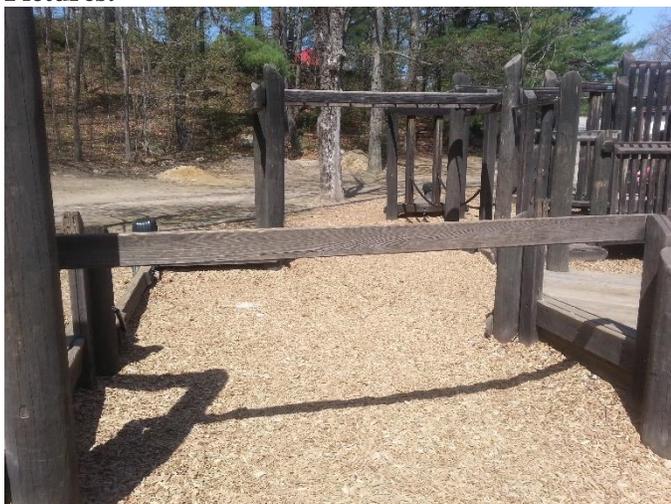
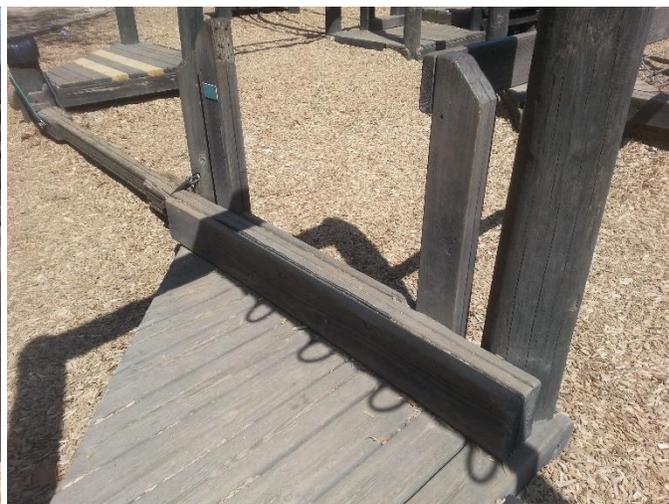
**Equipment type/name:** Rubber Bridge

The conveyor belt has been removed and one of the handrails is missing.

- **Rubber Bridge**
  - **Rebuild the Rubber Bridge with recycled plastic**
- **Suspension Bridge**
  - **Rebuild Suspension Bridge with recycled plastic and adjustment turnbuckles.**

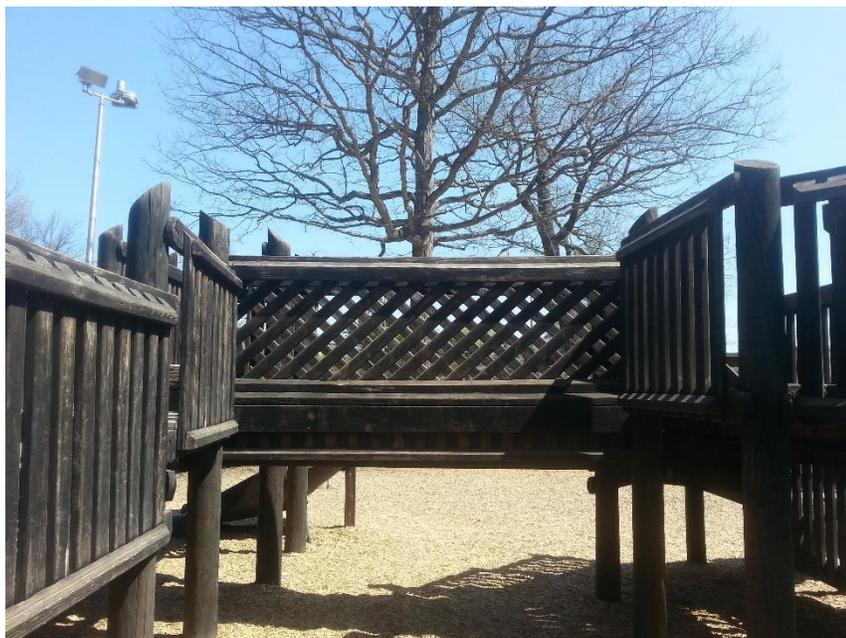
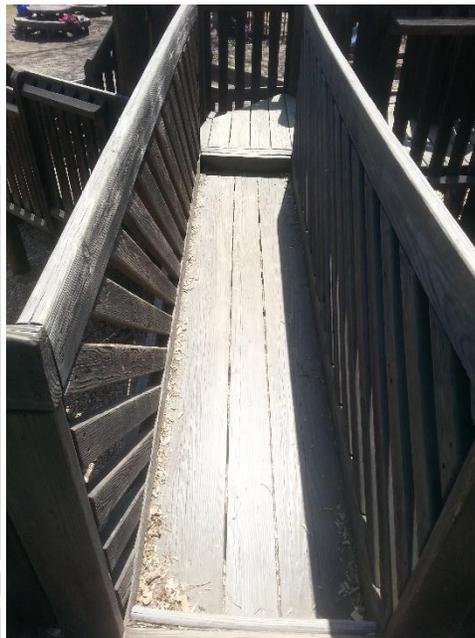
**Equipment type/name:** Suspension Bridge

The decking on chains has been removed.

Rebuild Suspension Bridge with recycled plastic and adjustment turnbuckles.

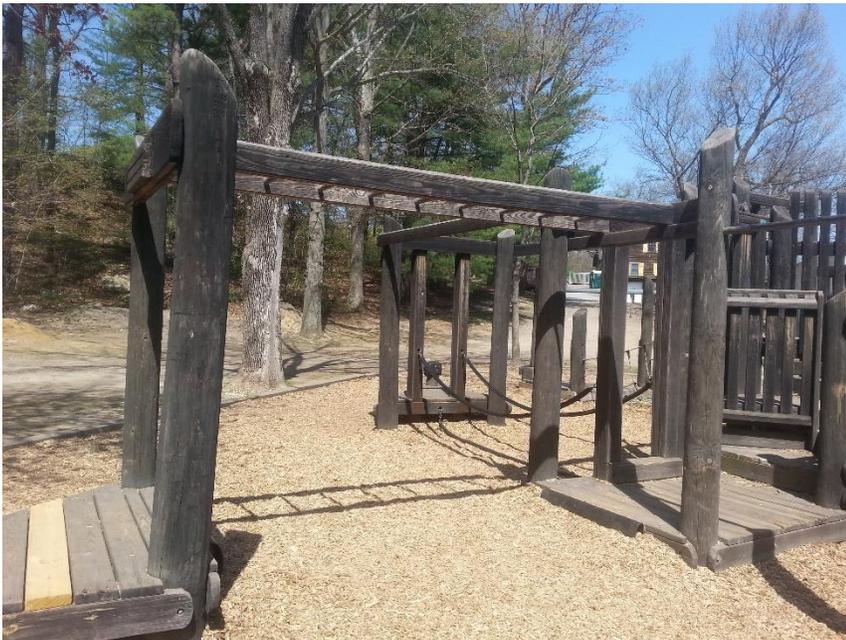
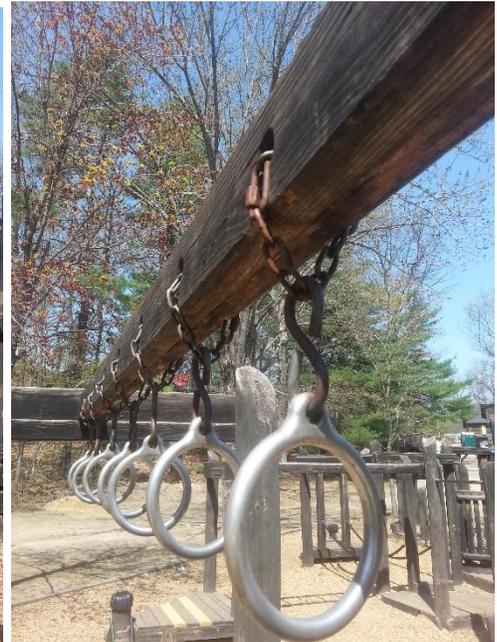
**Equipment type/name:** Overhead equipment

The site built overhead equipment is worn and the hardware is corroded.

Replace the overhead equipment with low maintenance manufactured equipment.

Rebuild low rings and low ladder with recycled plastic.

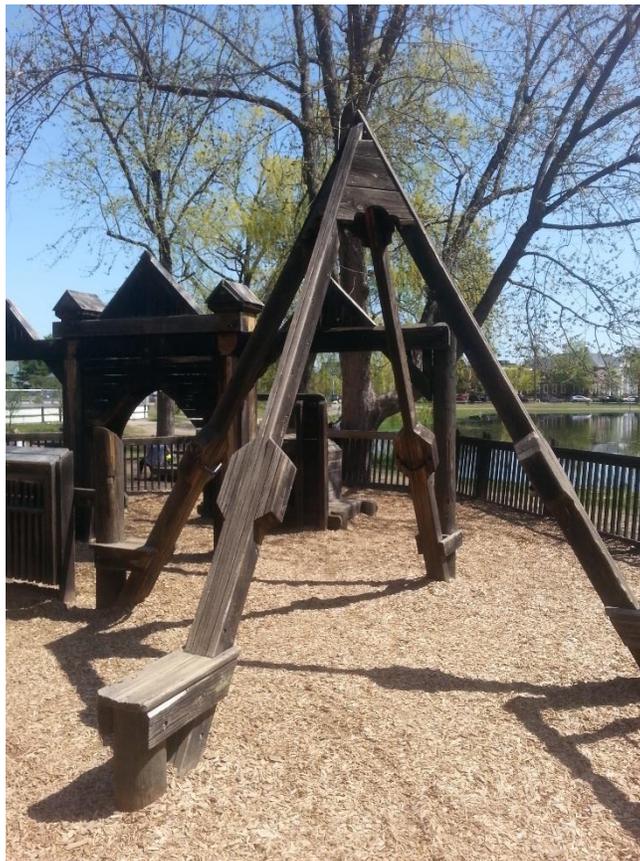
**Equipment type/name:** Pyramid

The tires have been removed

Rebuild the Pyramid with new custom equipment

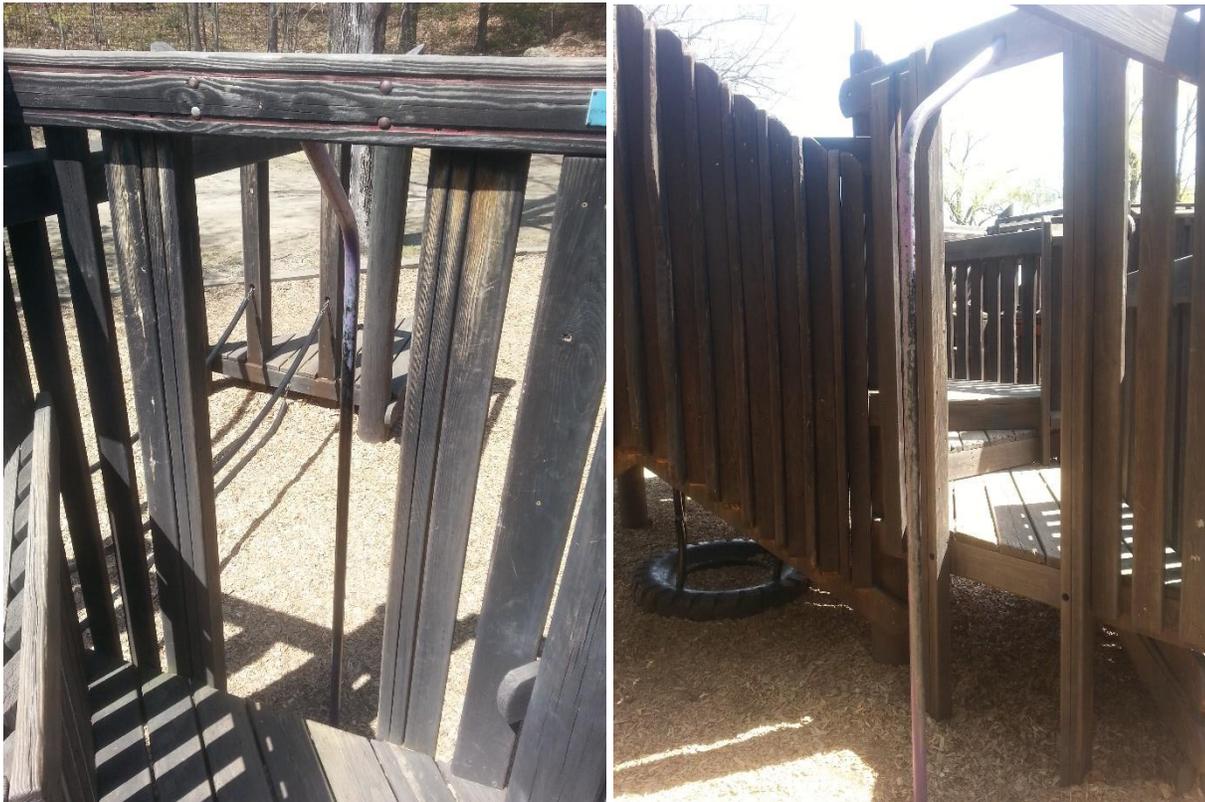
**Equipment type/name:** Fire pole

The Fire pole is no longer compliant

Replace with a new compliant Fire pole

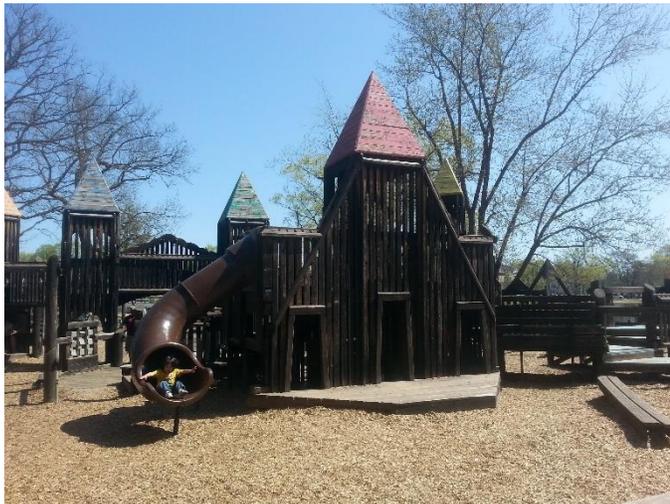
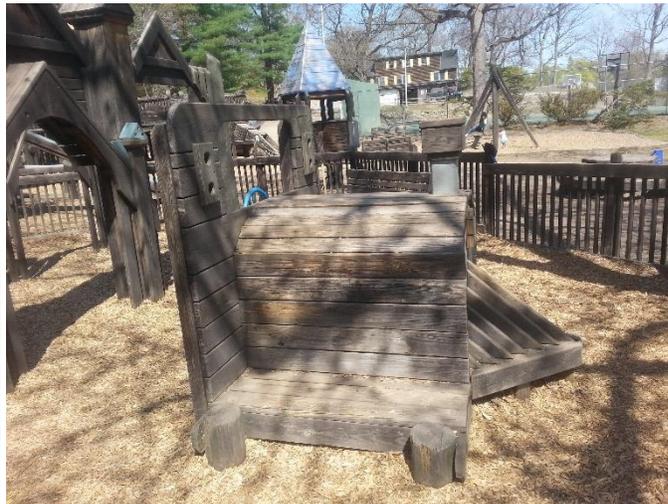
**Equipment type/name:** Details

The majority of the details are made from pressure treated wood

Rebuild the majority of the details using recycled plastic and composite materials.

Use solid body stain to add color and seal any remaining wood.

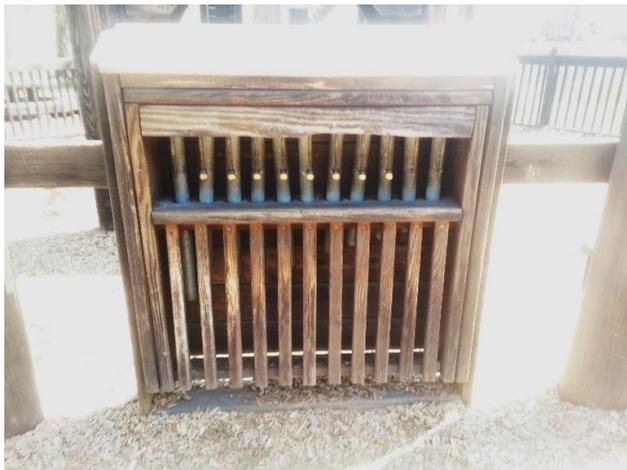
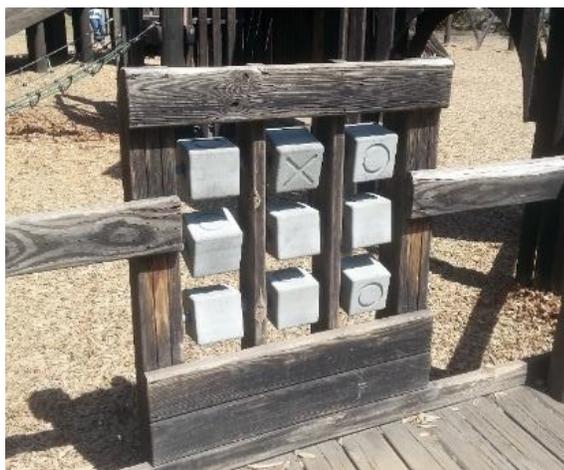
**Equipment type/name:** Activity panels

The Soundwall is missing parts

Repair Soundwall and stain/seal both panels with solid body stain
