Concord Municipal Airport

Terminal Area Study
SBG-04-14-2019

April 2021

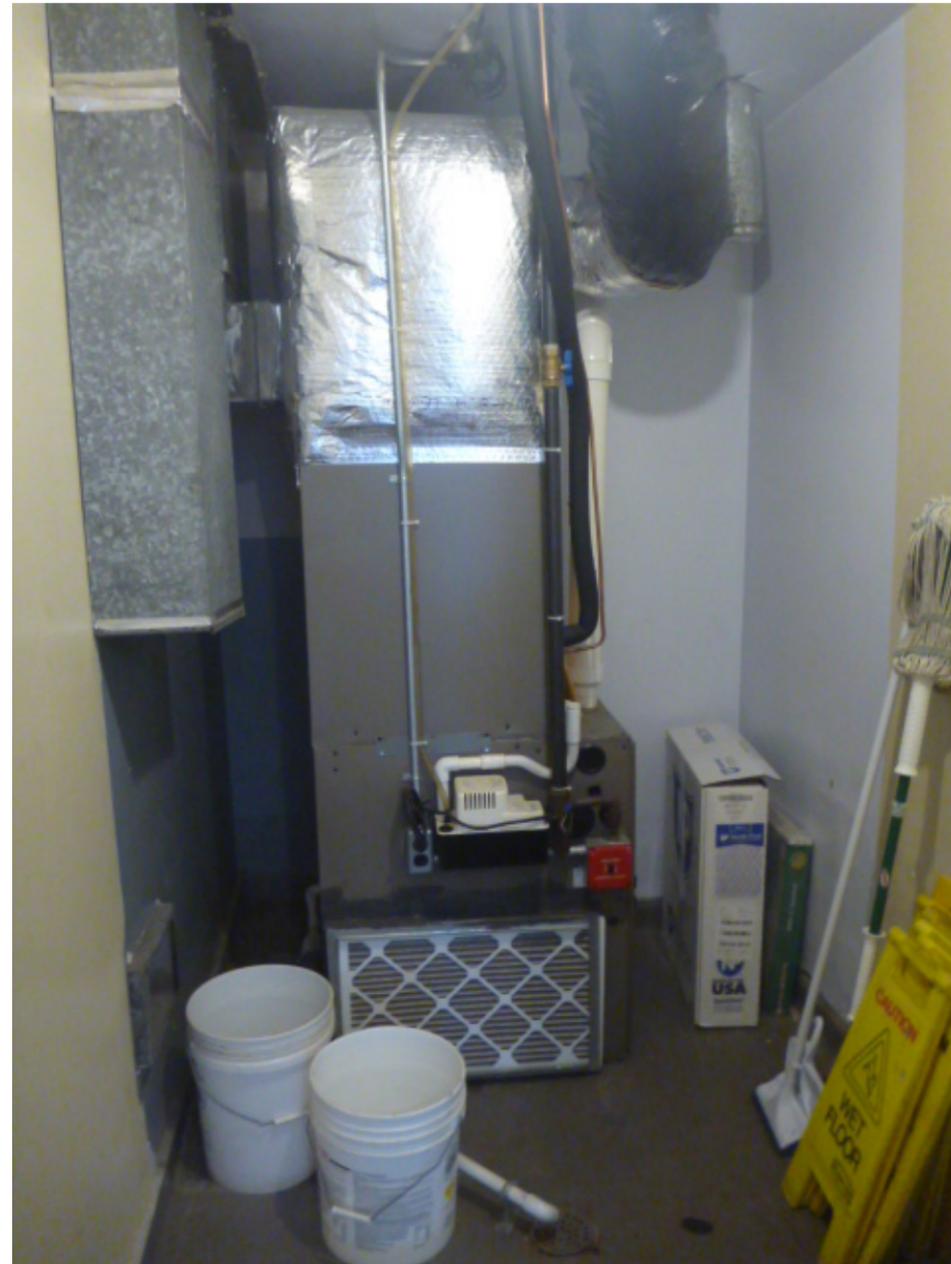
Figure 1-16. Exposed HVAC
HVAC unit located in the very rear of the Hangar directly next to the restrooms. This utility is not enclosed in a closet.

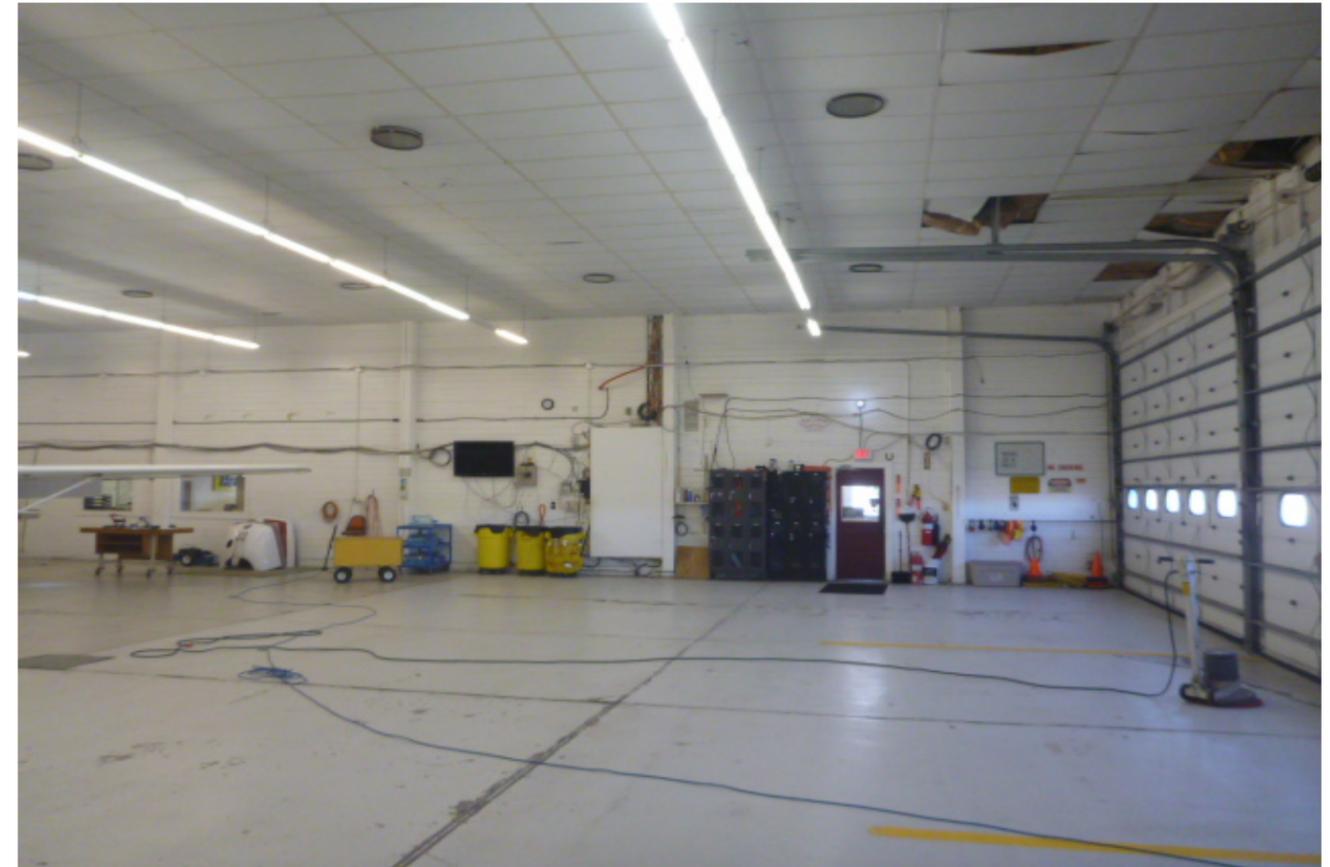
Figure 1-20. Hangar #1 Maintenance Facility

The roof of the Hangar was recently renovated. Signs of water damage is evident from previous issues with the roof.

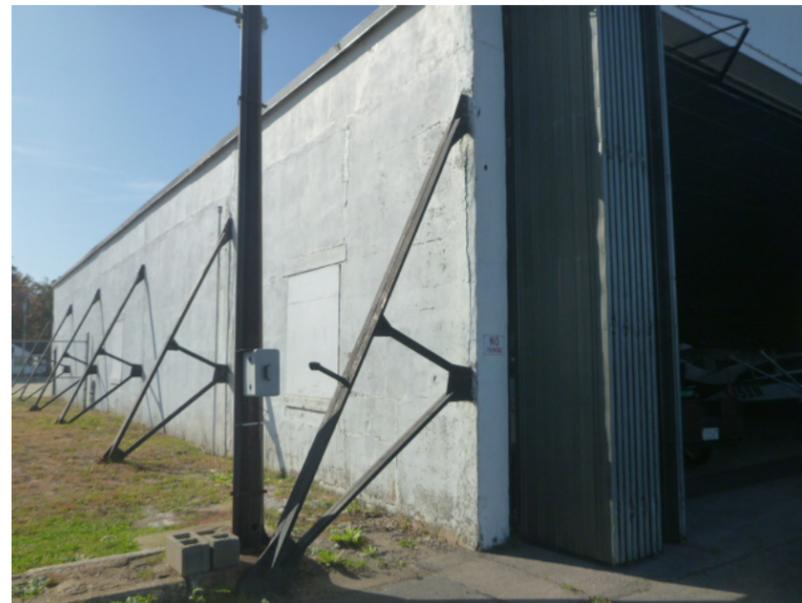
Figure 1-29. Hangar #2 - South Facing Façade
Airside view of front corner (Southeast corner) of Hangar #2.

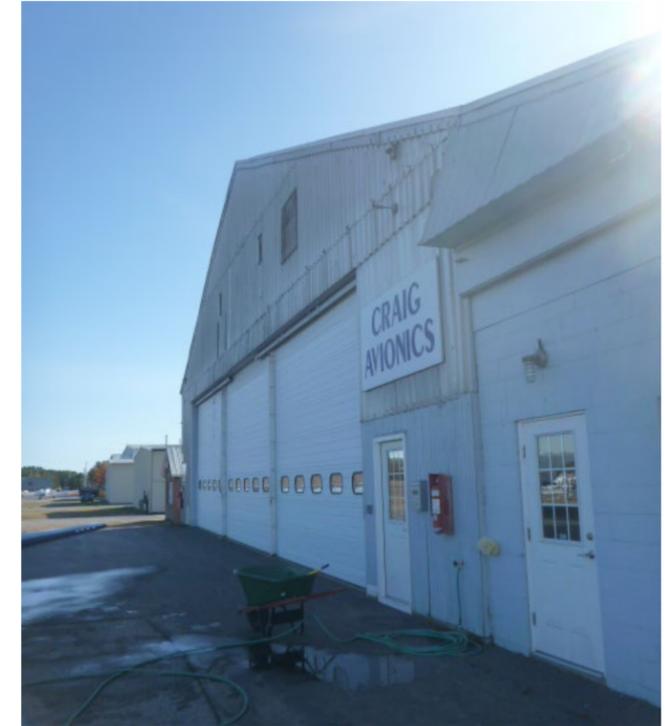
Hangar #3 is constructed of a steel frame, concrete blocks, an aluminum roof, and is partially covered in aluminum siding. The exterior of the hangar is in poor condition and is visibly worn. There is a small landside parking lot located on the north side of the hangar. There have been reports of flooding in this parking lot due to lack of suitable drainage. The water pools around the north entrance to the hangar which creates a dangerous hazard in the winter months.

The aluminum siding that covers a portion of the hangar appears dirty and in some areas the siding is warped. There is no visible cracking or crumbling in the walls. The aluminum roof was recently repaired. The ceiling is comprised of wooden planks covered in sheetrock panels. The ceiling is stained from water damage throughout and deteriorating in many areas which could create a potential hazard. The interior walls are also in need of attention. There are areas along the walls where the white insulation is badly stained and torn. The maintenance facility in Hangar #3 is very dimly lit despite having windows around the exterior. This Hangar is not equipped with nearly as many florescent lights as the maintenance facility located in Hangar #2. The floor in Hangar #3 is made of concrete slabs and is in good condition. The floor is clean and free of stains as it appears to be sealed for protection. The concrete slabs show no signs of heavy wear or deterioration.

Figure 1-33. Hangar #3 – East Facing Façade
Closer view of the front (East side) of Hangar #3

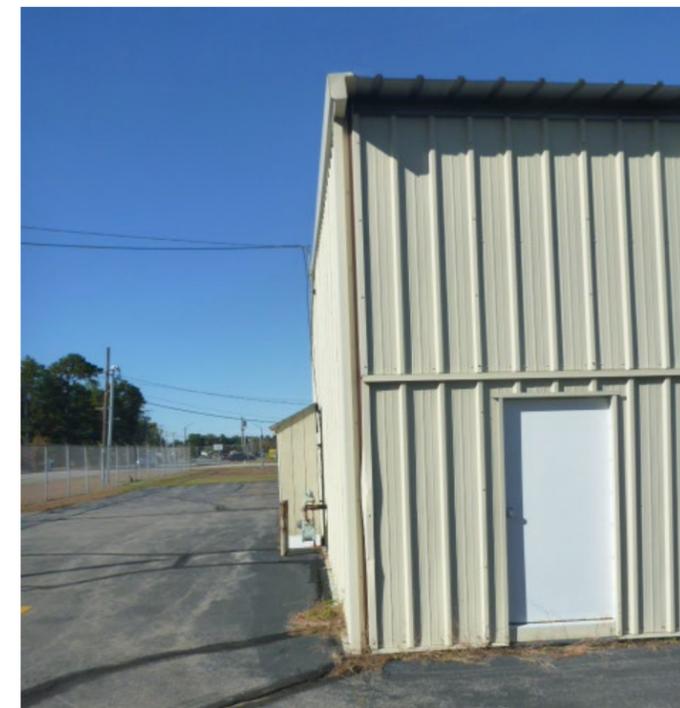
Figure 1-40. North T-Hangar
Cracks in the pavement around the West side of the North T-Hangar sealed with rubber.

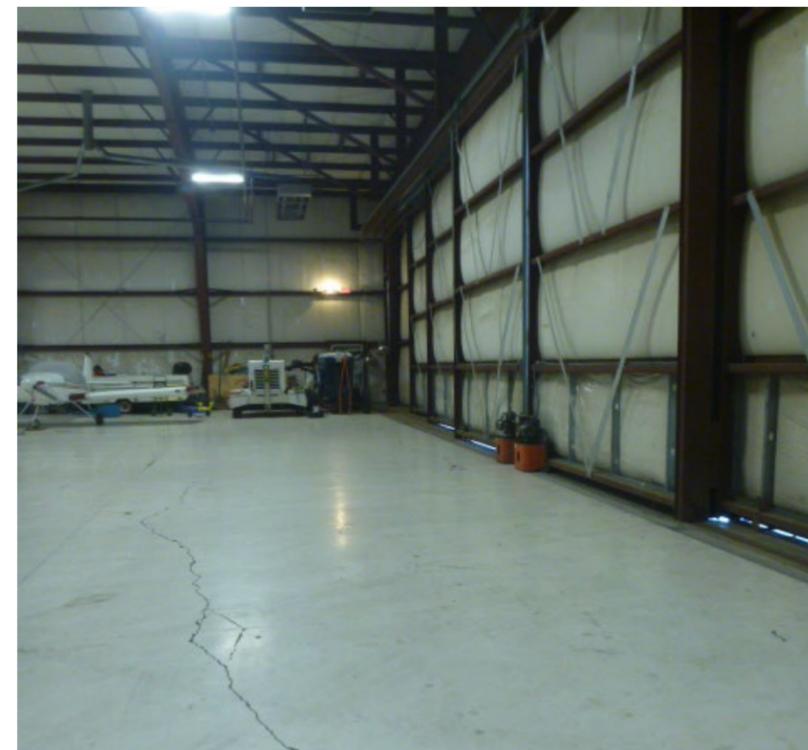
Figure 1-43. Hangar #4 Interior
Large crack in the floor spanning across several concrete slabs.

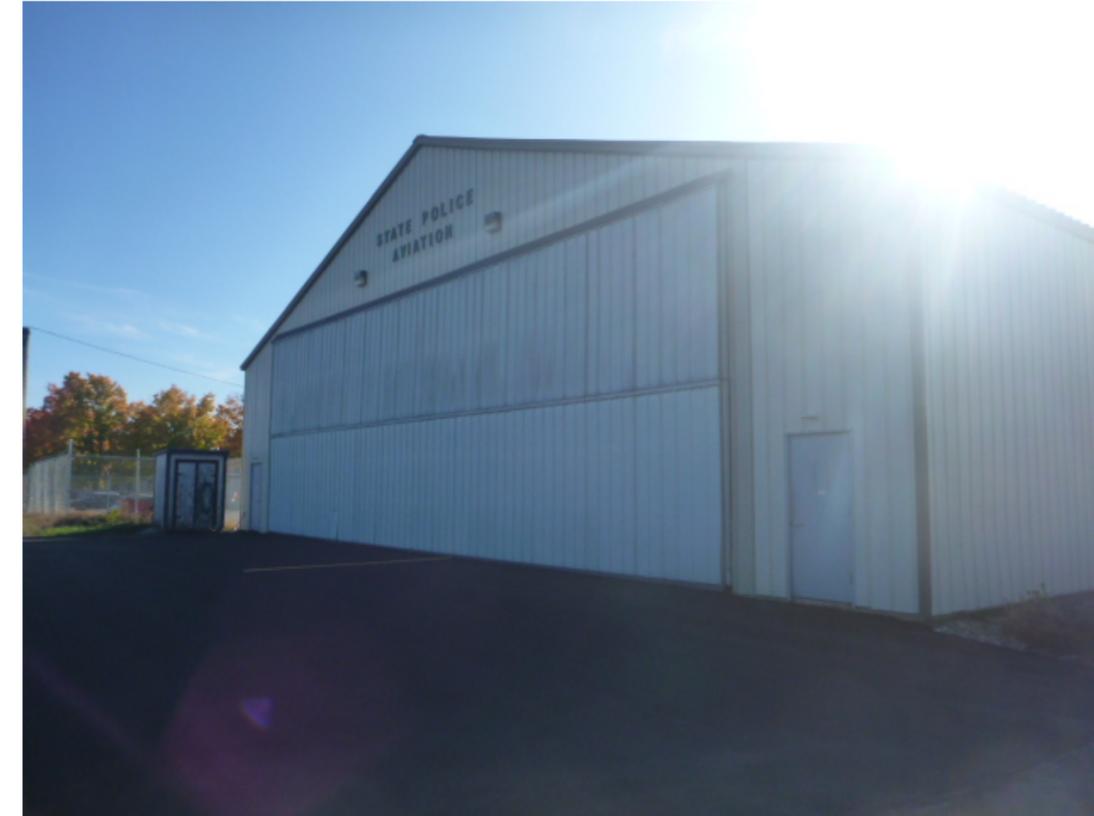
Figure 1-51. NH State Police Hangar – East facing Façade

The hangar is constructed of a steel frame, aluminum siding, and an aluminum roof. The structure appears to be in generally good condition. The bi-folding hangar door is aluminum and in working condition. The aluminum siding around the hangar is in good condition and is not dented or warped. The roof is also in good condition and has not been reported to leak. Utilities for the hangar include heating, plumbing, and electricity. There is a small office space and restroom in the hangar used by the NH State Police Aviation Unit.

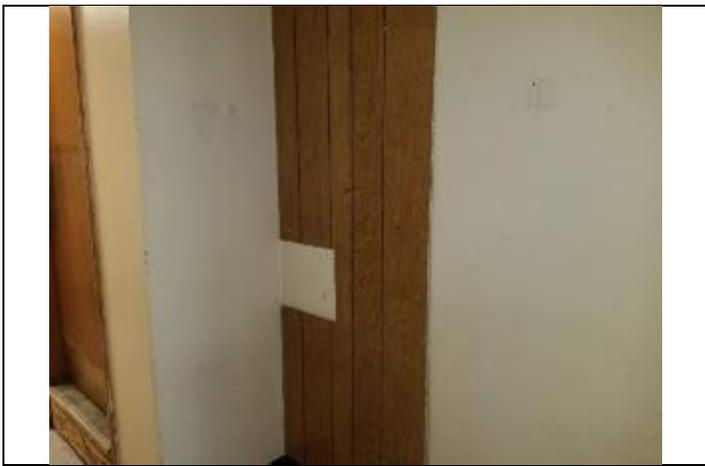
1. Yellow wall paneling adhesive behind wall panel at the south end of the first-floor hallway.

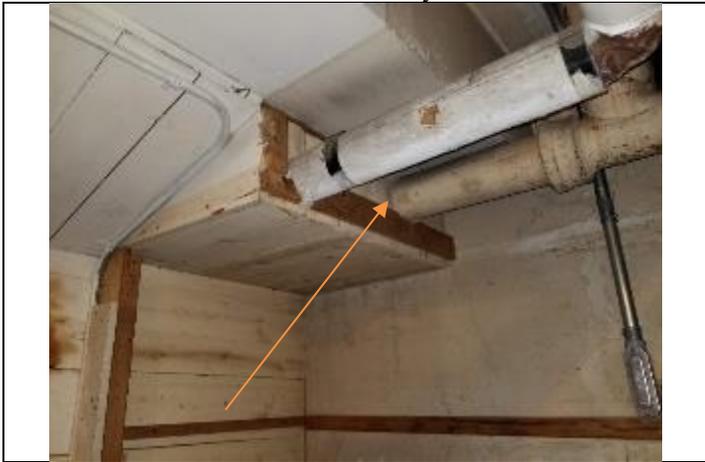
3. Example of pipe insulation run found in the basement.

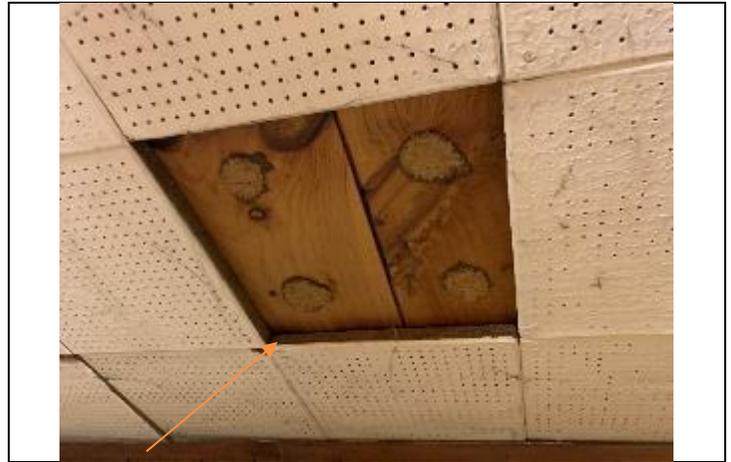
4. ACM glue daub under fixed ceiling tiles.
