## INDIVIDUAL INVENTORY FORM

NHDHR INVENTORY NUMBER: CON0175

1. Historic name: Ezra Ballard Farm
2. District or area: n/a
3. Street and number: 174 Little Pond Rd.
4. City or town: Concord
5. County: Merrimack
6. Current owner: Kathryn S. Hok

32. Name: Elizabeth Durfee Hengen, Preservation Consultant
33. Organization: for Concord Heritage Commission
34. Date of survey: Fall 2008

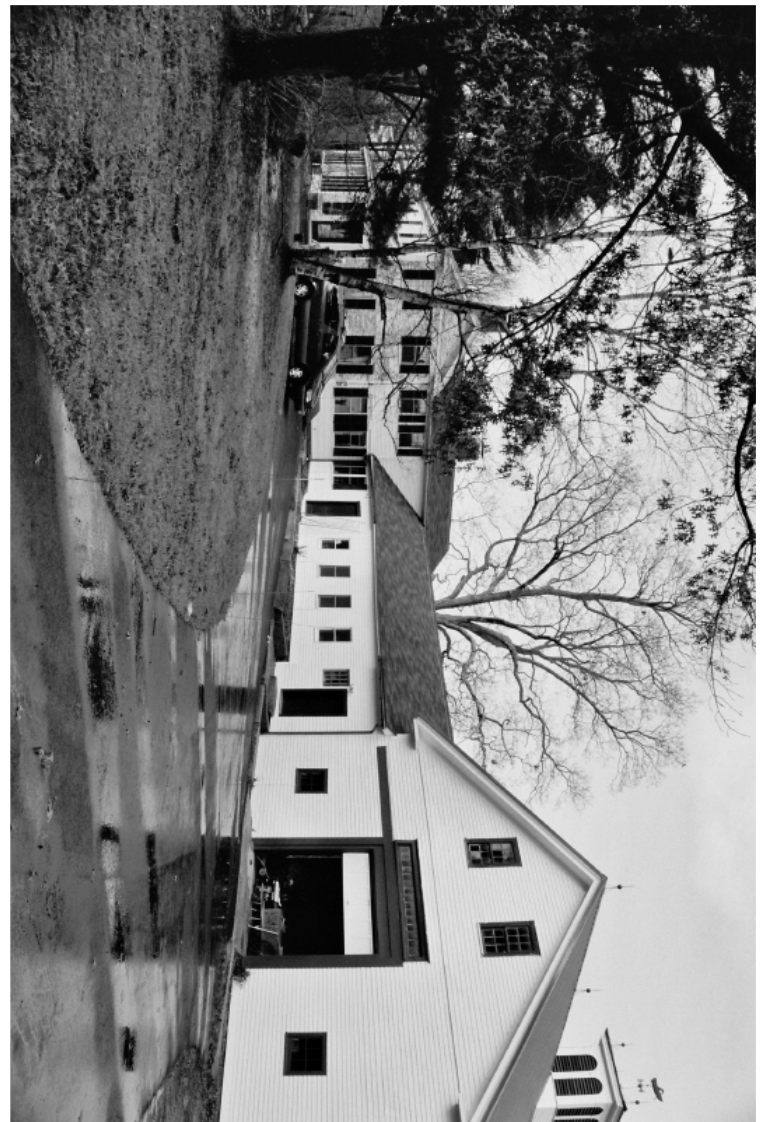
35. Photo #1
36. Date Fall 2008
37. Roll #7      Frame #8      Direction: NW
38. Negative stored at: NHDHR

**Description:** View of farmstead

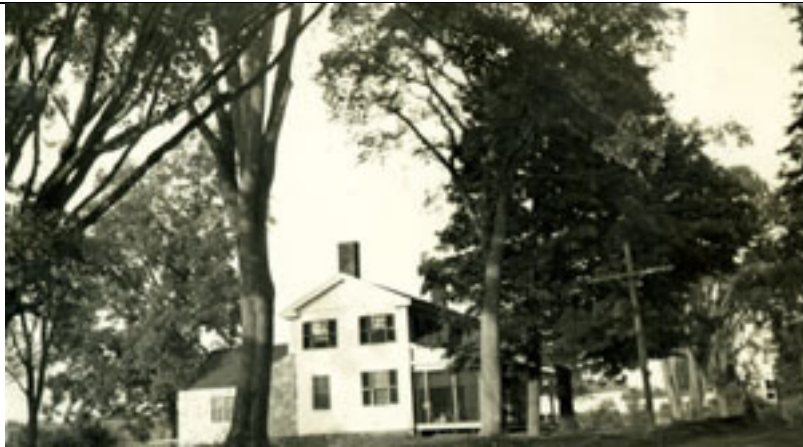
174 Little Pond Road photographed mid-20th century. *From Amsden, A Capital for New Hampshire, Chapter 24, opposite page 30.*

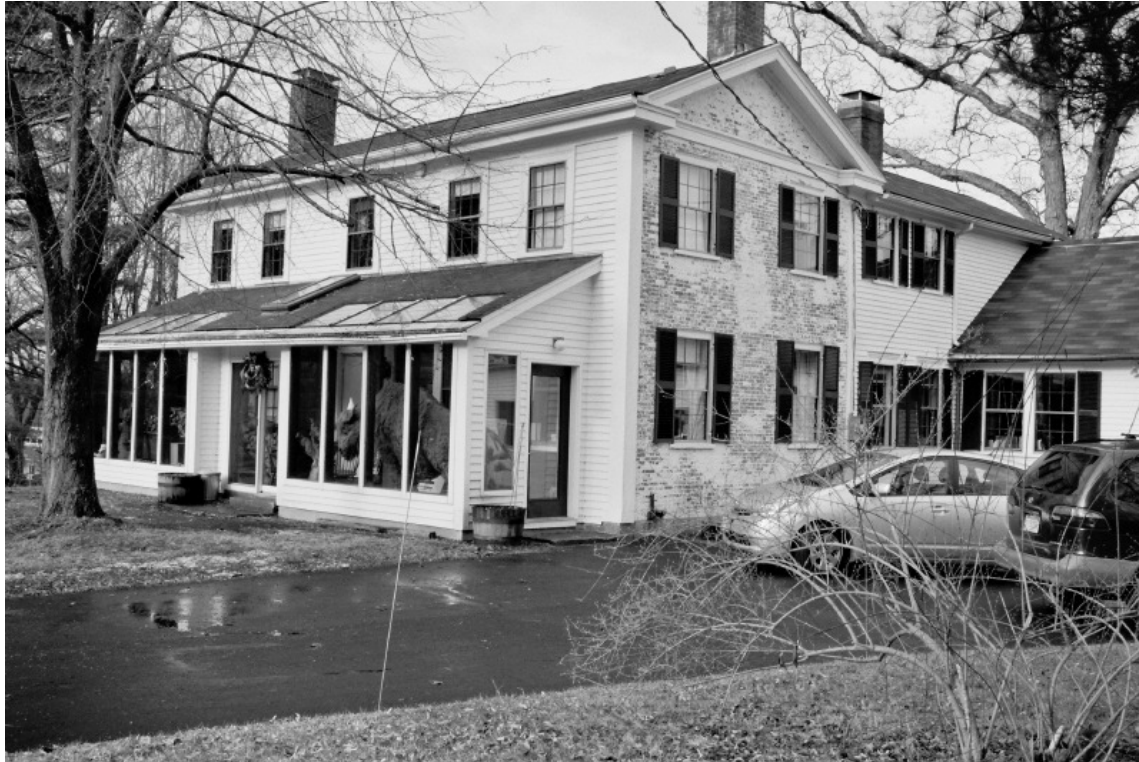
House (ca. 1840s): The house is a 2 ½ story, side-gable building sided with clapboards on the front and rear walls and brick on the two gable ends. It rests on a granite block foundation and has an asphalt-shingle roof. The cornice is boxed and features returns; a wood band hints at pedimented gable ends. Twin brick chimneys rise from the ridge, near the end walls. Much of the original 6/6 sash is extant. The facade is obscured by a late 20<sup>th</sup> c., shed-roof sunporch. The front entry door, sidelights and pilasters reflect ca. 1860s modifications, and the fanlight appears to be a reproduction. Projecting to the rear is a two-story frame ell whose roof appears to have been raised. A chimney projects from the ridge. Other mid-late 20<sup>th</sup> c. alterations to the house and ell include a screen porch and an addition in the NW juncture.

Photo 2 description: Farmhouse & rear ell  
Roll: 7 Frame: 7 Direction: NW

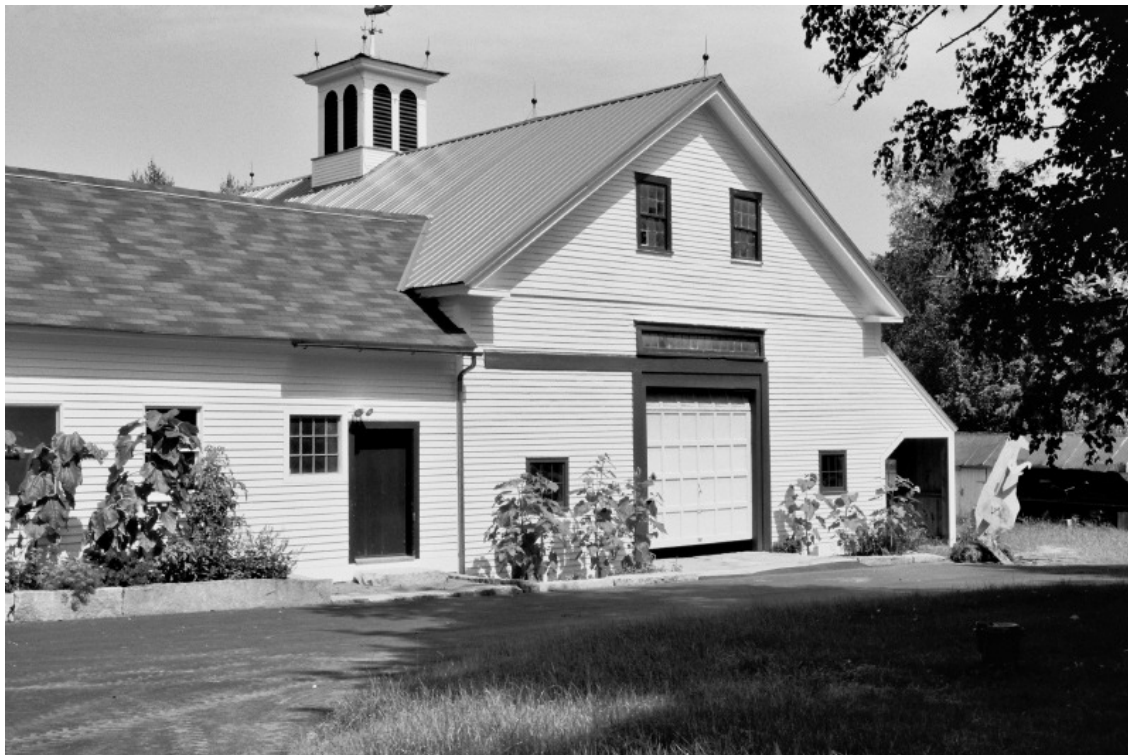
A lengthy wing/shed (ca. 1840s-50s) with historic fenestration and vertical-board doors extends east of the house, connecting to the barn.

Barn (ca. 1850-60s): The connected barn faces gable-end to the road. It has a timber frame. White-washed walls within the east bays indicate cows occupied that area, while horse stalls were on the west. The barn retains its hay fork. Walls are clad with clapboards on the south (front) and east sides, and vertical boards on the rear and west. The roof is covered with channeled metal and features a square ventilator with arched, louvered openings and weathervane. A mix of new and old windows provide light, as does the transom window over each of the exterior, rolling doors. Access to the lower level is via a ramp at the rear. A tractor shed, which extends the length of the east wall, was initially an overhang; sometime after 1964 it was enclosed. The frame of an addition off the northeast corner, now a workshop, may be contemporaneous with the barn, according to the owner. In 1964, it lacked a south

Photo 3 description: Front (south) elevation of barn and east end of attached shed  
Roll: 4 Frame: 8 Direction: NE

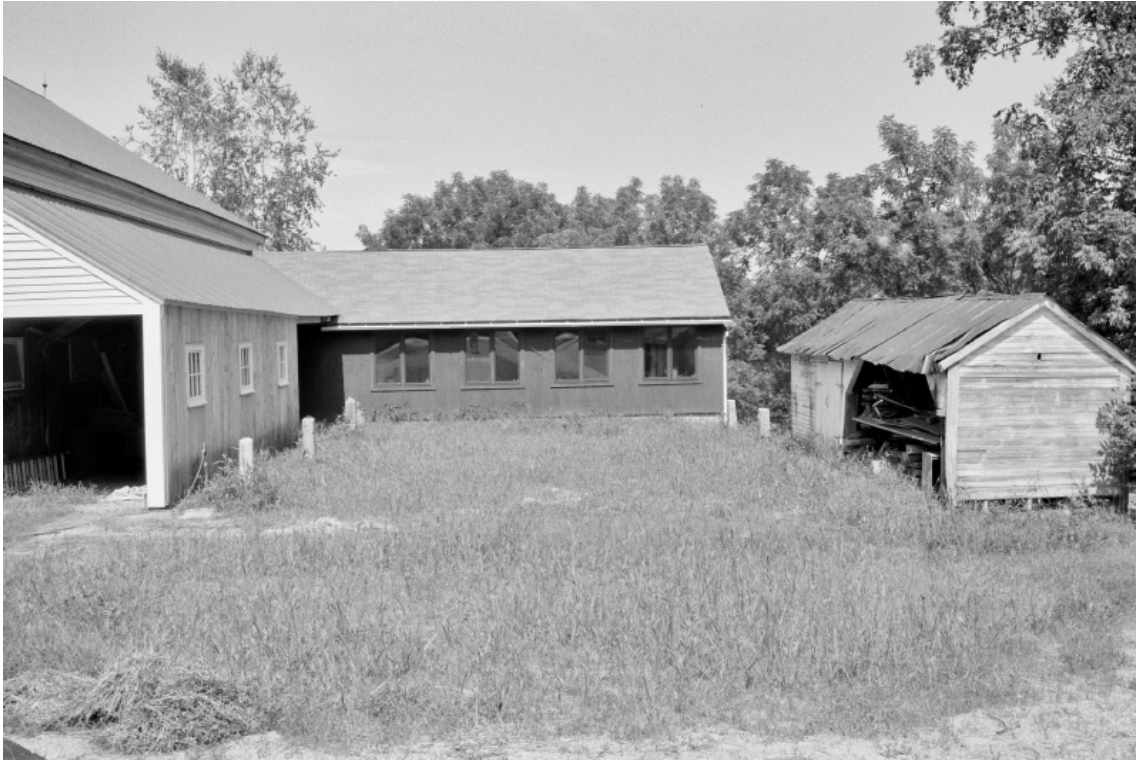
Milk shed (ca. late 19<sup>th</sup> c./ca. 1930s): Situated at the east end of the small barnyard, the milk shed was built in two sections. The older portion is the southern end and has post and beam framing, suggesting a 19<sup>th</sup> c. date. The north end appears ca. 1930s. Weathered clapboards and a corrugated metal roof cover the structure.

Photo 4 description: From left: tractor shed on east wall of barn, barn east addition & milk shed  
Roll: 4 Frame: 10 Direction: N

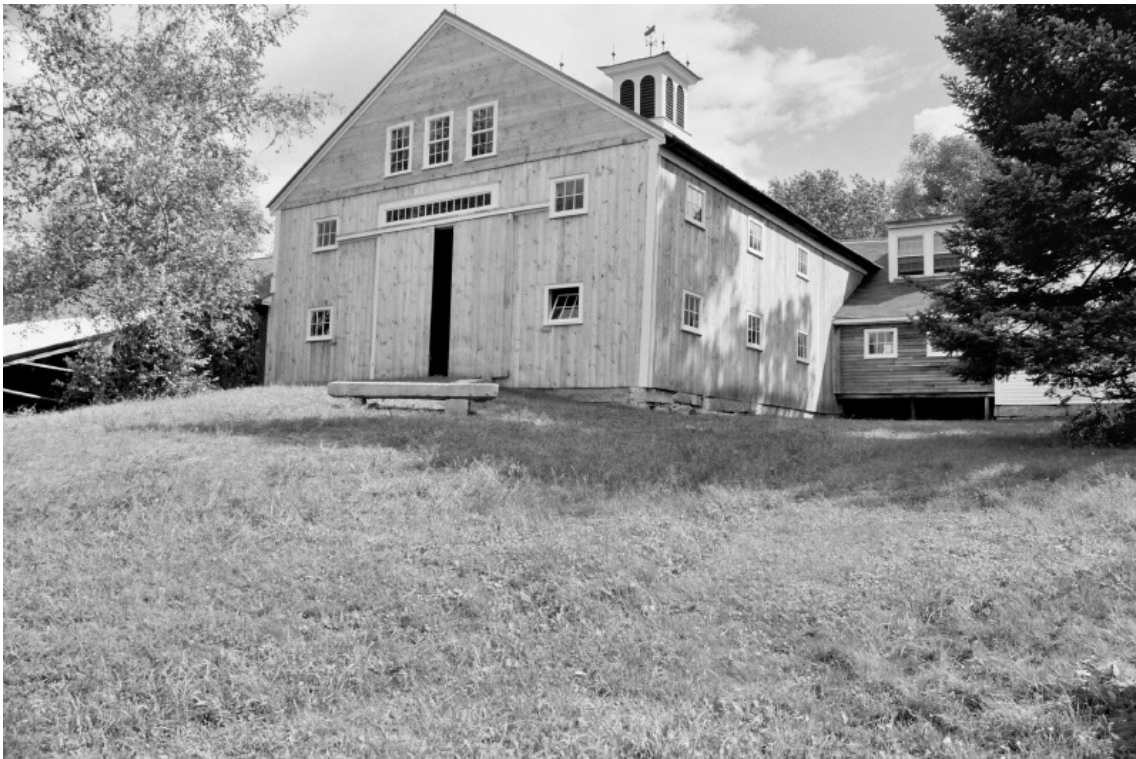
Photo 5 description: Rear (north) & west elevations of barn and rear of shed (east end)  
Roll: 4 Frame: 12 Direction: S
