# DOWNTOWN CONCORD PARKING SYSTEM STRATEGIC PLANNING FINAL REPORT

FINAL • January 2016

## 3.6 PUBLIC GARAGES CONDITION SURVEY

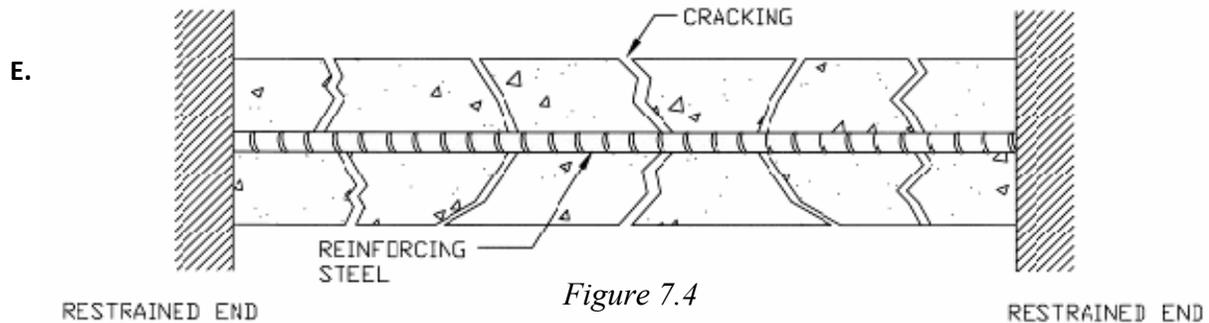
Figure 7.4

Volume changes due to thermal movement, shrinkage, creep, and loading can also contribute to the deterioration of reinforced concrete. These volume changes will produce stress in restrained members, which often results in cracking of the member (reference Figure 7.4).

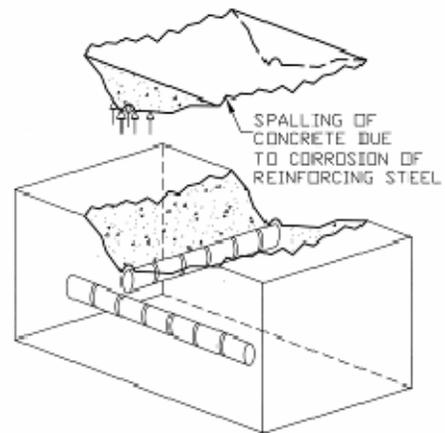
*Figure 7.1*

Concrete is a porous material, which is susceptible to water penetration and the resultant deterioration. The corrosion of embedded reinforcing steel is an electrochemical process supported by the presence of water acting as an electrolyte. In addition, water penetrating into concrete can carry water-soluble chlorides, from de-icing salts, to the reinforcing. The combination of chlorides and water accelerates the corrosion process (reference Figure 7.1).

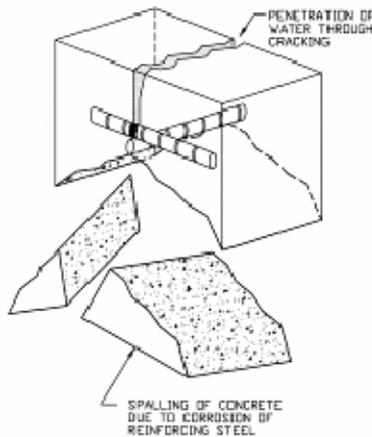
*Figure 7.2*

Corrosion of reinforcing steel, or other embedded ferrous items such as electrical conduit, is the second major factor contributing to deterioration of reinforced concrete (reference Figure 7.2).

This corrosion process produces by-products or rust. These by-products occupy a minimum of 250% of the volume of the parent metal. This increase in volume produces tensile stresses within the surrounding concrete. As concrete has poor tensile strength properties, cracking will occur, allowing additional moisture and chlorides to reach the reinforcing steel, thereby accelerating the corrosion process. The deterioration caused by this corrosion includes the reduction of the cross sectional area of the reinforcing and the delamination of the surrounding concrete.

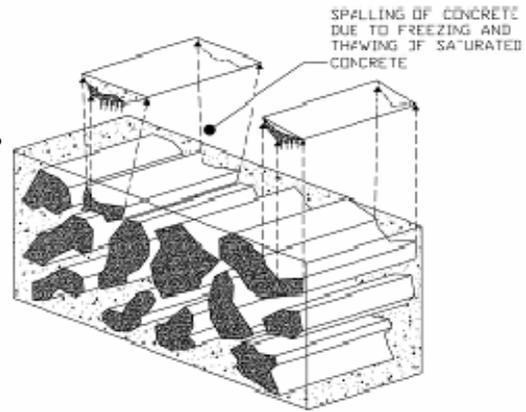
Figure 7.3

As previously mentioned, these pressures can cause progressive failure of the cement paste and result in scaling of the concrete and delamination of concrete along subsurface fracture planes (reference Figure 7.3).

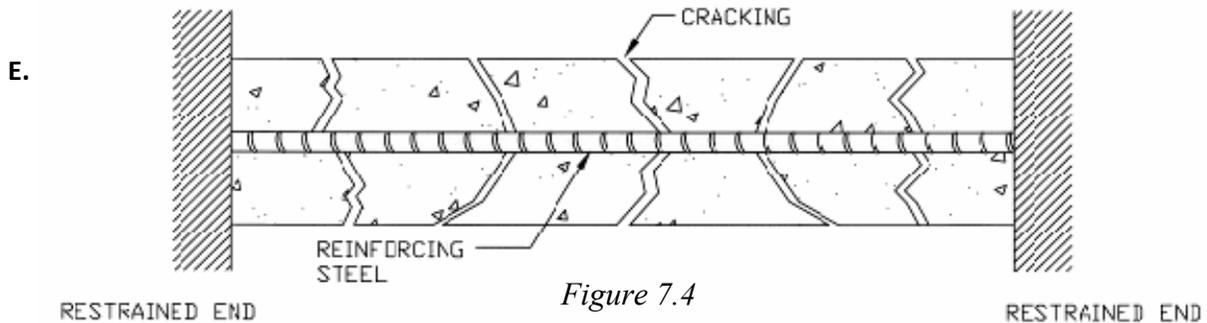
Figure 7.4

Volume changes due to thermal movement, shrinkage, creep, and loading can also contribute to the deterioration of reinforced concrete. These volume changes will produce stress in restrained members, which often results in cracking of the member (reference Figure 7.4).
