Concord Municipal Airport

Terminal Area Study
SBG-04-14-2019

April 2021

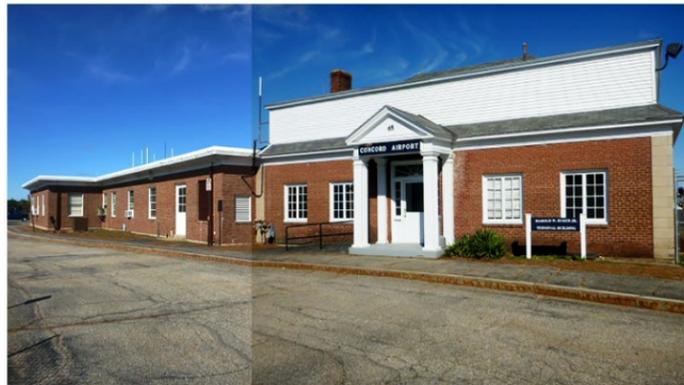
3.1 Main Terminal Building

The main terminal building (MTB) is a focal point at Concord Municipal Airport during major events such as presidential candidate visits and the NASCAR races, as well as certain events held at St. Paul's School. The airport accommodates a steady flow of corporate aircraft and smaller general aviation traffic throughout the year. Historically, most pilots and passengers bypass the terminal building due in part to its lackluster appearance, unobtrusiveness as a point of entry from airside to

landside, and inadequate lounge/lobby space. The City of Concord and a group of volunteers recently remodeled the terminal building lobby to add function and appeal for arriving passengers. The lobby received a fresh coat of paint, new lighting, and furniture. A small room off the main lobby received the same updates and is used as a pilot lounge. The building is still grossly lacking in the functional amenities offered by a modern terminal building such as adequately sized and furnished lobby and meeting space, flight planning/pilot lounge, and office/concession space. Although many of these features are present in the existing building, they are outdated and/or not adequately sized.

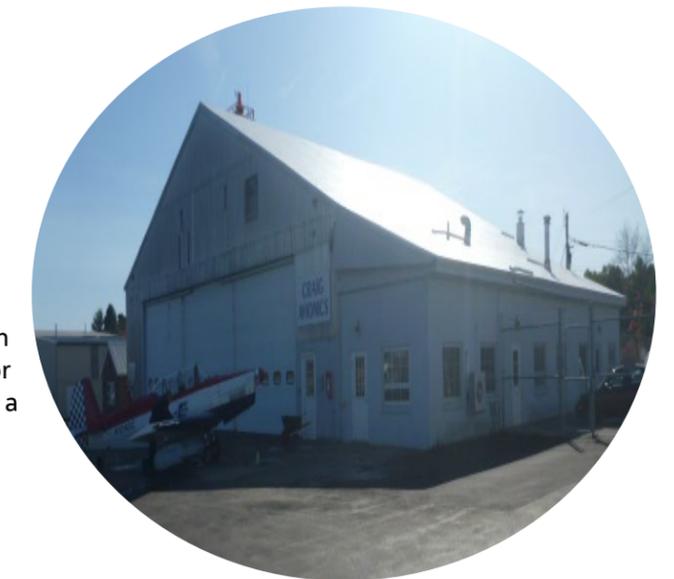
3.4 Hangar #3

Hangar #3 is home to Craig Avionics. This avionics repair shop has been a tenant of Concord Municipal Airport since 1988 and offers services for aircraft radio repair/installation. Hangar #3 is heated and has a breakroom, workshop, office space, restroom, and pilot lounge.

Hangar #3 is constructed of a steel frame, concrete blocks, an aluminum roof, and is partially covered in aluminum siding. The exterior of the hangar is in poor condition and is visibly worn. There is a small landside parking lot located on the north side of the hangar. There have been reports of flooding in this parking lot due to lack of suitable drainage. The water pools around the north entrance to the hangar which creates a dangerous hazard in the winter months.

The aluminum siding that covers a portion of the hangar appears dirty and in some areas the siding is warped. There is no visible cracking or crumbling in the walls. The aluminum roof was recently repaired. The ceiling is comprised of wooden planks covered in sheetrock panels. The ceiling is stained from water damage throughout and deteriorating in many areas which could create a potential hazard. The interior walls are also in need of attention. There are areas along the walls where the white insulation is badly stained and torn. The maintenance facility in Hangar #3 is very dimly lit despite having windows around the exterior. This Hangar is not equipped with nearly as many florescent lights as the maintenance facility located in Hangar #2. The floor in Hangar #3 is made of concrete slabs and is in good condition. The floor is clean and free of stains as it appears to be sealed for protection. The concrete slabs show no signs of heavy wear or deterioration.

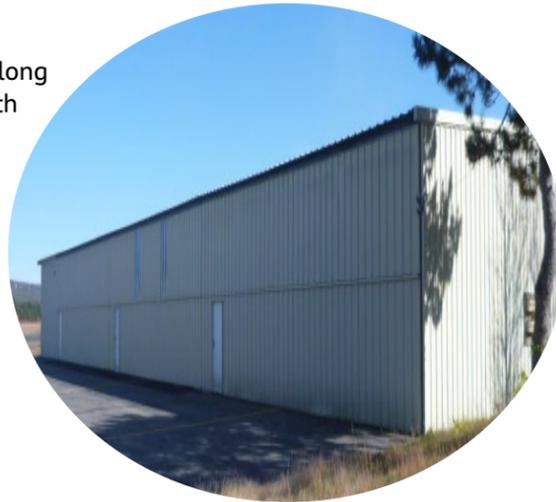
3.5 T-Hangars

There are two T-hangars within the study area and they are located along Airport Road. Each T-hangar has six aircraft bays. There are three north facing and three south facing. Combined, both T-hangars provide twelve sheltered parking spaces which are currently all occupied. The aluminum roofing is in good condition on both T-hangars and there have been no reports of leaking. The pavement surrounding the T-hangars is made of asphalt and is in fair condition. There are numerous large cracks in the asphalt that have been repaired with rubber crack sealant.

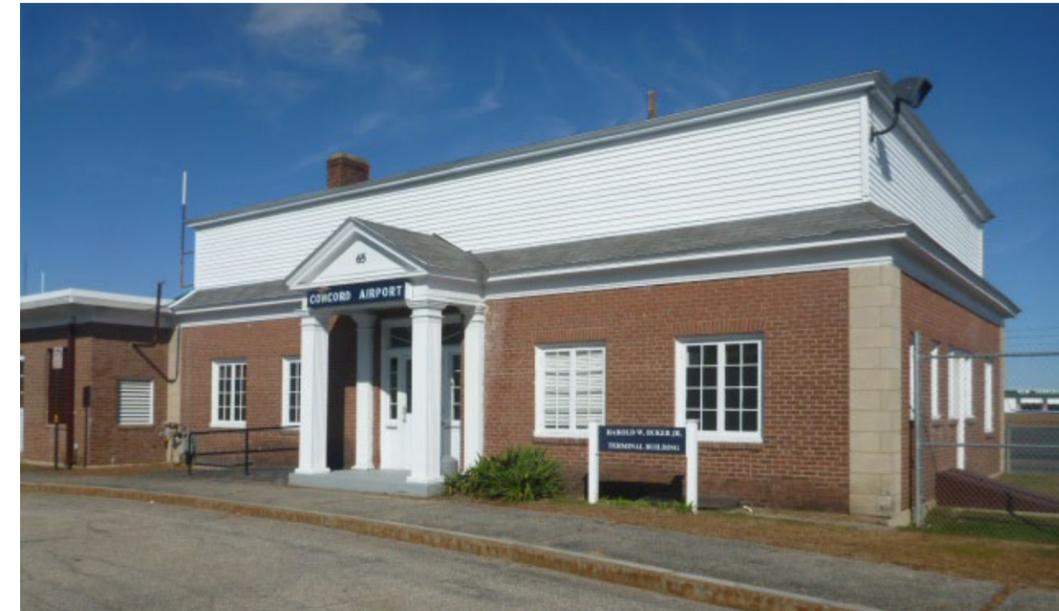
Figure 1-1. Main Terminal Building – West Facing Façade

Front (West) façade of the Concord Municipal Airport Main Terminal Building. This view shows the main part of the terminal where a pilot lounge, restrooms, and small kitchen are located.

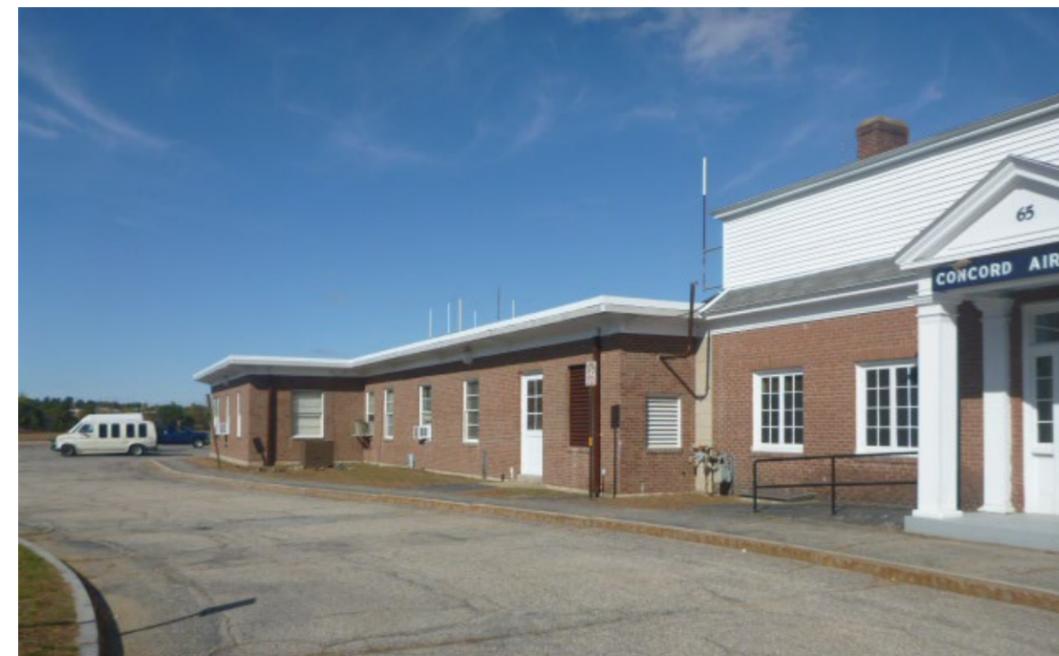
Figure 1-2. Main Terminal Building- West Facing Façade

Front (West) façade of the Concord Municipal Airport Main Terminal Building. This view shows the extension off the left of the terminal where office space is located.

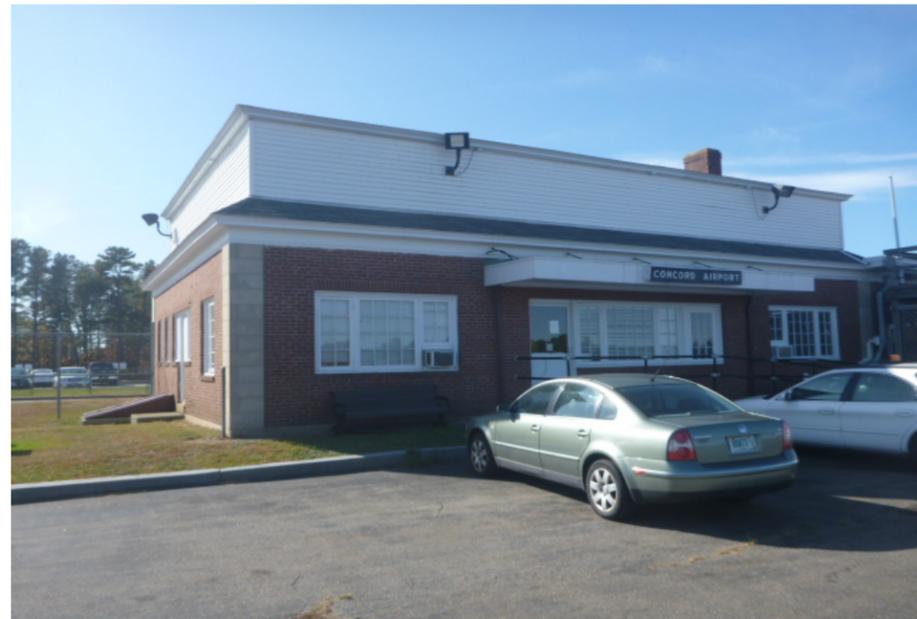
Figure 1-3. Main Terminal Building – East Facing Façade
Rear (East) façade of the Main Terminal Building as seen from the South West corner of the corporate apron. This view shows the airside entrance into the main part of the terminal building.

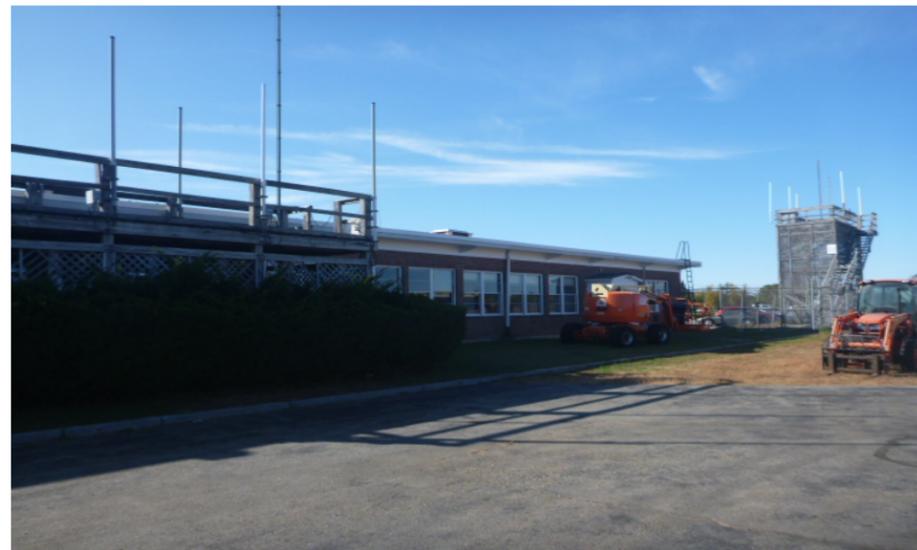
Figure 1-4. Main Terminal Building - East Facing Façade
Rear (East) façade of the Main Terminal Building as seen from the North West corner of the corporate apron. This view shows the extension off the main part of the terminal where offices are located.

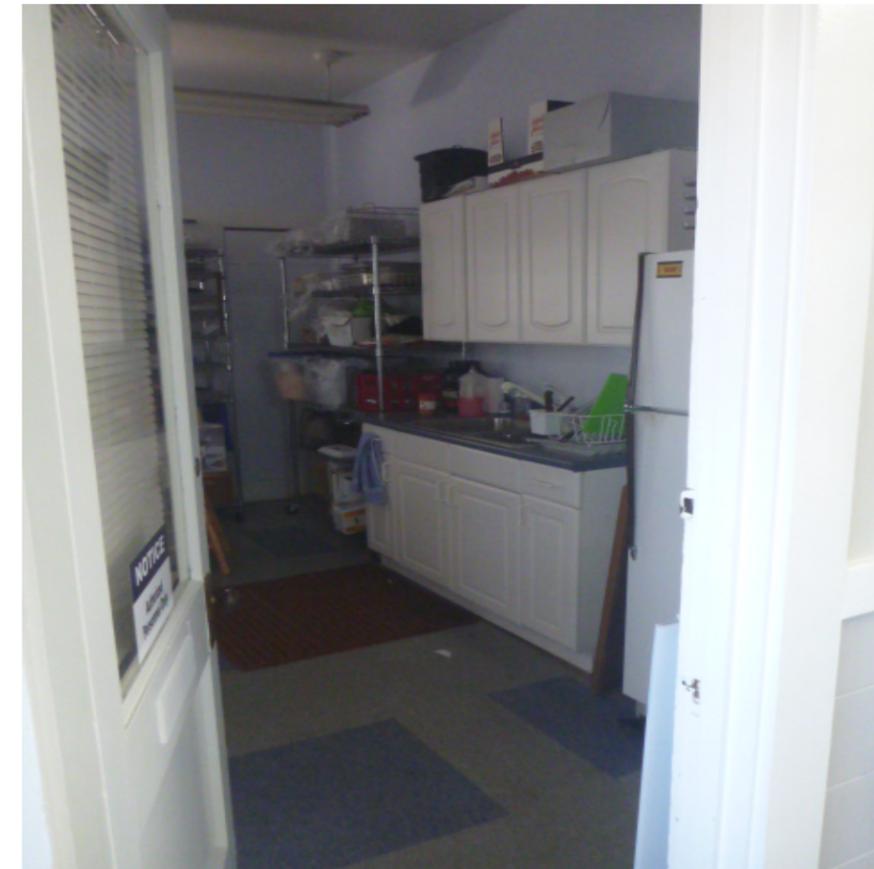
Figure 1-5. Kitchen
The kitchen located in the original part of the Terminal Building.

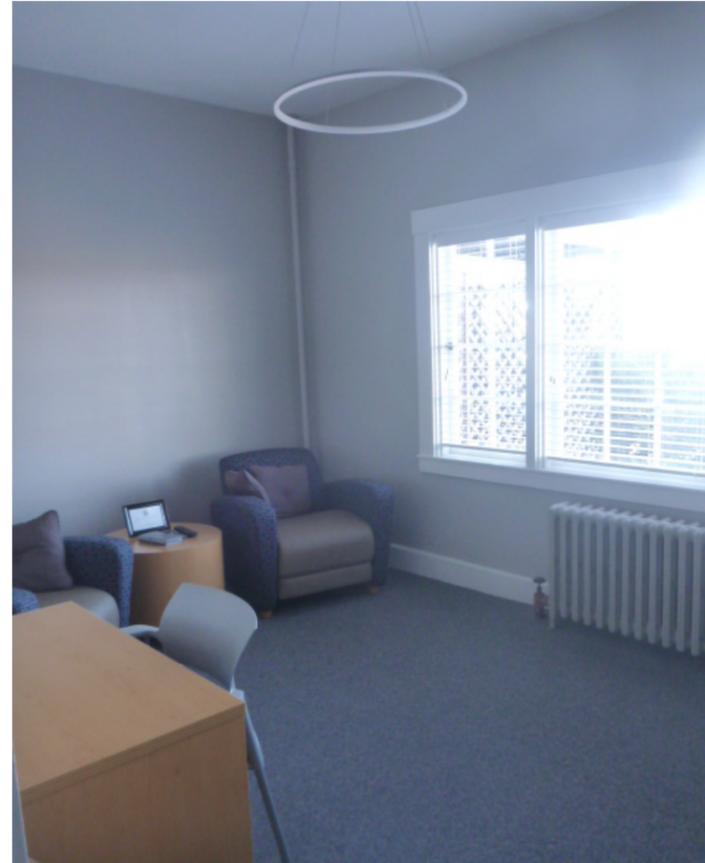
Figure 1-6. Pilot Lounge.
Recently updated Pilot Lounge located in the older part of the Terminal.

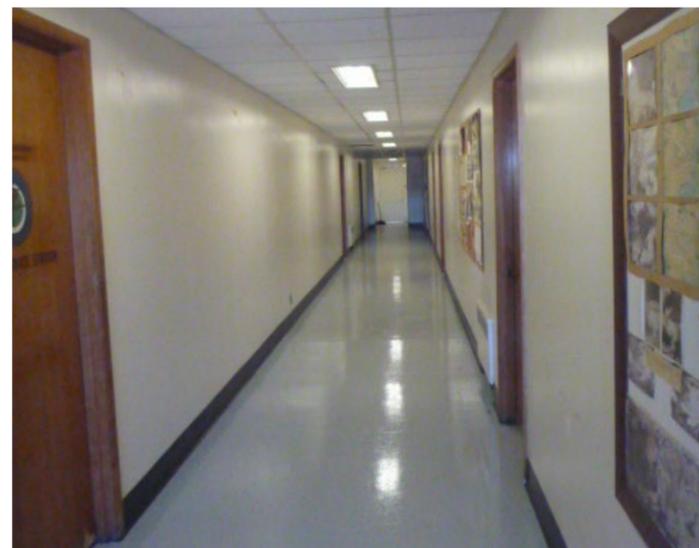
Figure 1-7. Hallway leading to Offices
Hallway in newer terminal expansion leading to offices.

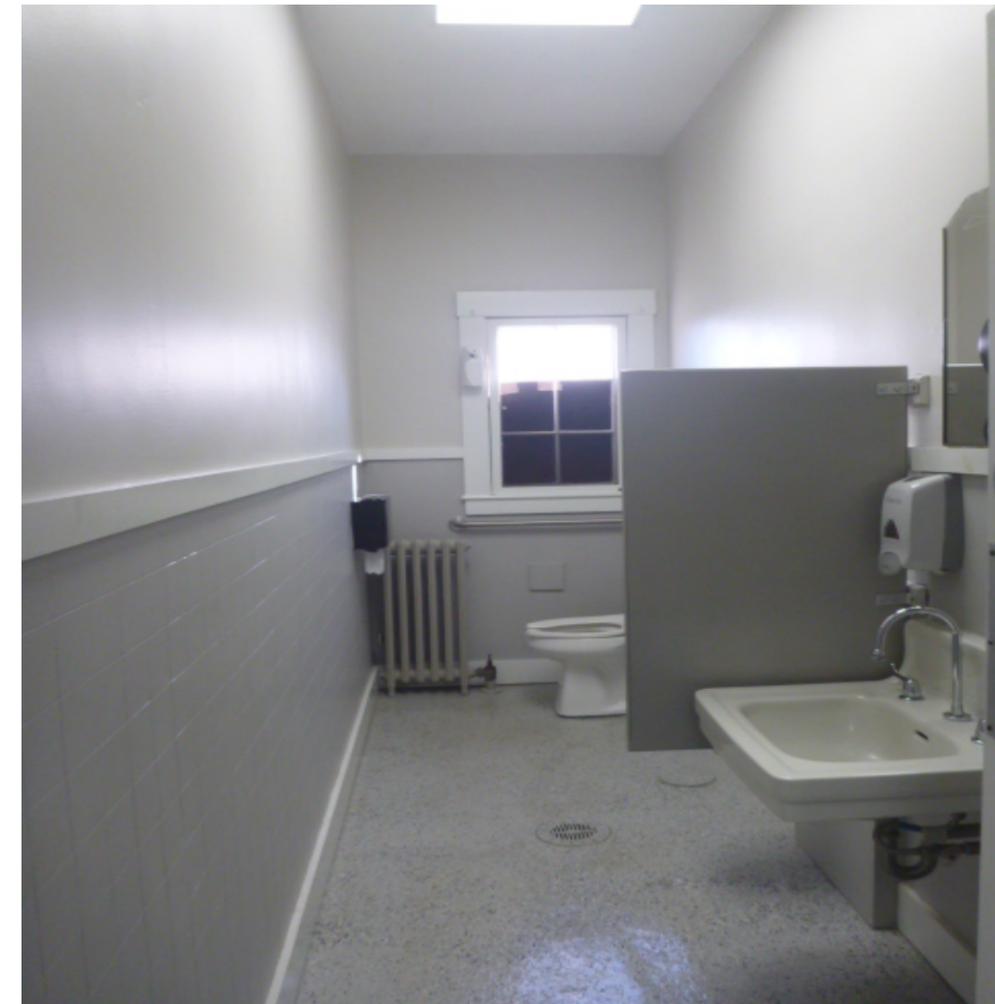
All the utilities in the building are functioning including the heating and plumbing. There are several restrooms in the Terminal Building. A women's restroom and handicap accessible unisex restroom are in the older part of the terminal and a single unisex restroom is in the expansion. The building is heated using exposed radiators throughout. Additionally, there are multiple air-conditioning units installed in various windows of the building. The Terminal Building could benefit from more energy efficient upgrades in the means of windows, HVAC, and lighting.

Figure 1-8. Restroom Located in Expansion
One of two unisex bathrooms in the building. This restroom is located in the newer part of the terminal.

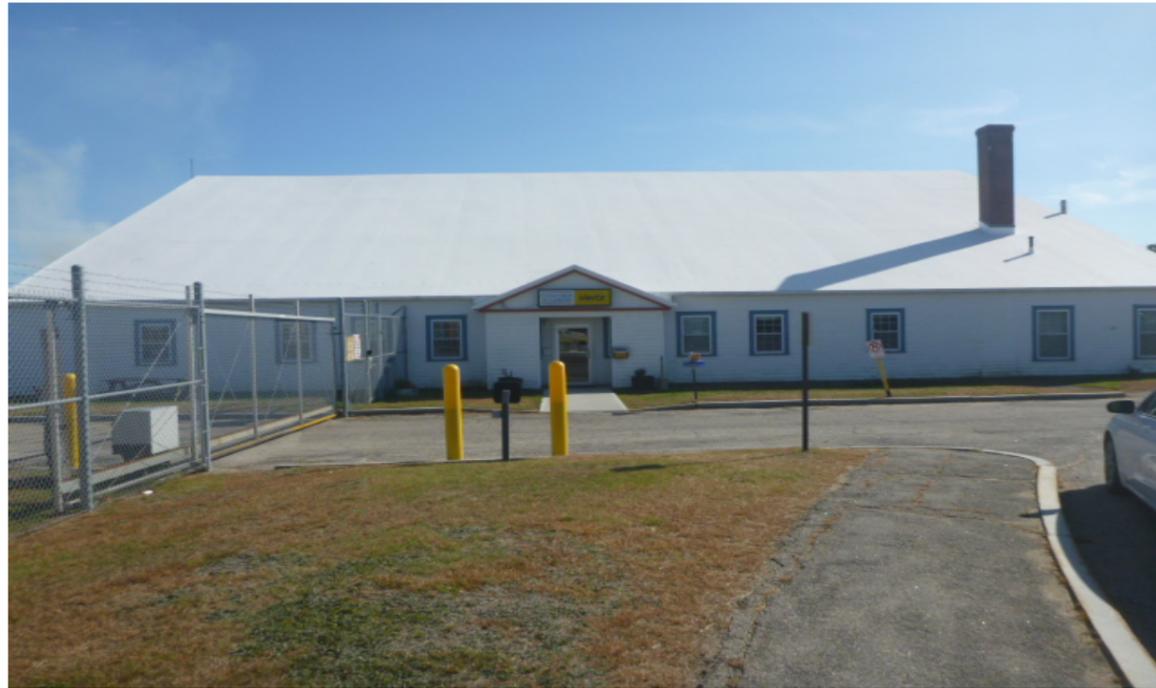
Figure 1-9. Hangar #1 FBO –North Facing Façade

Landside entrance (North) of Hangar #1 as seen from the Southwest corner of the Main Terminal Building.

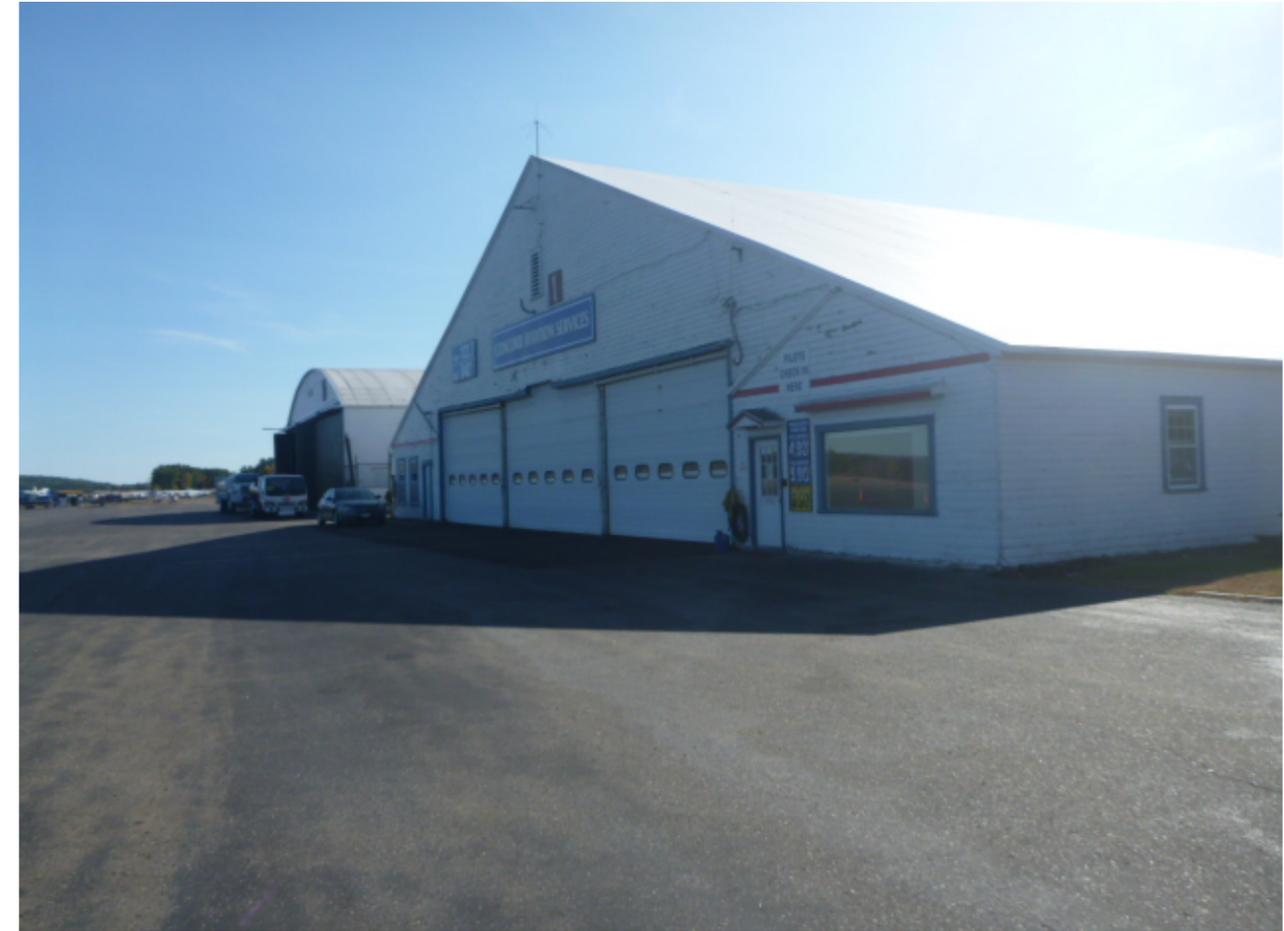
Figure 1-10. Hangar #1 FBO –East Facing Façade

Airside entrance (East) of Hangar #1 as seen from the Southeast corner of the Main Terminal Building.

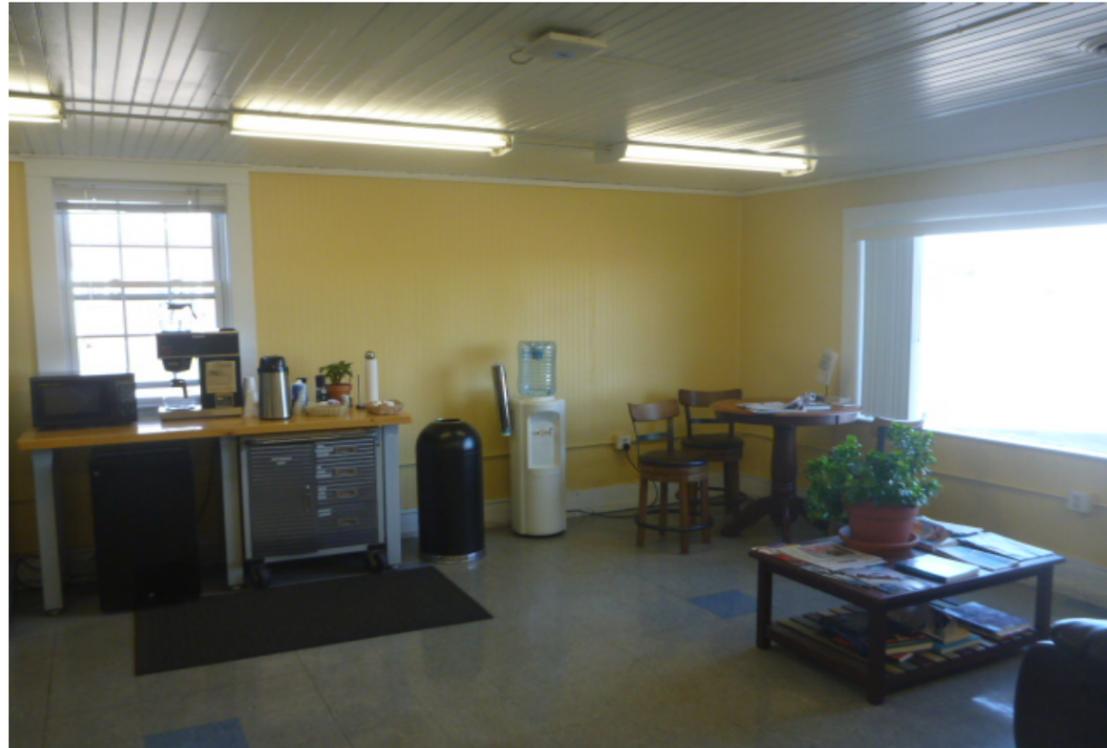
Figure 1-11. Lounge Area
Hangar #1 as seen from the Concord Aviation Services reception counter.

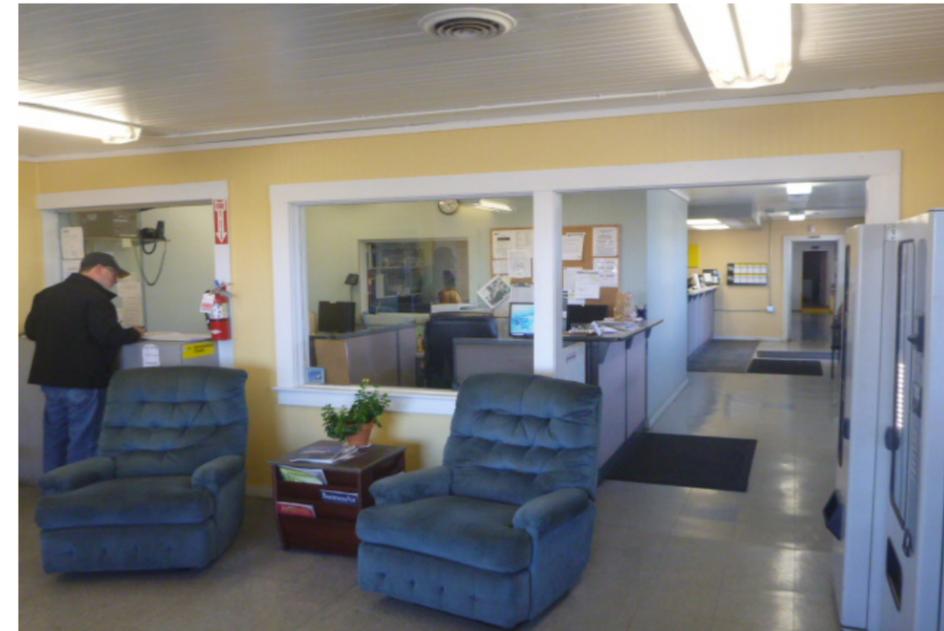
Figure 1-12. Reception Counters
Reception counters for Concord Aviation Services as seen from the lounge area.

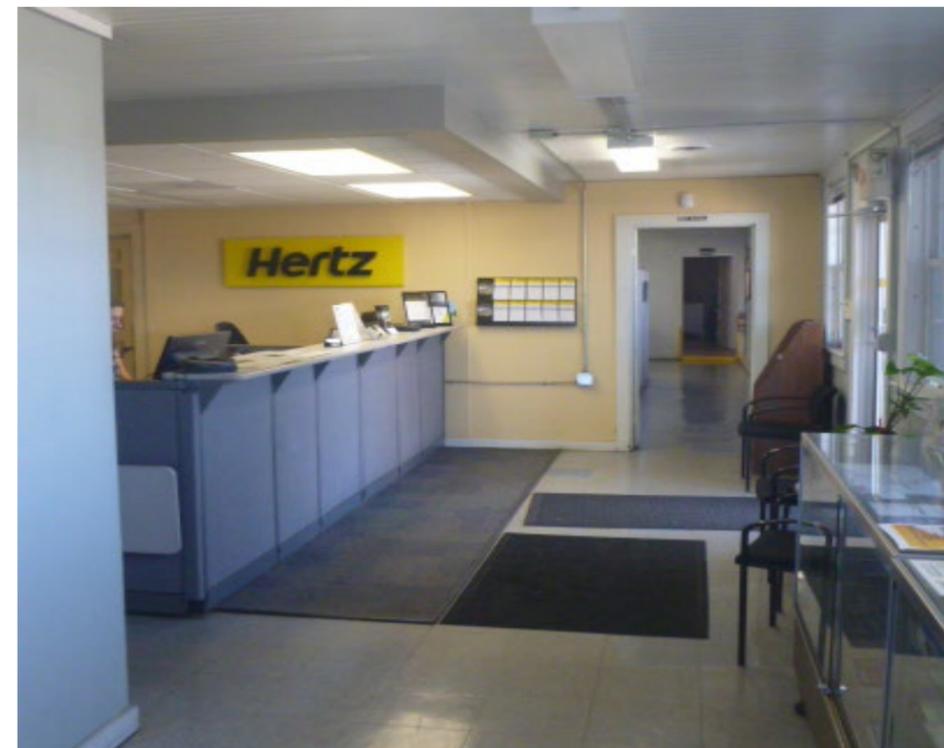
Figure 1-13. Hertz Rental Cars
Hertz rental car reception counters as seen from the FBO reception counters.

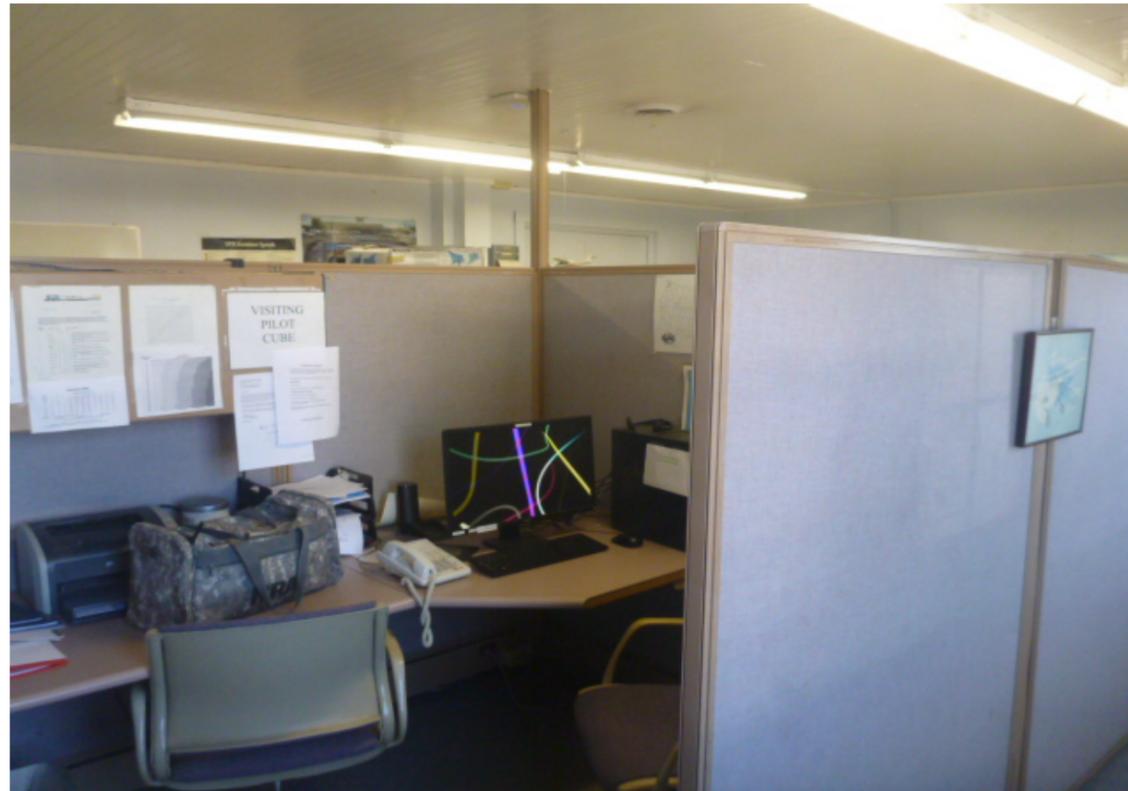
Figure 1-14. Rear Office Space

The additional office space towards the rear (West) of the building is used for flight instruction and desk space for pilots. There are about eight desks which are mostly divided by office cubical walls. This rear office area is in dire need of refurbishment. The area is cluttered, tight, and poorly laid out (desk space is very limited due to computers taking up most of the area). The desks are in poor condition and some are beginning to bow from the weight of the extremely out-of-date computer monitors and other materials on top of them. Other than filing cabinets there is no storage area for instruction materials in this part of the hangar. The office furniture looks heavily worn and in need of replacement. The restrooms in this half of the hangar are in the rear next to an exposed HVAC system. There is a men's and women's restroom, neither of which are handicap accessible. The restroom stalls are made of plywood which has been painted and the doors have been fitted with eyehooks for locks. The dimensions of the stalls are small and not accommodating to those with disabilities.

Office space located in the rear (West end) of the Hangar 1. This space is used by visiting pilots and for flight instruction.

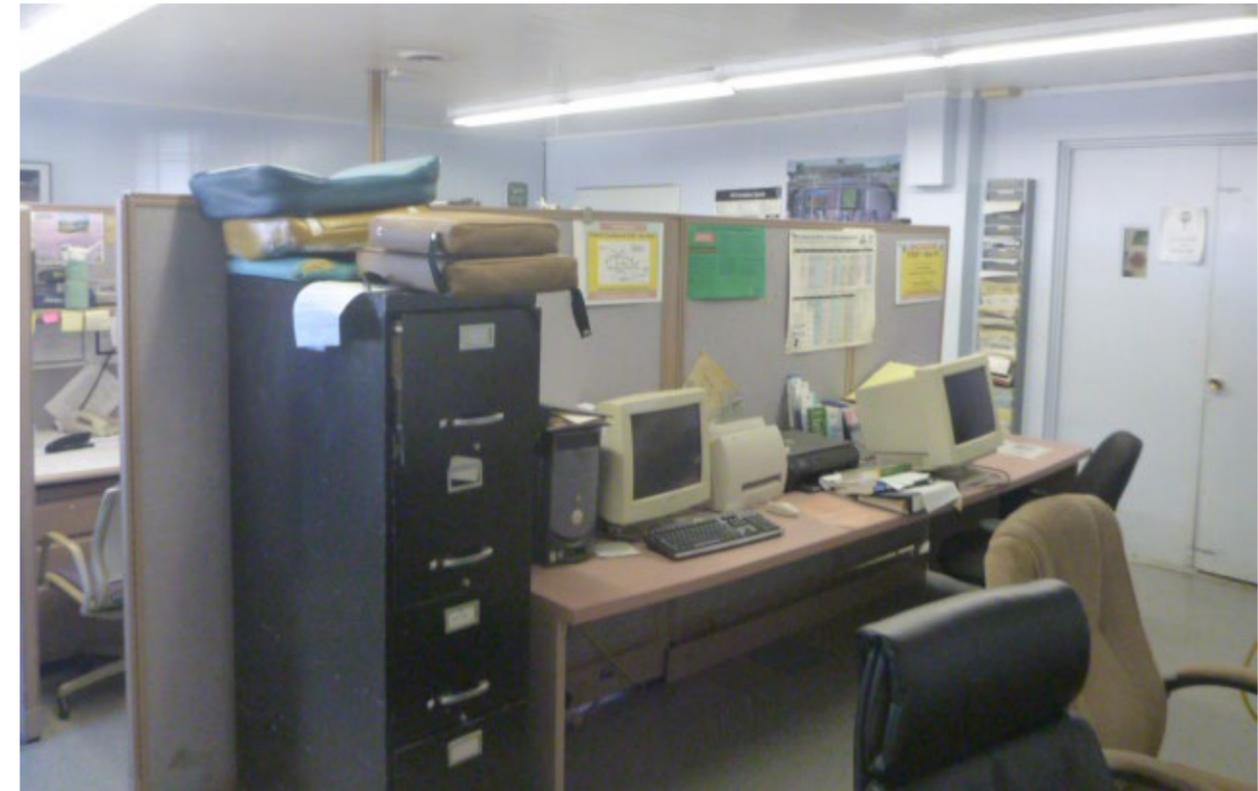
Figure 1-15. Rear Office Space

Rear office space as seen from the entrance into the restrooms.

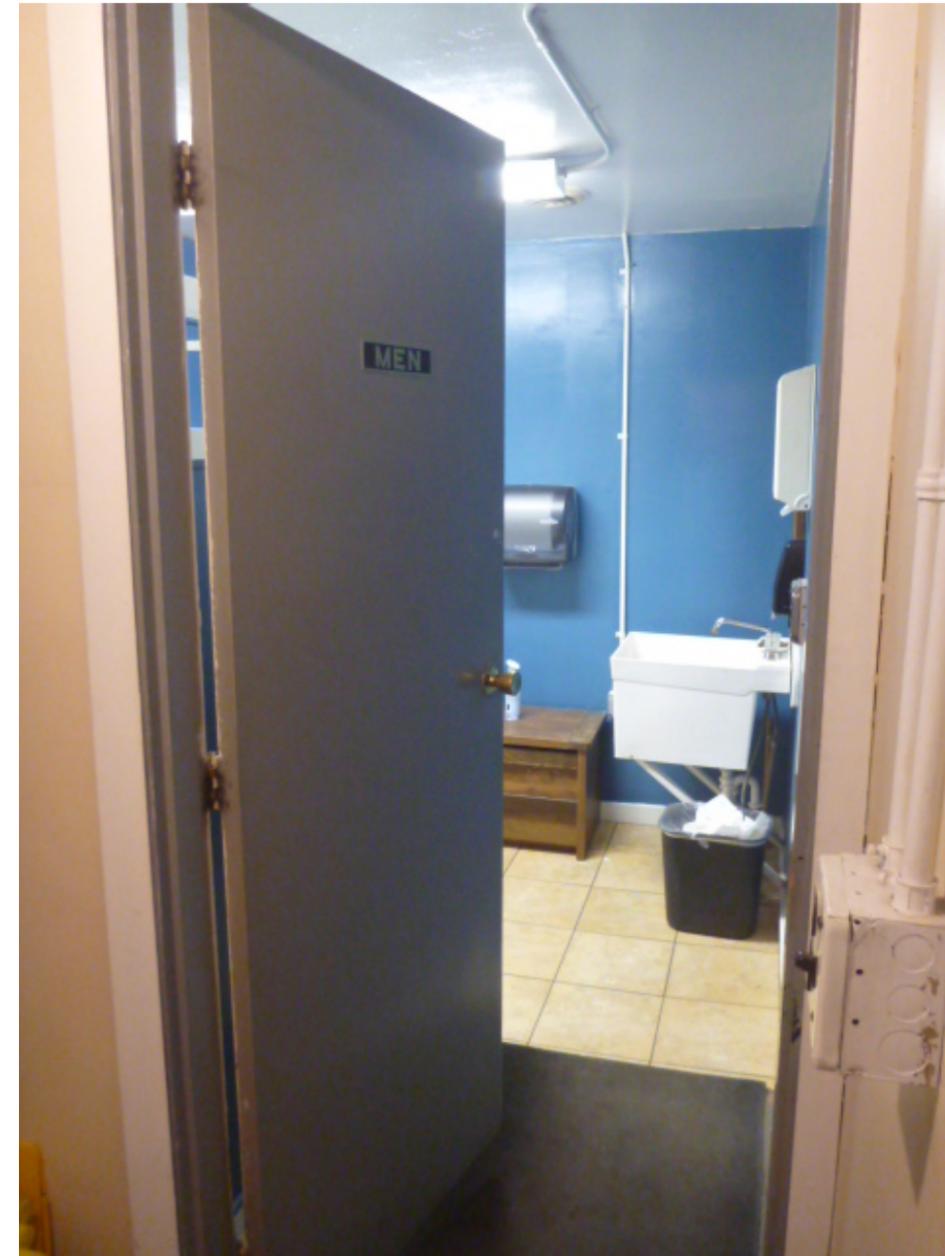
Figure 1-17. Men's Restroom
Men's Restroom as seen from the HVAC unit (not shown) which is located directly to the left.

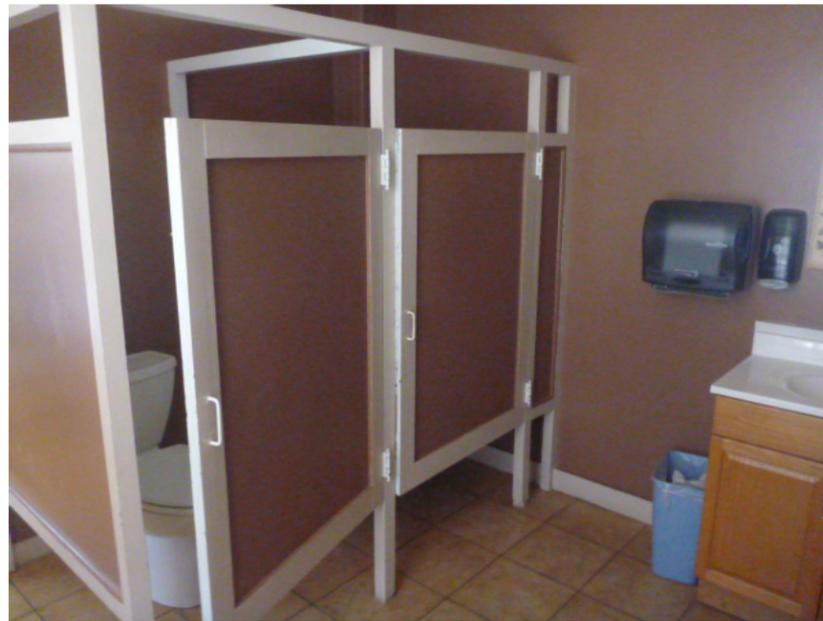
Figure 1-18. Women's Restroom

Women's Restroom which is located directly right of the Men's Restroom.

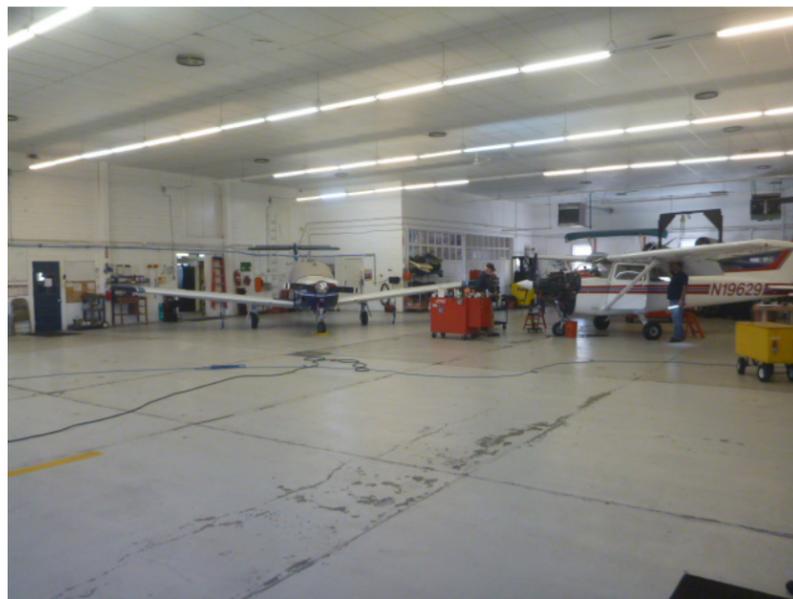
Figure 1-19. Hangar #1 Maintenance Facility

The other half of Hangar #1 is the Concord Aviation Services aircraft maintenance facility. This half of the hangar is also heated and has a workshop, a restroom, parts storage, and small office space. The maintenance facility is well kept however it is in need of several repairs and updates. The ceiling is made of tile which is deteriorating in areas where the hangar doors open. This poses a potential hazard to both the people and aircraft inside if the debris from the ceiling were to fall. The roof on Hangar #1 was recently renovated and there are no signs of leaks on any of the ceiling tiles. The floor in the maintenance facility is made of concrete slabs that have been painted white. The concrete slabs are beginning to deteriorate in some areas and the white paint is fading throughout the floor. The interior walls are wooden and also painted white and gives the appearance of a bright and spacious facility which is lit by hanging fluorescent lights.

Maintenance facility located in Hangar #1.

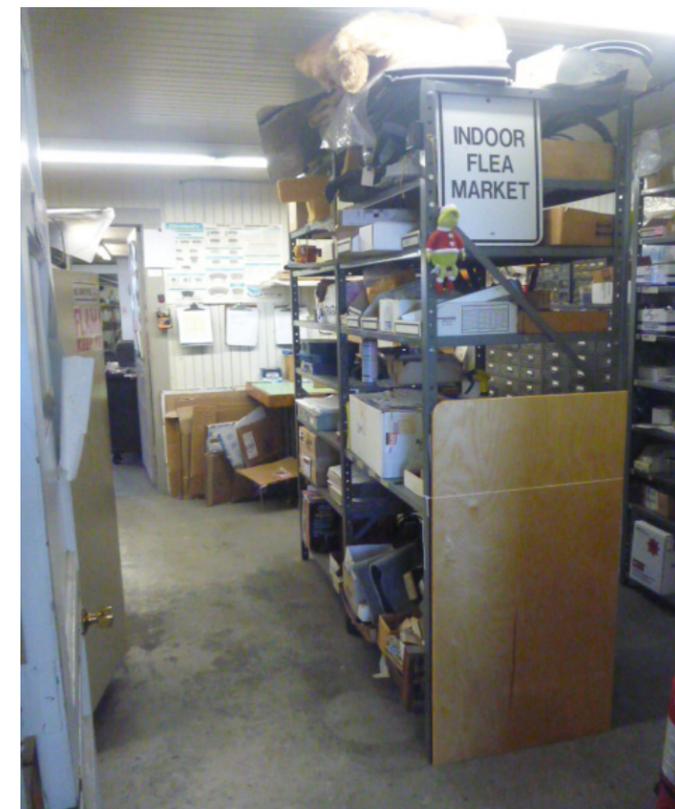
Figure 1-23. Parts Storage

Shelves in the parts storage room as seen from the entrance way of the connected workshop. Note the storage shelves which are filled to capacity.

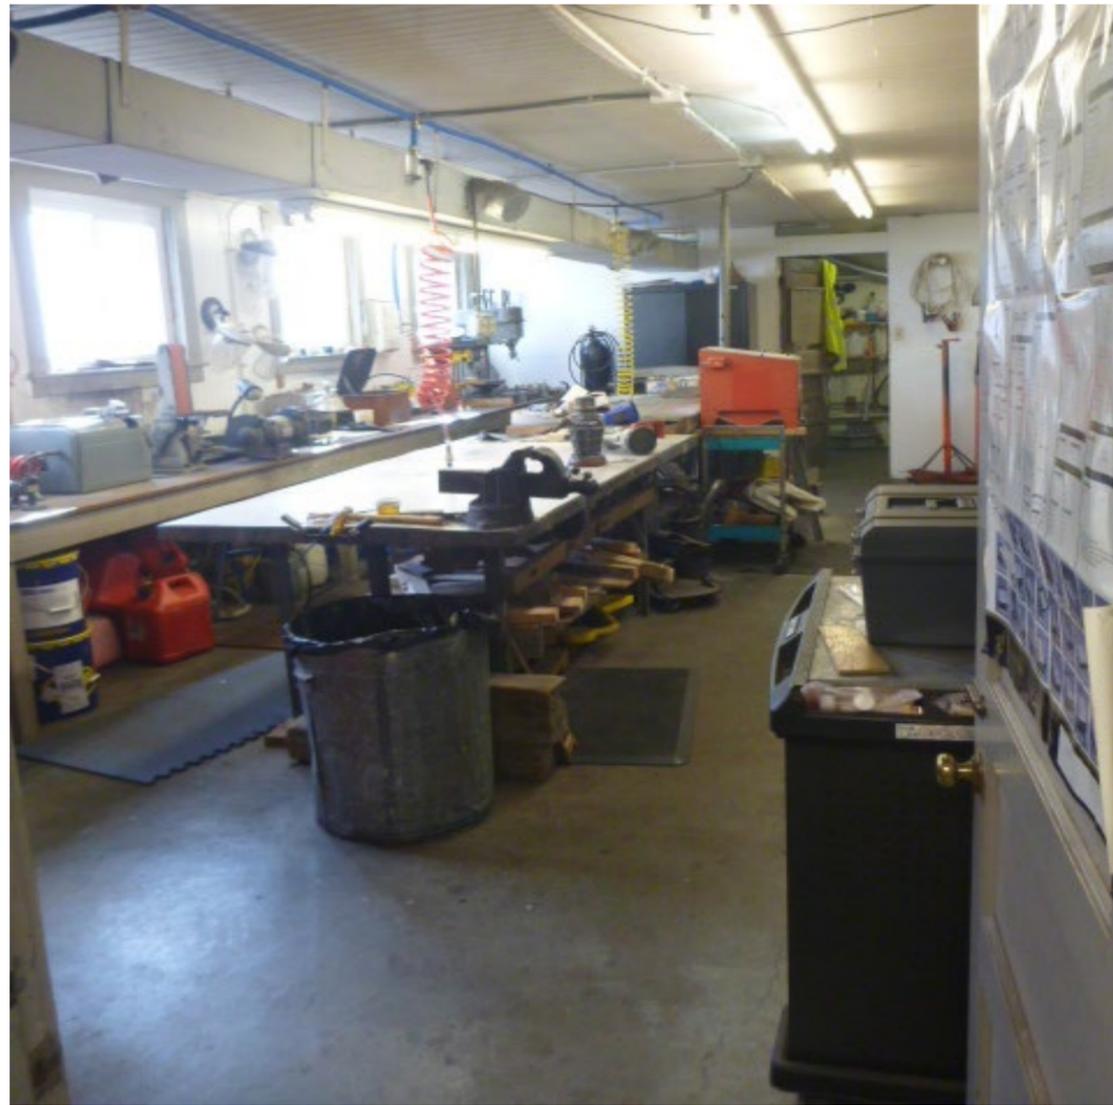
Figure 1-24. Workshop
Workshop as seen from the door way into the parts storage room.

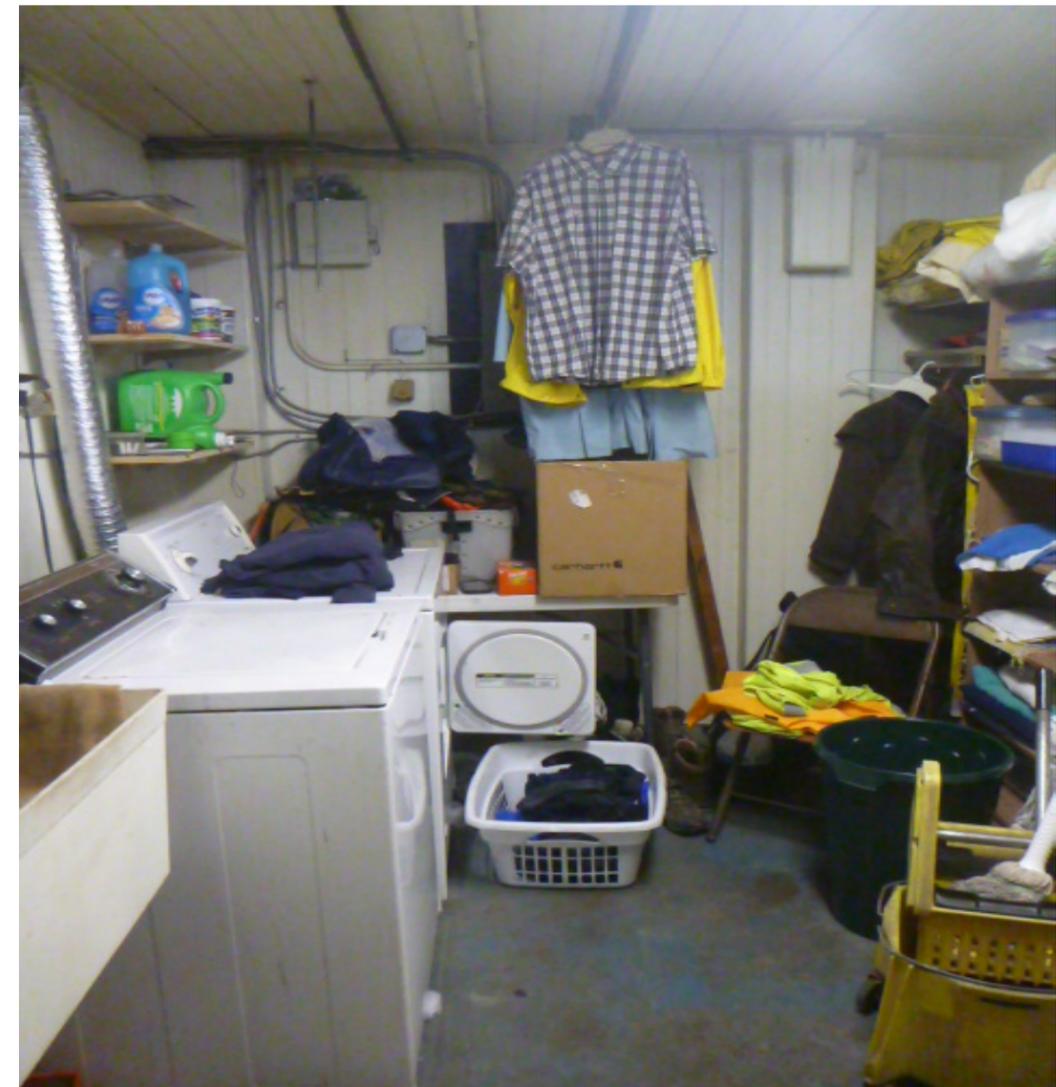
Continuing East is where the restroom and a washer and dryer are located. This is the rear of the hangar (East side) and this area is accessible from the workshop. This portion of the hangar is a very confined space that appears to be in disarray. The washing machine and dryer are available for maintenance employees who actively use them. The tight space appears to be doubling as a small storage space and laundry area. The very little shelving that exists is at capacity with clothing, cleaning supplies, and miscellaneous items. Additionally, this area houses another portion of the hangar's HVAC unit, a shower, and restroom. This portion of Hangar #1 is inadequate for providing a clean space for maintenance employees to use as its intended purpose.

Figure 1-25. Laundry Area
Washer and dryer located in the very rear of the South half of Hanger #1. Not pictured is the restroom and shower also located in this area.

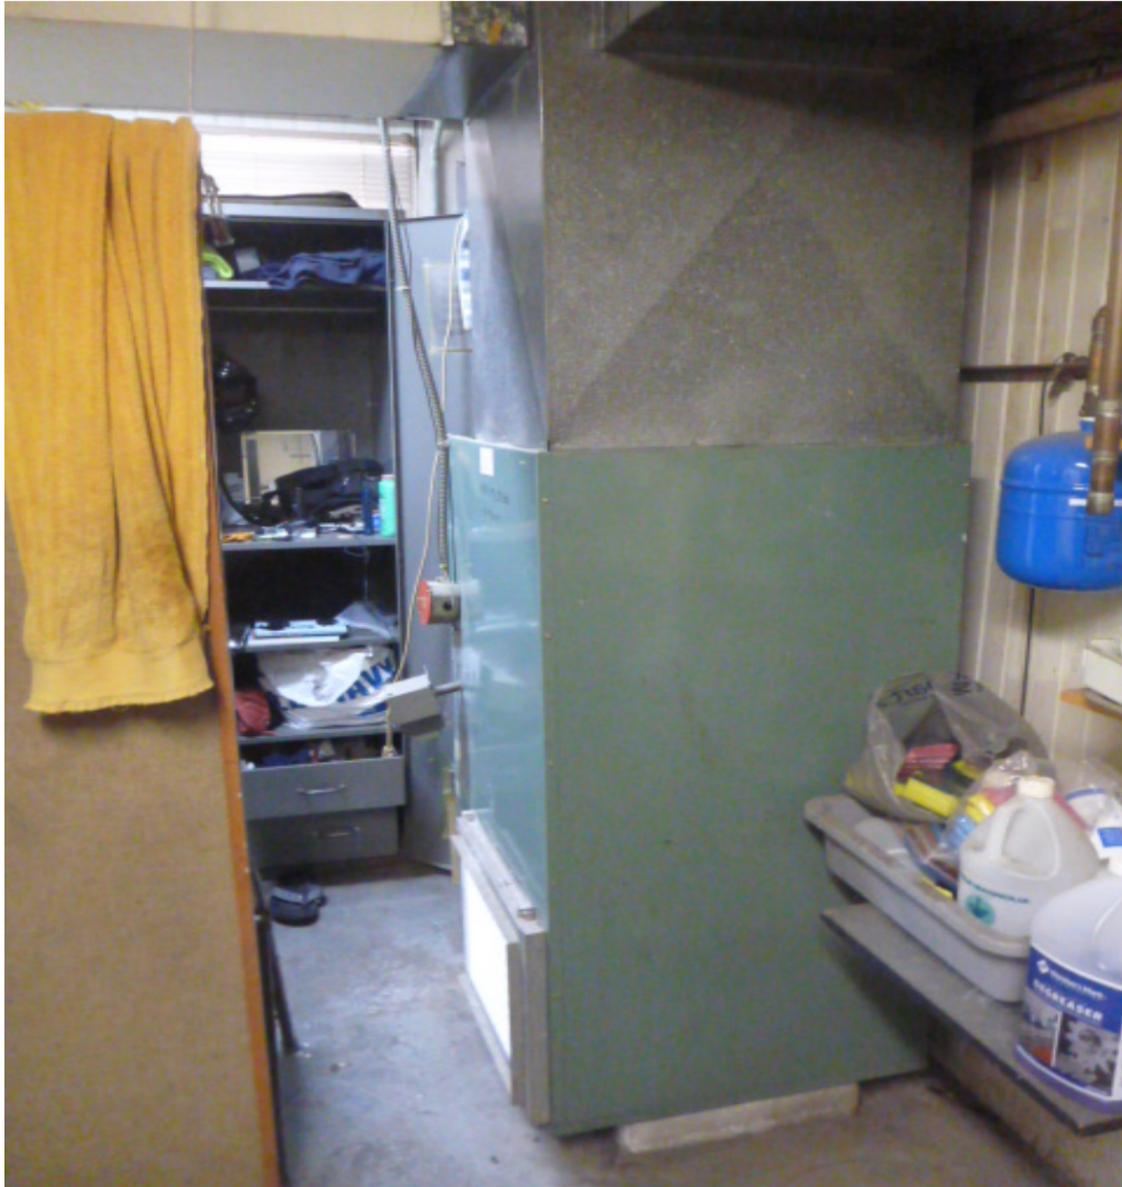
Figure 1-26. Laundry Area

Part of the HVAC unit that occupies a large amount of space in the laundry area. Behind the brown divider (left) is the shower stall.

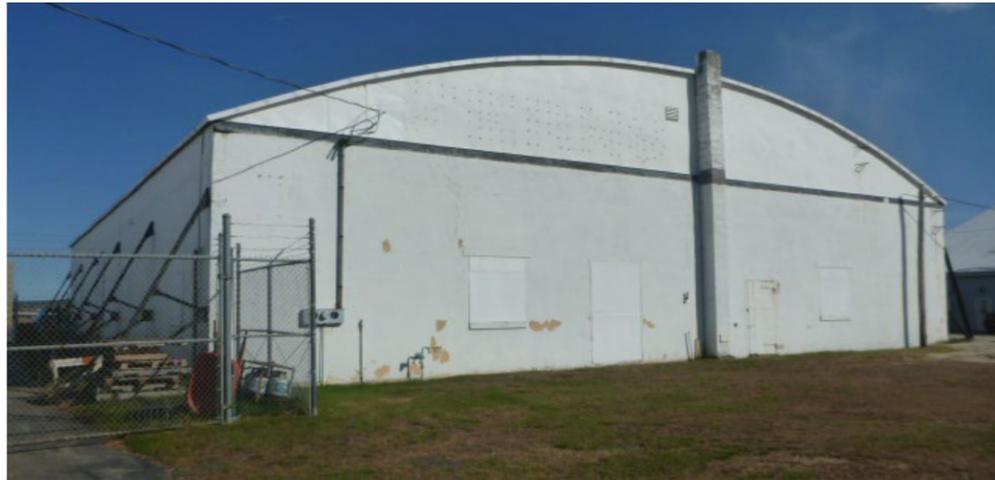
Figure 1-28. Hangar #2 - West Facing Façade
Landside view of the rear (West side) of Hangar #2 as seen from the Southwest corner of the FBO.

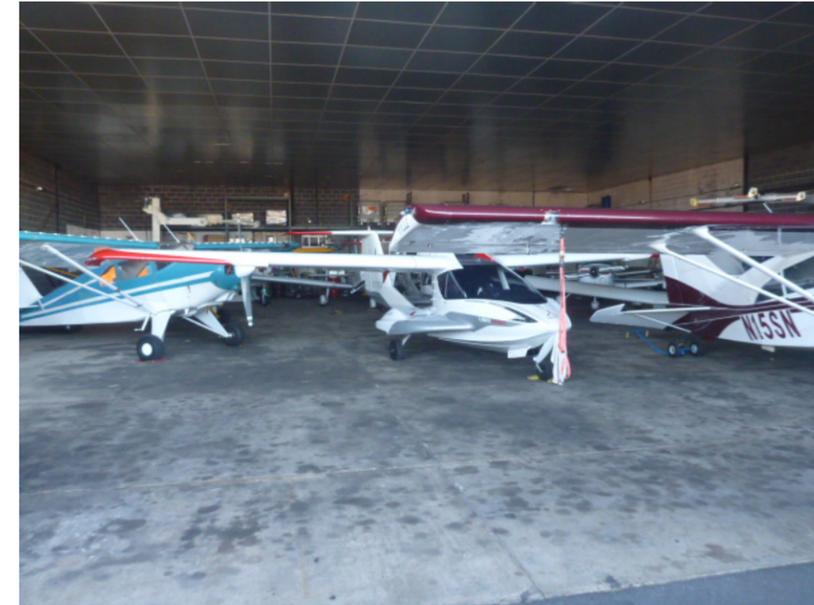
The interior of Hangar #2 is in good condition given the distressed exterior. The floor is made of concrete slabs like those in the maintenance facility. Although the floor is covered in oil stains the overall condition of the concrete is in good condition. The ceiling which is covered in tiles is in good condition with no visible signs of damage or leaks. The interior walls are sturdy and made of numerous materials including concrete block, brick, and wood. There is shelving in the rear of the hangar, but it does not have a dedicated storage room, restroom, or office space.

Figure 1-30. Interior of Hangar #2
Interior of Hangar #2 as seen from the entrance (East side).
