Concord Municipal Airport

Terminal Area Study
SBG-04-14-2019

April 2021

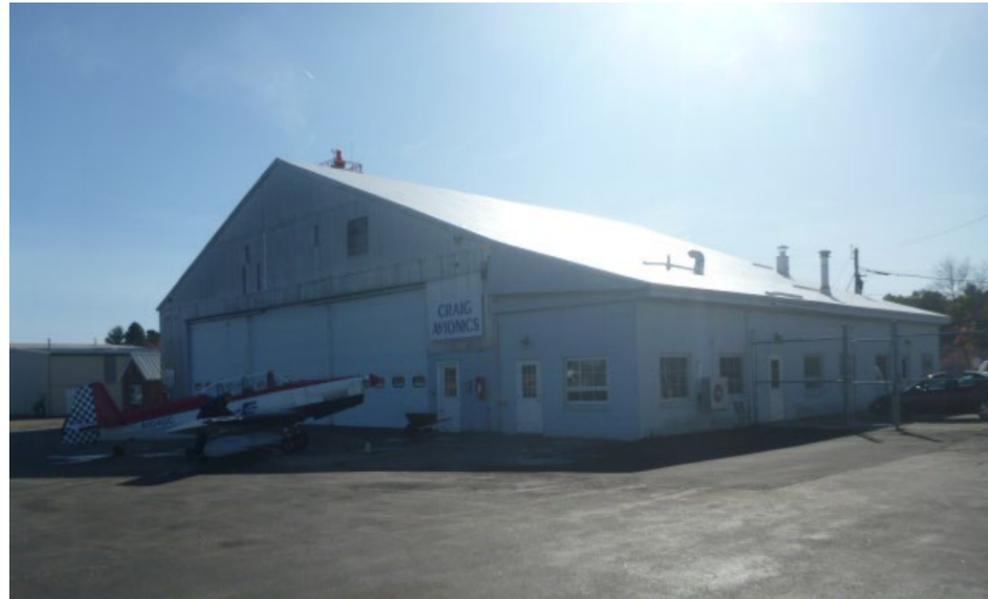
Figure 1-32. Hangar #3 – East Facing Façade
Front (East side) of the Hangar where Craig Avionics is located.

Hangar #3 is constructed of a steel frame, concrete blocks, an aluminum roof, and is partially covered in aluminum siding. The exterior of the hangar is in poor condition and is visibly worn. There is a small landside parking lot located on the north side of the hangar. There have been reports of flooding in this parking lot due to lack of suitable drainage. The water pools around the north entrance to the hangar which creates a dangerous hazard in the winter months.

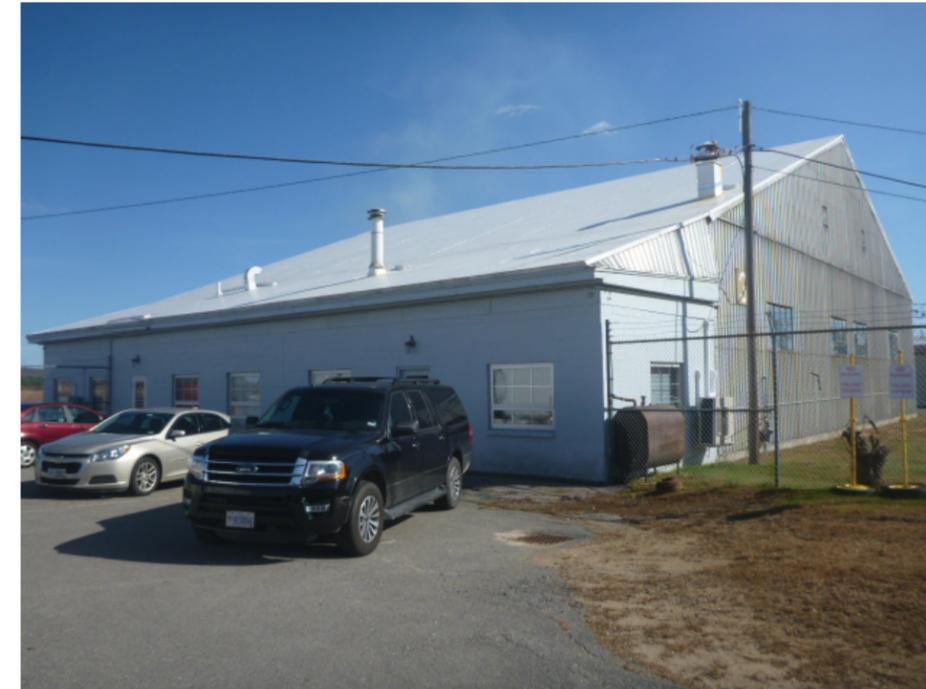
Figure 1-37. Hangar #3 – North Facing Façade
Landside entrance to Hangar #3. This small parking lot is reported to flood.

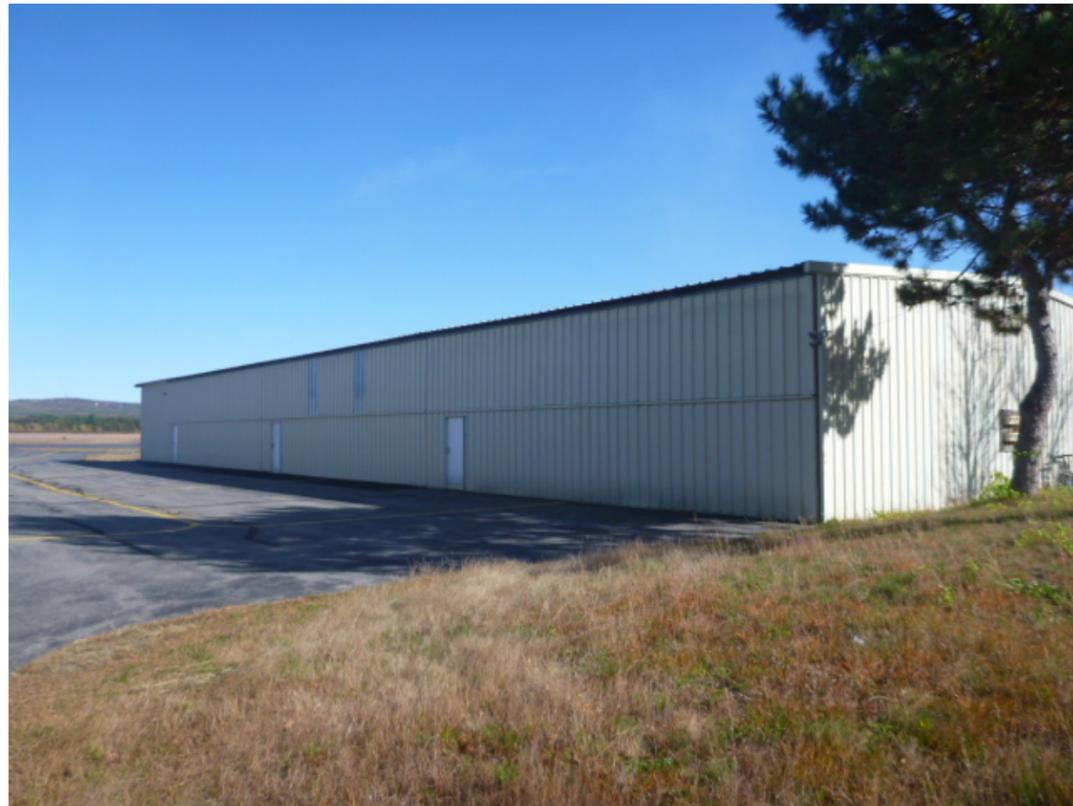
To the south of Hangar #3 are two T-Hangars that are in good condition. The T-Hangars are made of steel frames, aluminum siding, and aluminum roofing. The exterior of the hangars is in good condition and there are a few areas where the siding is dented. The T-Hangar's do not have heating or plumbing but do have electricity. The aircraft bays are lit, and some hangar doors are fitted with clear plastic panes to allow for natural light.

Figure 1-38. North T-Hangar
North facing façade of the North T-Hangar.

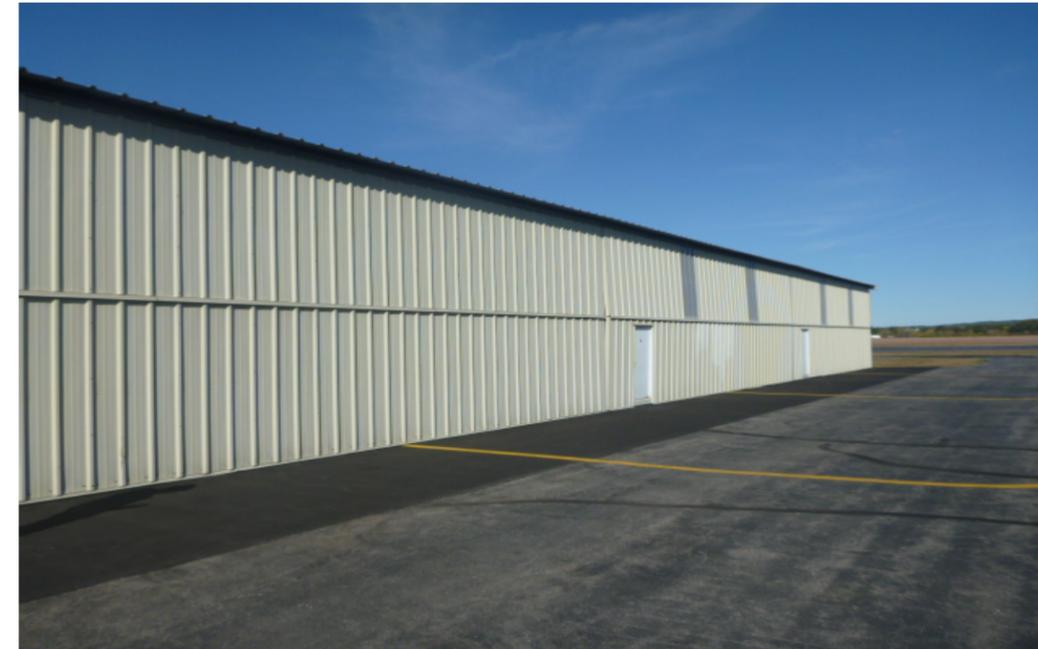
Each T-hangar has six aircraft bays. There are three north facing and three south facing. Combined, both T-hangars provide twelve sheltered parking spaces which are currently all occupied. The pavement surrounding the T-hangar's is made of asphalt and is in fair condition. There are numerous large cracks in the asphalt that have been repaired with rubber crack sealant. The aluminum roofing is in good condition on both T-hangars and there have been no reports of leaking.

Figure 1-39. South T-Hangar
South facing façade of the South T-Hangar.

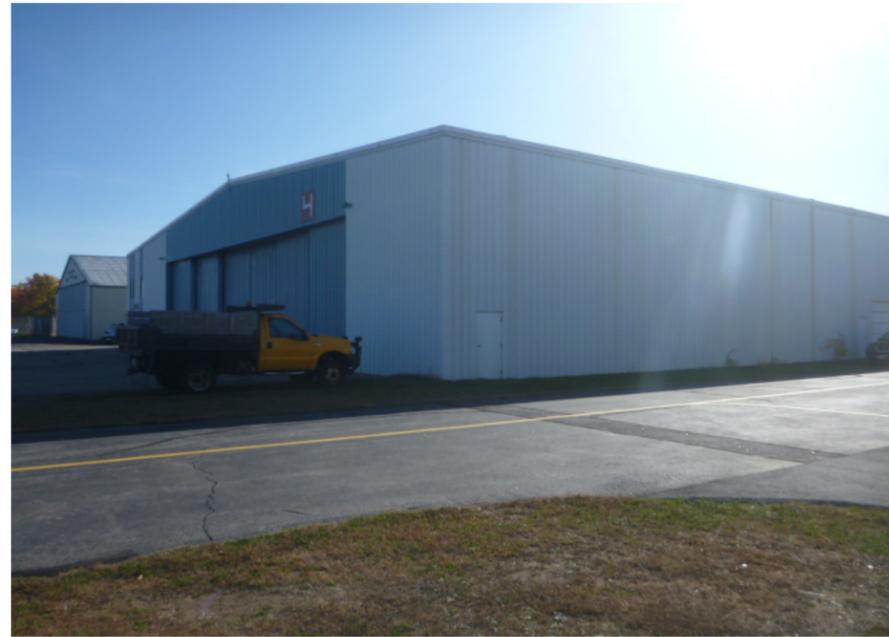
Hangar #4 offers additional heated community aircraft storage which is a commodity in high demand at the Airport. The heat in this hangar is reportedly much more reliable than the that of Hangar #2. The hangar is spacious and can accommodate small jet aircraft and twin turboprop aircraft such as a King Air. Hangar #4 is in good condition both externally and internally. The hangar is constructed of a steel frame, concrete blocks, aluminum siding, and an aluminum roof. The siding is in good condition and showing some signs of aging in a few areas of the structure. The roof is also in good condition and has not shown any signs of leaking or need for repair. The interior of Hangar #4 is very bright due to the white insulation covering the walls and the white paint on the concrete floors. The hanging florescent lights are fitted with newer bulbs that illuminate the hangar with bright white light. The ceiling is in good condition as well. The tiles show no signs of previous water damage or leaking. The insulation surrounding the interior of the hangar is also in good condition and does not show signs of sagging or warping. The floor in Hangar #4 is made of concrete slabs which are worn but fair condition. There are areas of the floor that have large cracks that span across several concrete slabs. Additionally, there are chips throughout the concrete as well as staining and areas of faded paint.

Figure 1-41. Hangar #4 – North East corner
East facing façade (front) and North facing façade (right side) of Hangar #4.

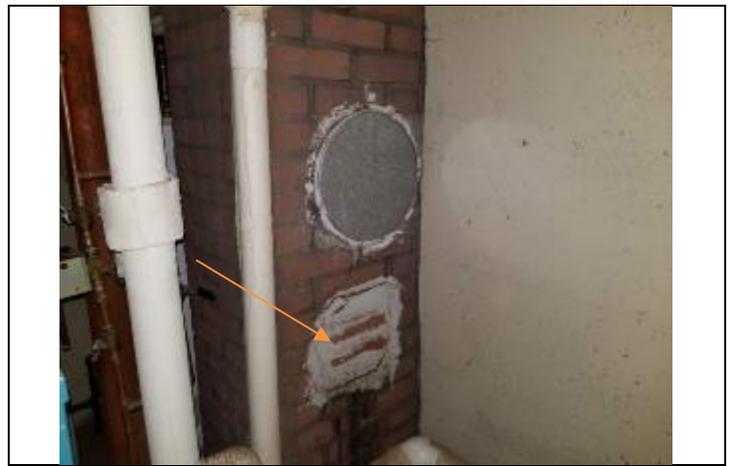
2. Flue cement in room B2..

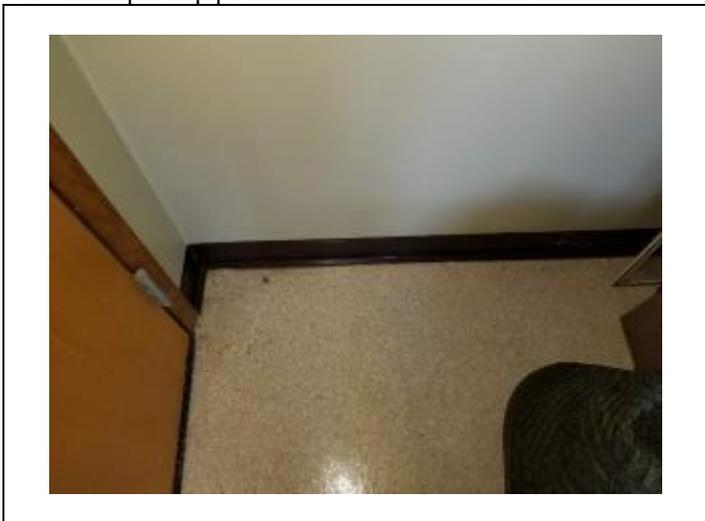
5. ACM pebble pattern sheet flooring and adhesive in Room K.

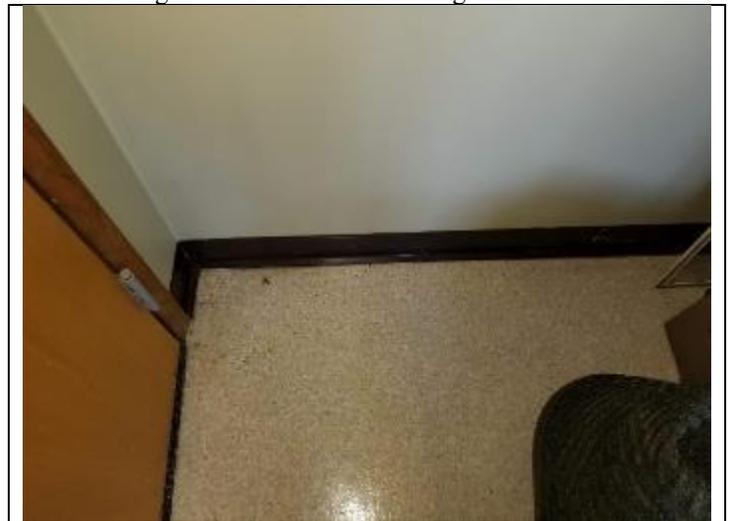
6. Sheet Flooring.
