City of Concord, NH

Storm Water Master Plan

April 2007

Final Report

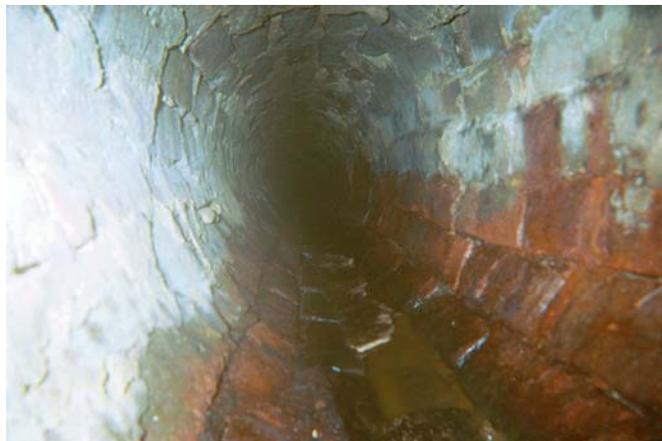
Typical Photo of Pipe Taken During Inspection

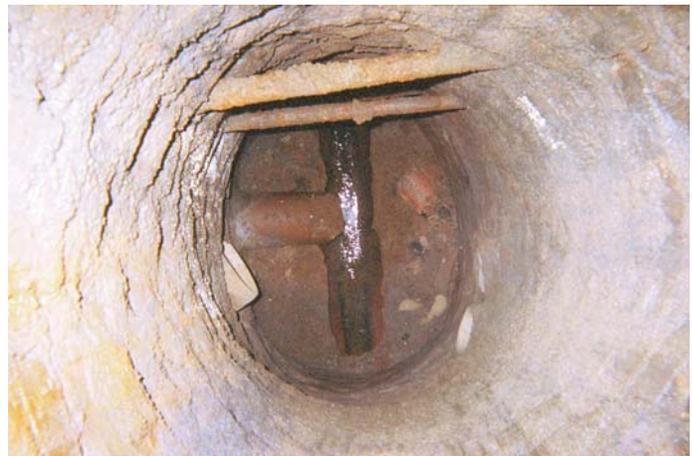
A top-only partial inspection.

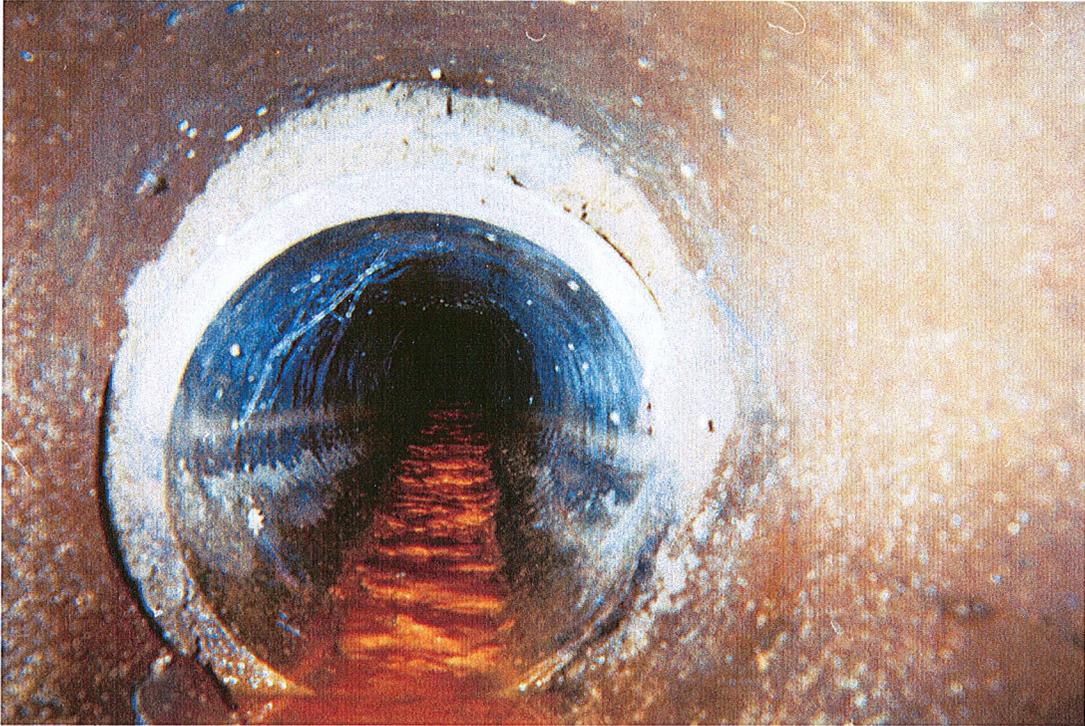
Possible cross connection near the corner of Concord Street and South State Street. The field crew noticed evidence of light sewage and a strong sewer smell on Concord Street flowing east from South State Street to South Main Street (manhole numbers 2033-J14 – above, to 2031-J14). Pipe out of manhole 2032-J14 (towards 2031-J14) is shown below.

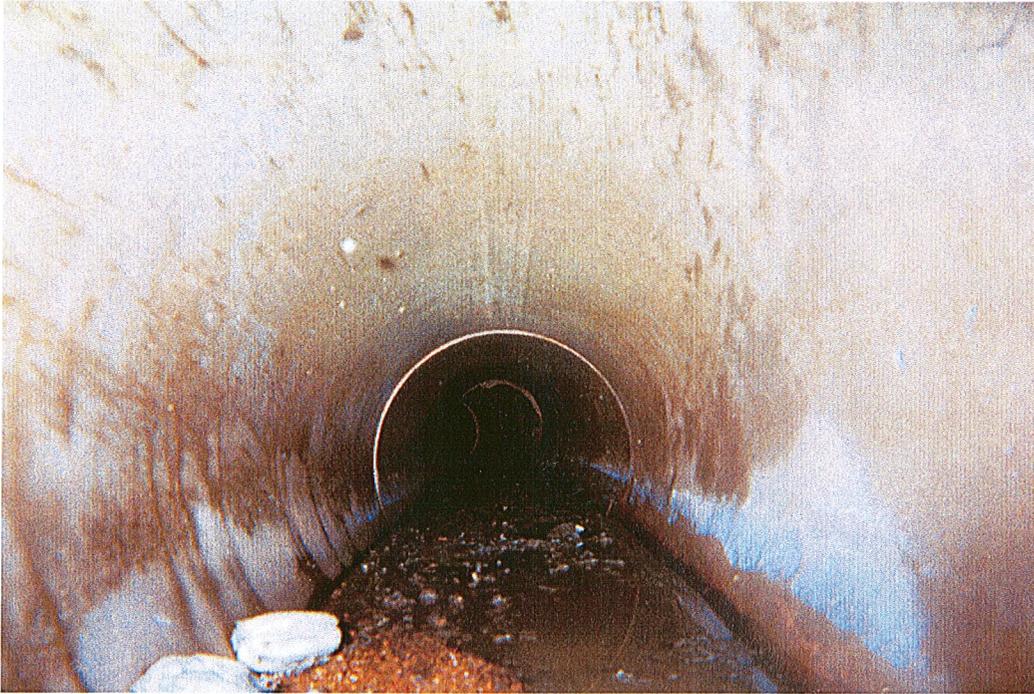
Possible sewage in the drain line running south on Rumford Street from Franklin to Beacon (manholes 3316-I13 to 2973-I13). Pipe leaving manhole 2972-I13, corner of Rumford and Beacon is shown above. Floatables, color and odor all suggest sewage in this line.

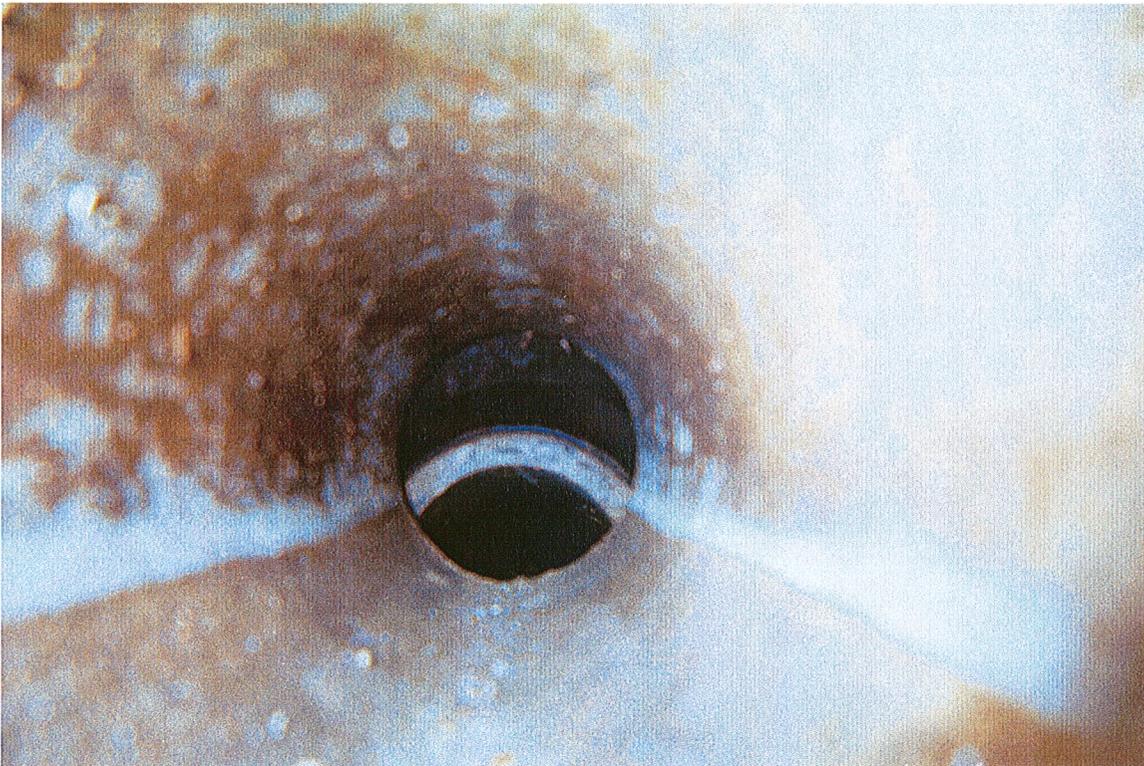
Manhole 3480-I13, Beacon Street at Lyndon Street.
4" catchbasin lateral experiencing differential settling at joint.

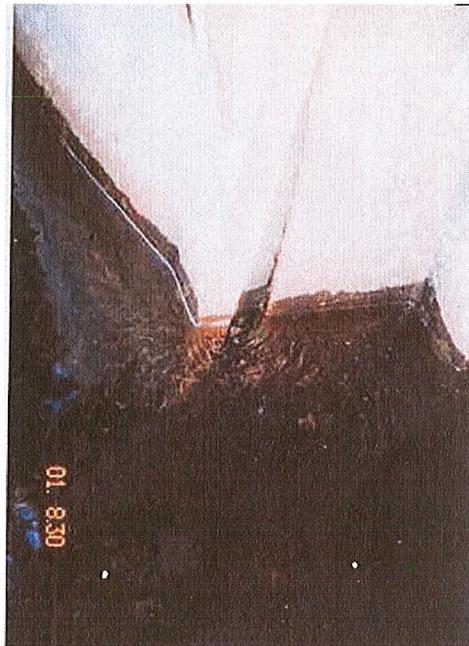
Pipe 2.54
Close up of flapgate edge.

Surface disturbance indicates flow.

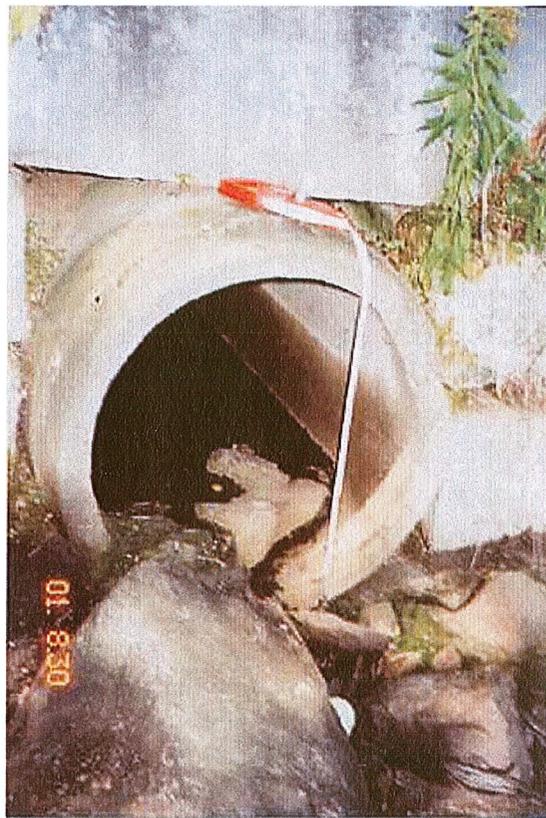
All pipes found in the investigation area are listed in Table 7-1 and Figures 7-1a through g. Eighteen outfalls had no flow during dry weather, including two pipes, 4.24 and 23.48, which contained stagnant flow but were not flowing at the time of investigation. It is unlikely that there are illicit connections in the drainage systems tributary to these pipes. Eleven pipes had flow, while one pipe and a rectangular channel were submerged so flow could not be confirmed. Seven streams were found having regular sandy streambeds entering the main river stem. Five of these streams were flowing, one was not flowing, and flow could not be confirmed at one.

Pipe 4.24 Showing stagnant water.

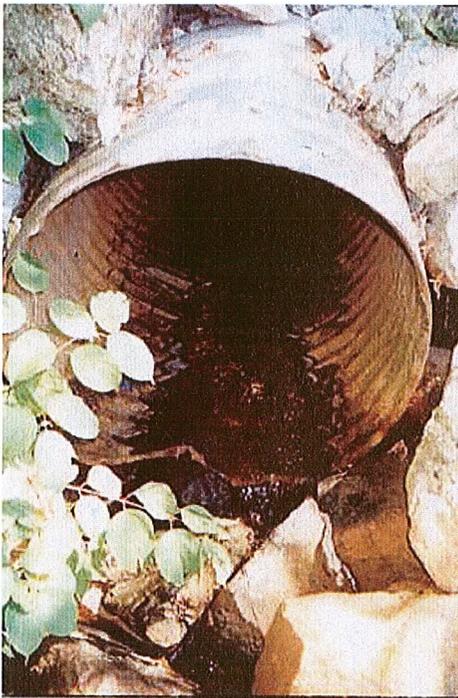
Pipe 6.30 Showing flow.

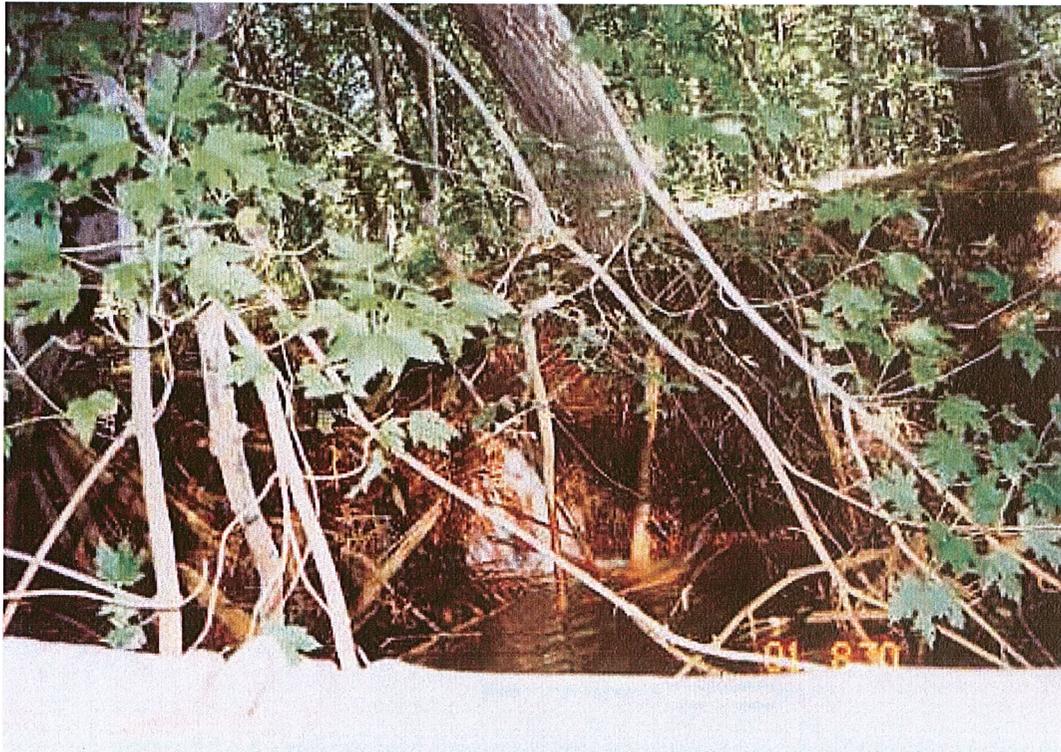
Stream 2: Left bank upstream of Manch St Bridge, and inlet cove.

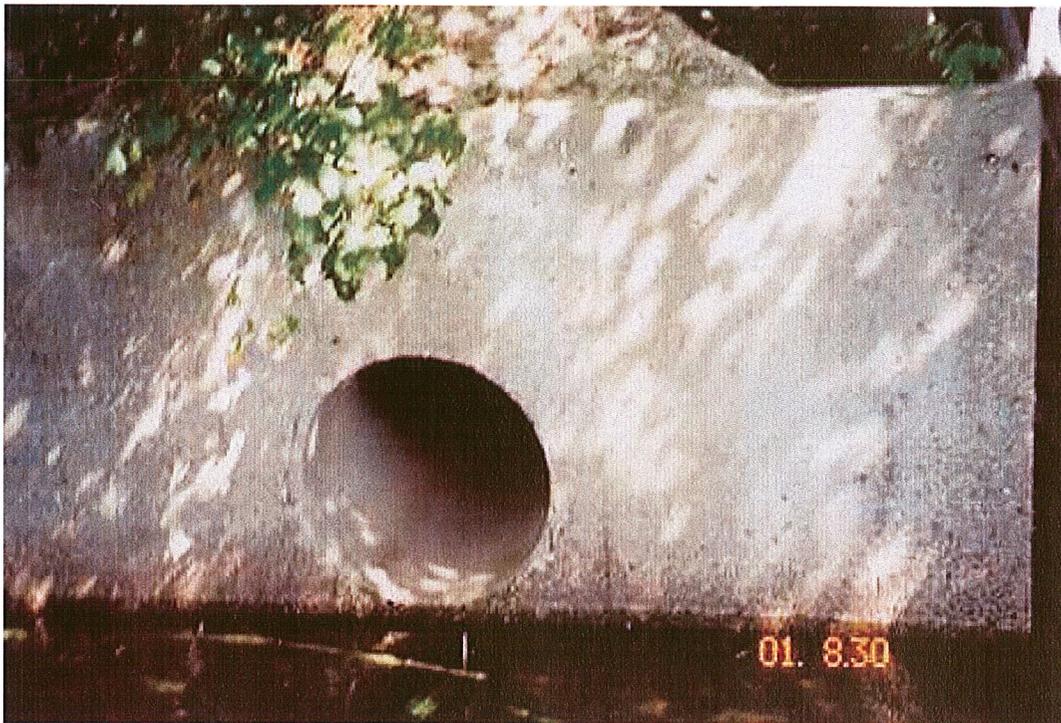
Pipe 9.24, 24-inch pipe. Left bank, d/s of Loudon Road.

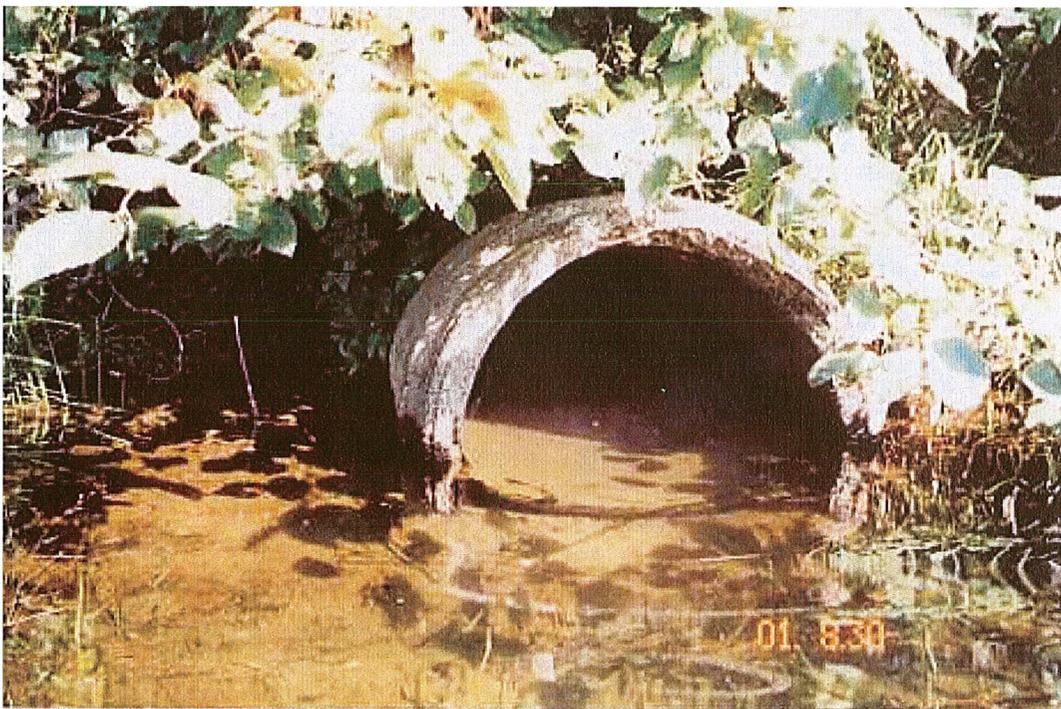
Pipe 10.24, 24-inch pipe. Left bank, d/s of Loudon Road.
Discharge could not be confirmed due to submergence.

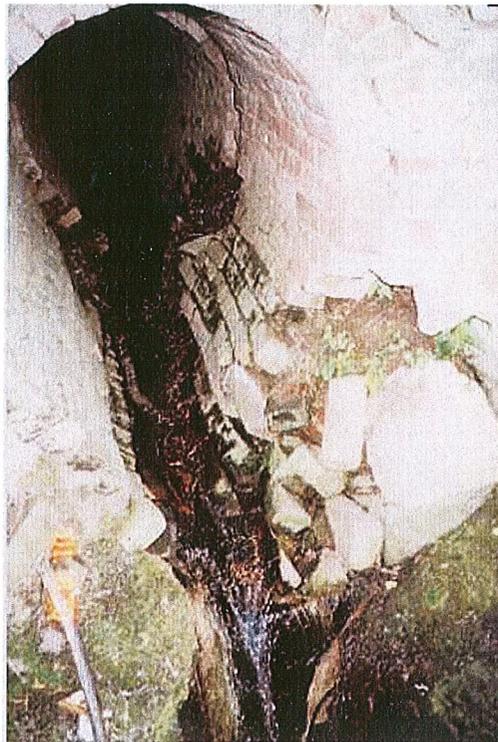
14.egg – Flow approx. 2gpm

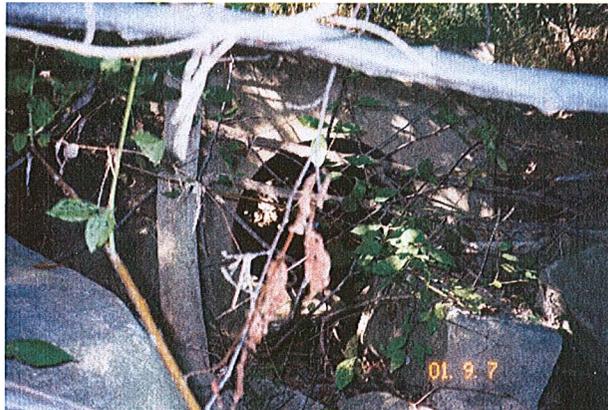
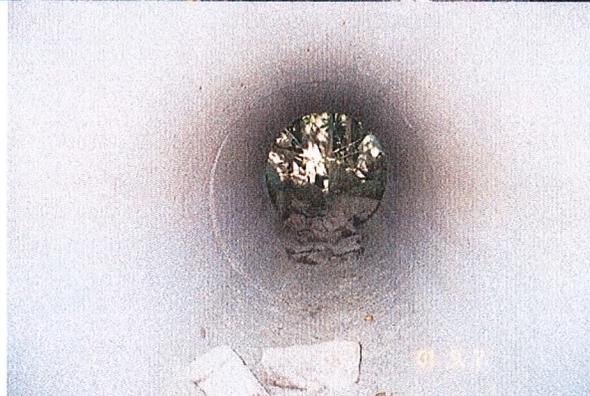
Pipe 18.36 – 36-inch pipe. Right bank, upstream of 393 Bridge.
Just a short length of pipe, overgrown, but not flowing.

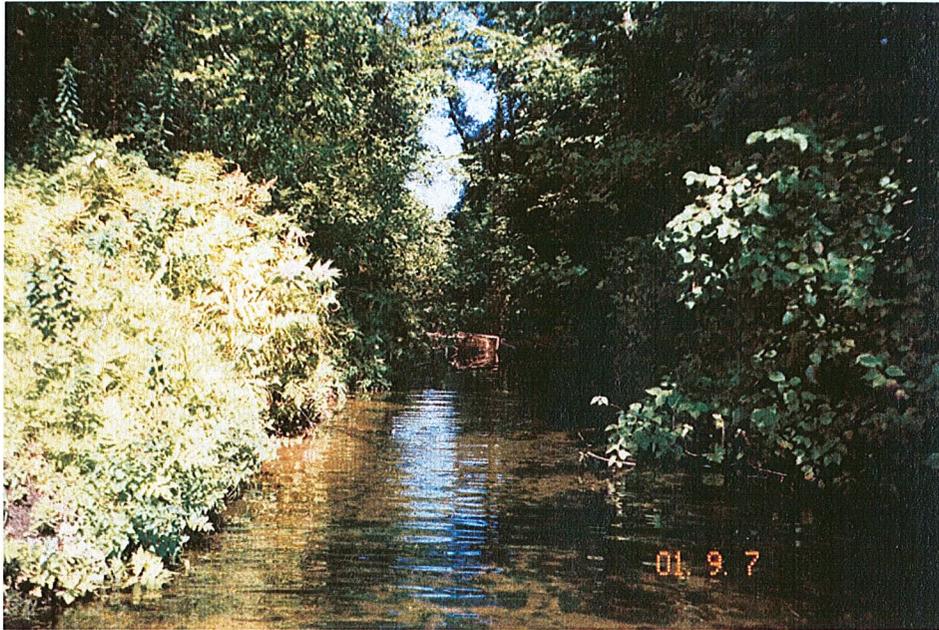
Stream 3 – shopping carts make it impassible by boat.

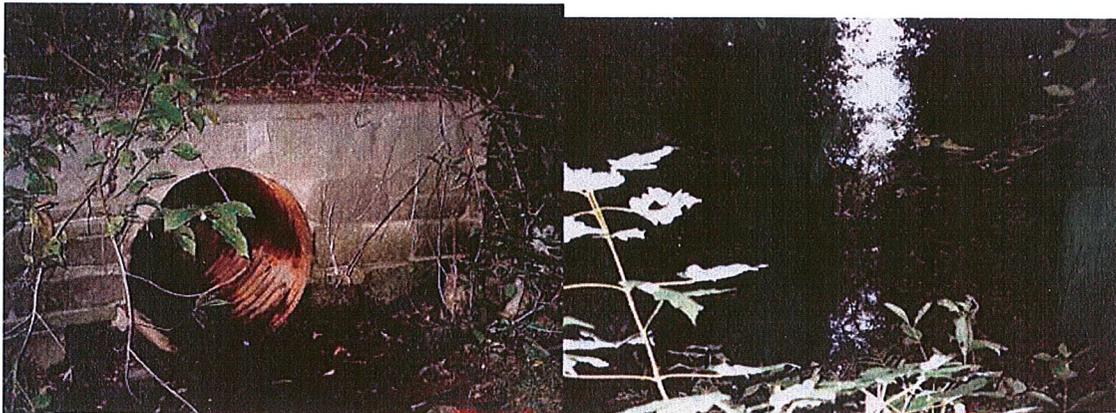
Pipe 21.30 – 30 inch outfall into Stream 4. D/S from 21.30.

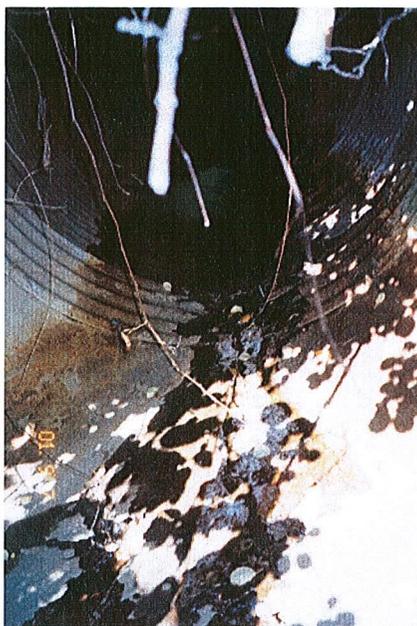
Pipe 23.48 – 48"
Flow too shallow to sample.

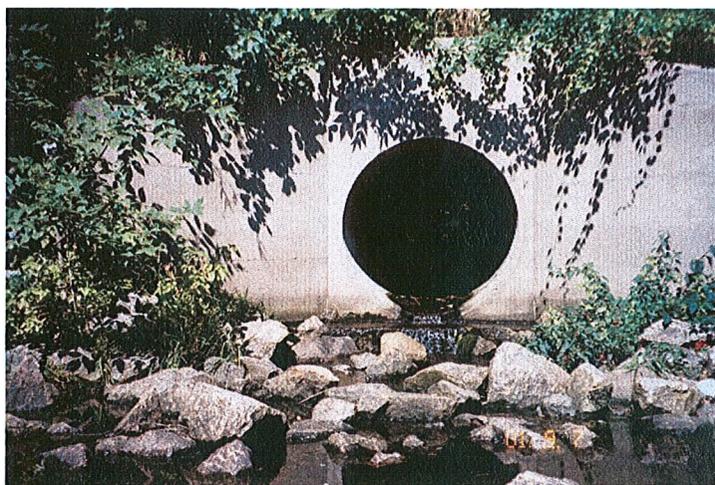
Pipe 24.54 – 54-inch pipe. Right bank u/s of Loudon Road.

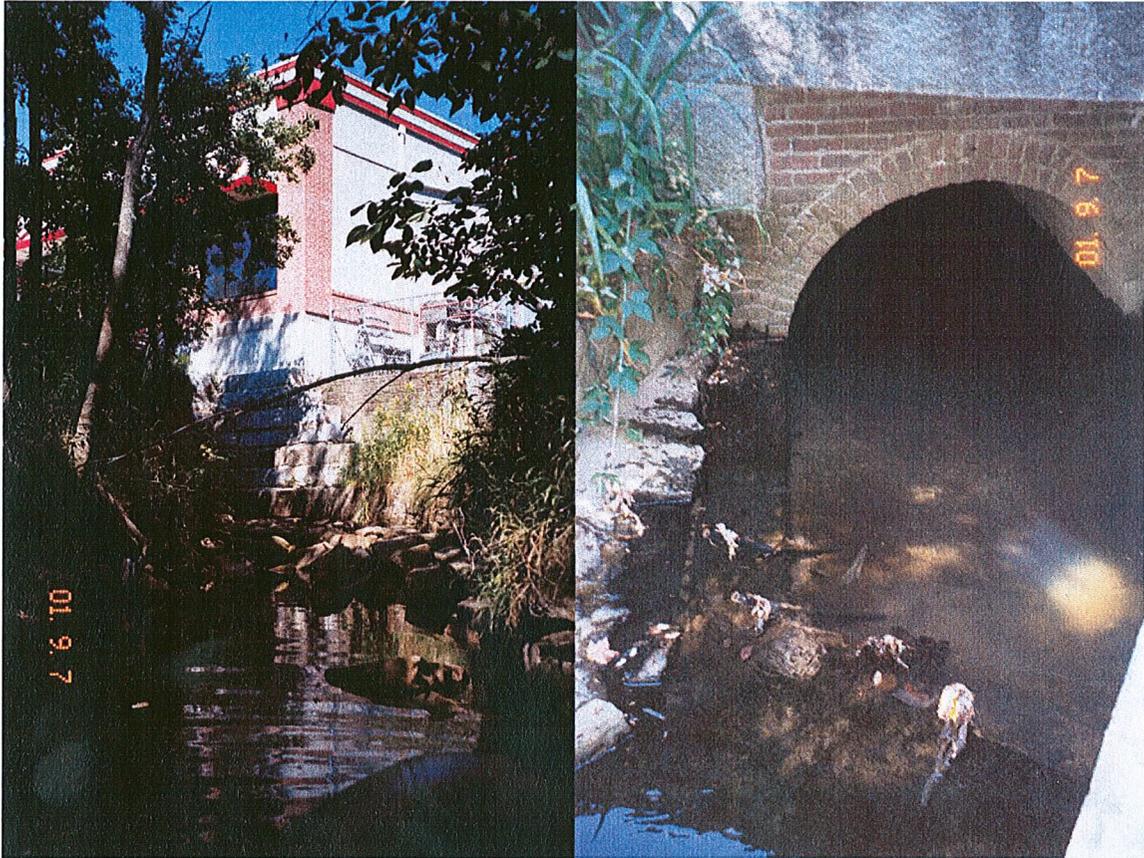
Pipe 25.54 – 54-inch brick pipe. Evidence of stormwater (debris). Outfall is located at edge of Boston Market parking lot, under stone lintel.

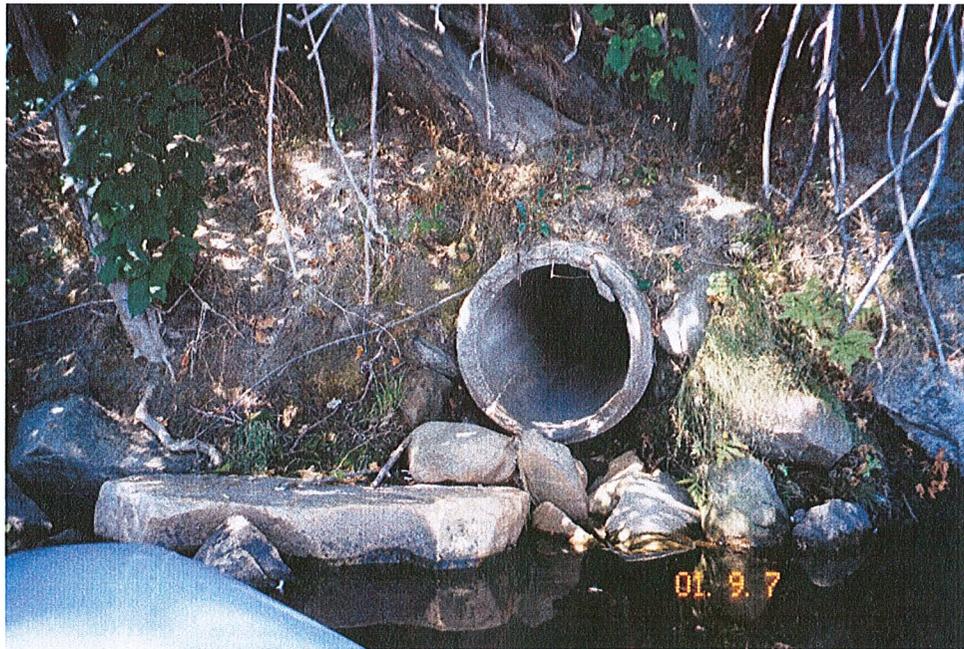
Pipe 26.18 – 18-inch concrete. Right bank upstream of Loudon Road.

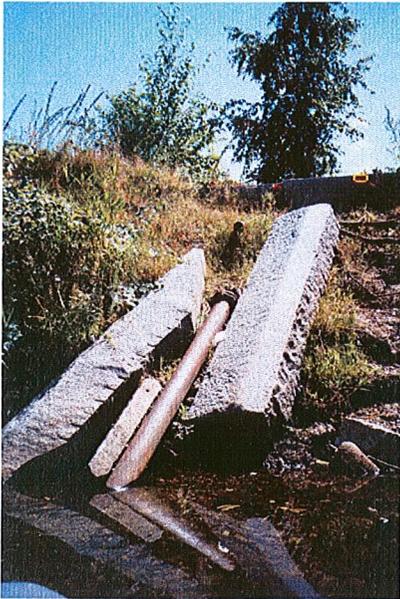
Pipe 28.5 Left bank. Iron pipe near fire station's practice building.

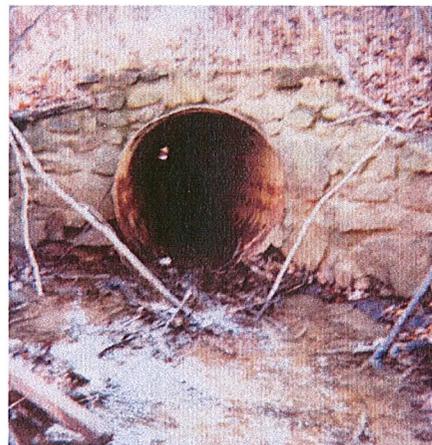
C3.48
48" galvanized pipe
under I393 from Sugar Ball Rd.

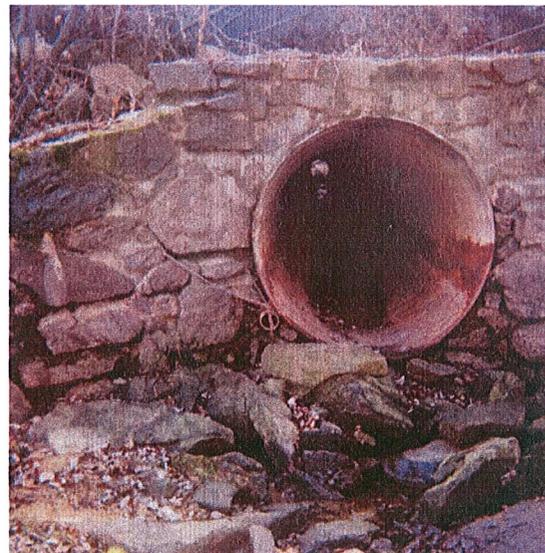
C5.4

48" Galvanized pipe
under I393

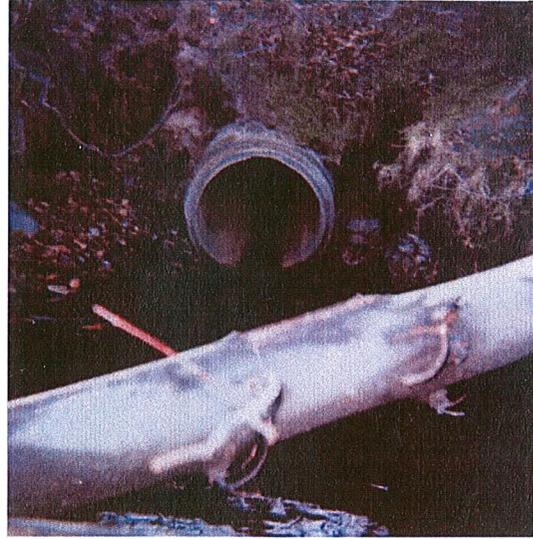
C7.24
24" RCP
By Everett Arena

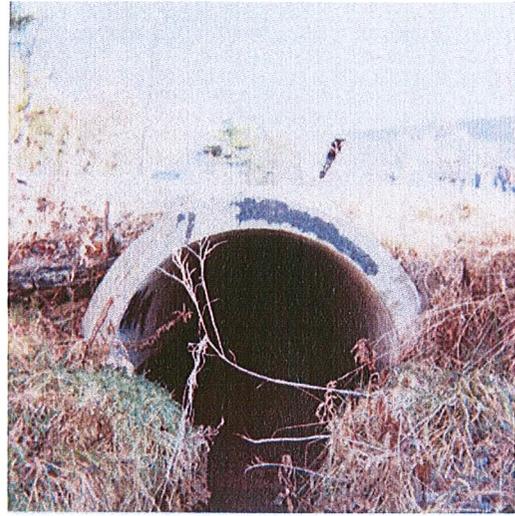
C11.60
6" RCP

By Old Turnpike Road
Behind Commercial Bldgs.

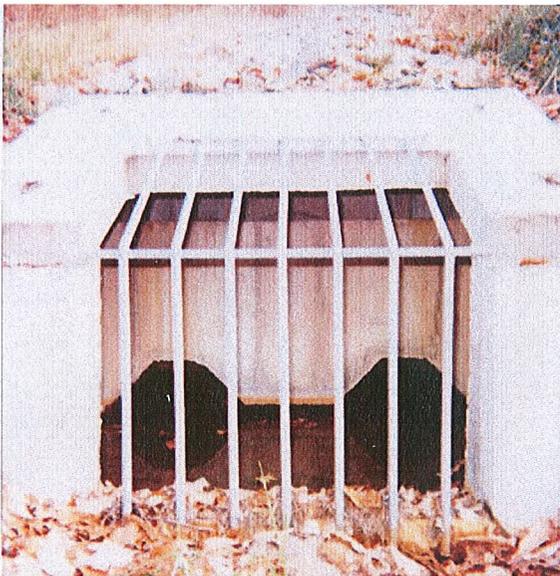
C12A

Twin concrete pipes
Garvin Falls Road Outlet
